Vendor Surveillance / Inspection Report – 01

Inspection item description Kelt Inlet Separator OAK Project 5486

PO #:	AFE 2106 0013L			Report #:	003		
Level of Inspection:	Periodic review			Date of Visit:	June 18 2021		
Equipment Description:	Inlet separator package			Tag #:			
Type of Inspection:	Visual surveillance of build final						
PO Delivery Date:				Estimated Delivery Date:	July 2021		
Project:	Oak Inlet Separator			LSD:			
Inspector:	Mark Copithorne			Phone/Email:			
CEL Quality Contact	403-844-3341			Phone/Email:			
Vendor:	Aspire Energy			Vendor Job No:	5486		
Vendor Main Contact Name:	David Street			Phone/Email:	403-314-5422		
Location of Equipment:	22 Mckenzie Dr Red Deer AB						
Applicable Codes, Standards, and Specifications:	<p>Please refer to the Engineered Design / Drawings, Fabrication and Assembly Codes / Standards and applicable Engineering Specifications utilized for the particular equipment / project for acceptance criteria and LIST THE DOCUMENTS IN THIS SECTION.</p> <ul style="list-style-type: none"> • ASME B31.3 • ASME Section 8 Div 1 • CSA B51 • PESR • Alberta Safety Codes Act • Standard Industry Practice • Specifications <p>The percentages below are ba

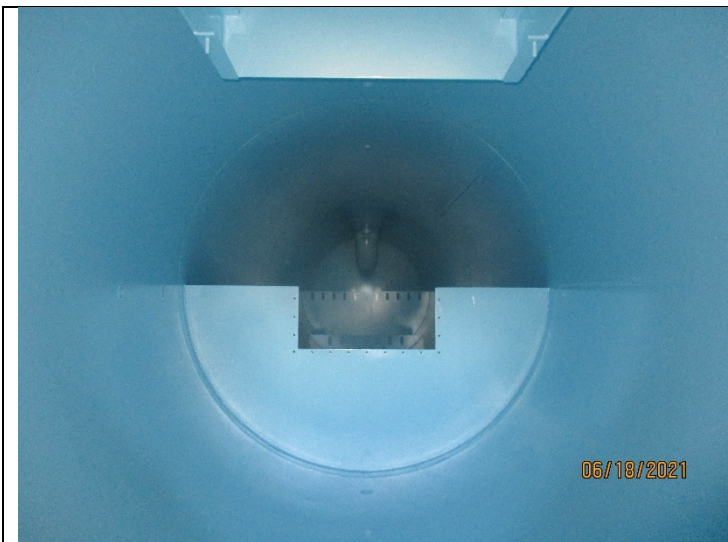
Figure 1 weir assembly as to be shipped

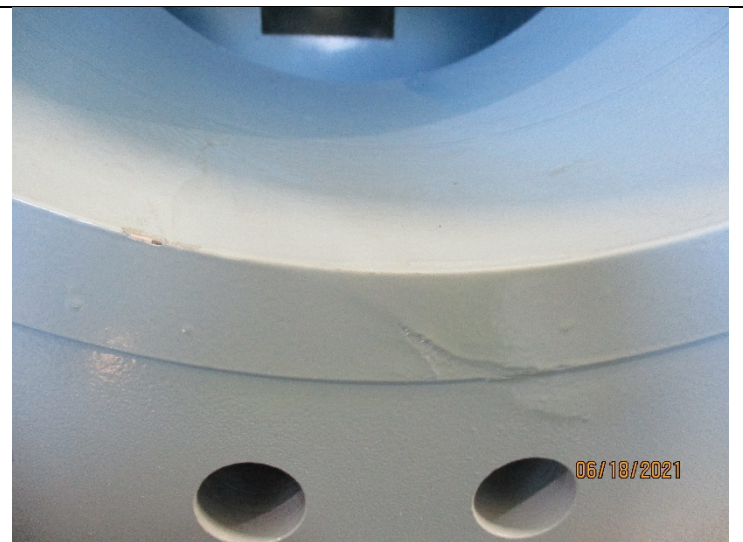
Figure 2. damage to manway coating, seal face. To be repaired by Aspire May 19 2021

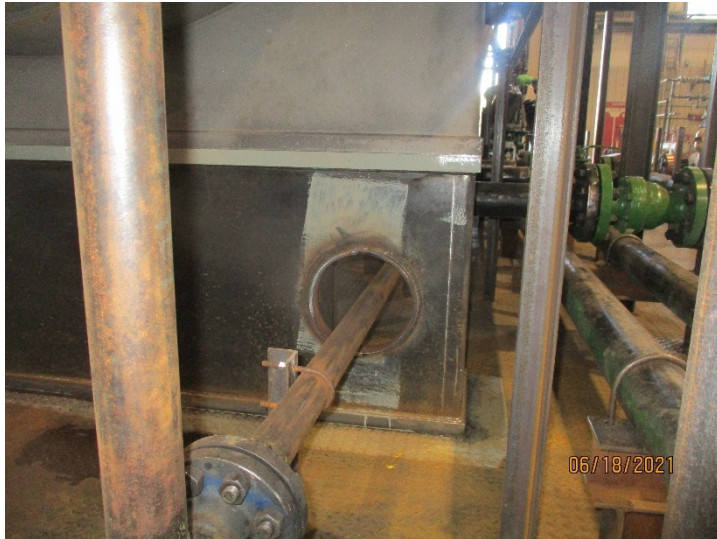
Verify hole in saddle support will not affect load bearing ability of the vessel with full hydrotest weight of water.
David Street to supply supporting engineering documentation

Hole thru saddle support, Aspire to confirm load bearing ability of saddle with full hydrotest weight

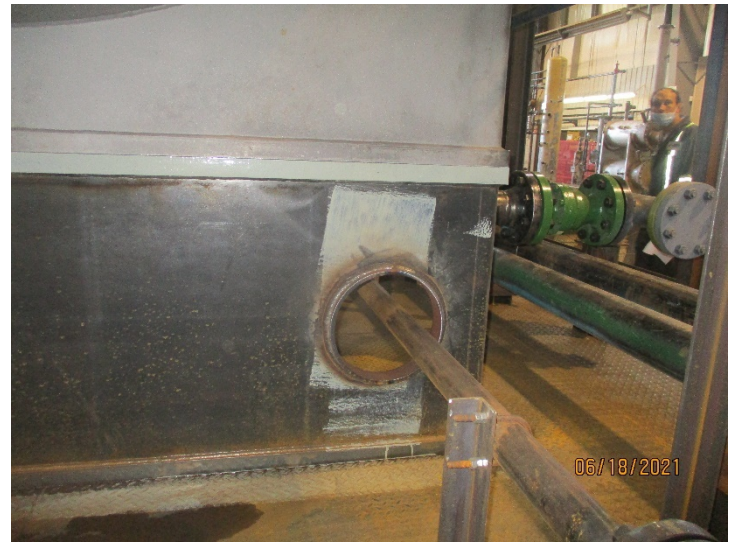
Hole is 8 inch diameter with a 0.375" wall reinforcement

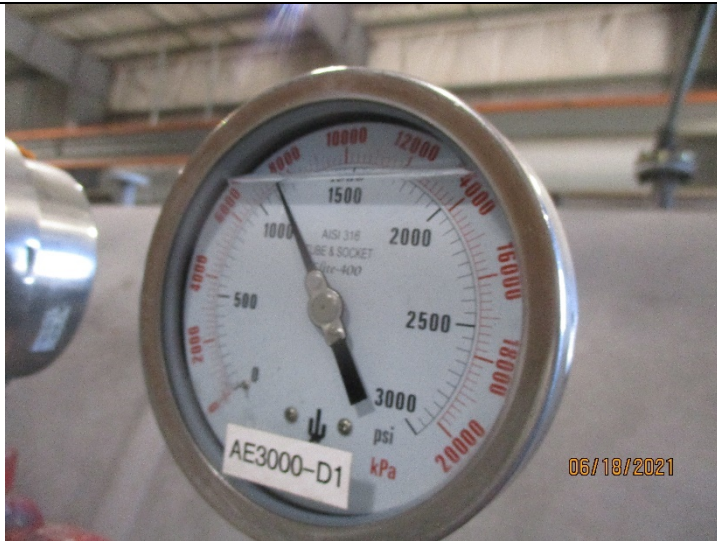
Figure 5: Piping hydrotest at 1100 psi Gauge AE 3000-D1

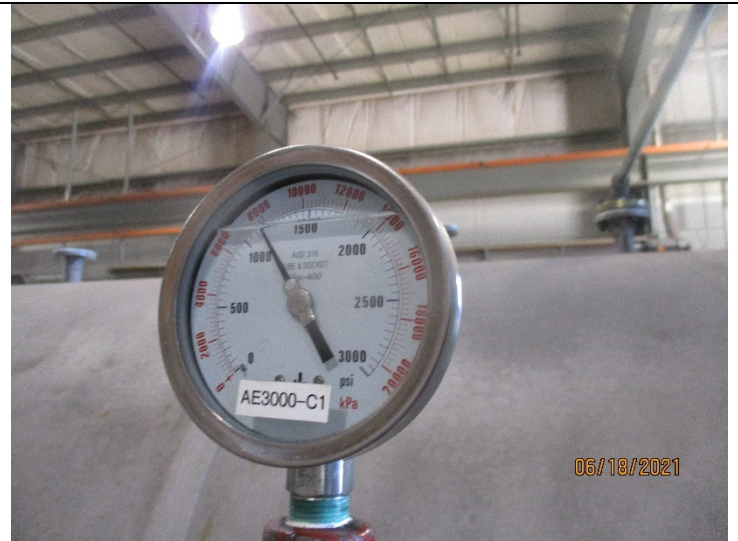
Figure 6: Piping hydrotest at 1100 psi Gauge AE 3000-C1
