**Canadian Natural Resources Limited
GENERAL PRESSURE VESSEL INFORMATION**

District: Fort St. John, BC		Skid No.					
Facility: Lady Fern Compressor Station		Location (LSD): b-17-I/94-H-01					
Vessel Name & Equipment Number: LPG Storage Bullet							
Orientation: Horizontal							
Status: Operating				Regulatory Inspection			
PRESSURE VESSEL NAMEPLATE DATA							
Registration Number A0571773				CRN Number T 3671.23451			
Vessel serial number: S0700031				Size: 9 ft x 64 ft 7 in			
Shell thickness: 17.4mm				Shell material: SA 516 70N			
Head thickness: 10.2mm				Head material: SA 516 70N			
Tube wall thickness:				Tube material:			
Tube diameter:				Tube length:			
Channel thickness:				Channel material:			
Design pressure	Shell: 250 PSI			Operating pressure	Shell:		
	Tubes:				Tubes:		
Design Temp.	Shell: 125 deg F			Operating temperature	Shell:		
	Tubes:				Tubes:		
X-ray: RT-4				Heat treatment: Nil			
Code parameters: ASME VIII / Div 1				Coated: No			
Manufacturer: Trinity Containers LLC				Built: 2007

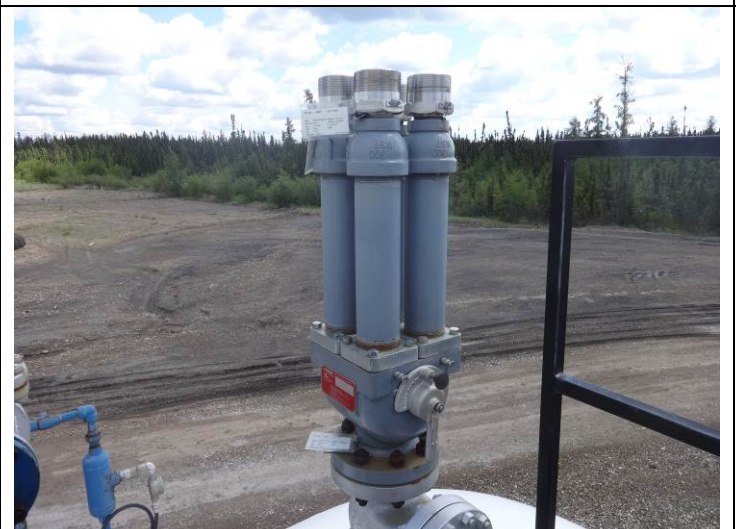
PSV Block Valve, locked open
