**Canadian Natural Resources Ltd.  
GENERAL PRESSURE VESSEL INFORMATION**

**Job# 105.00390**

District: <b>Fort St John, BC</b>	Skid No.
Facility: <b>Ladyfern Compressor</b>	Location (LSD): <b>b-17-I/94-H-01</b>
Vessel Name Equipment Number: <b>LPG Storage Bullet</b>	
Orientation: <b>Horizontal</b>	
Status: <b>In Service</b>	Regulatory Inspection

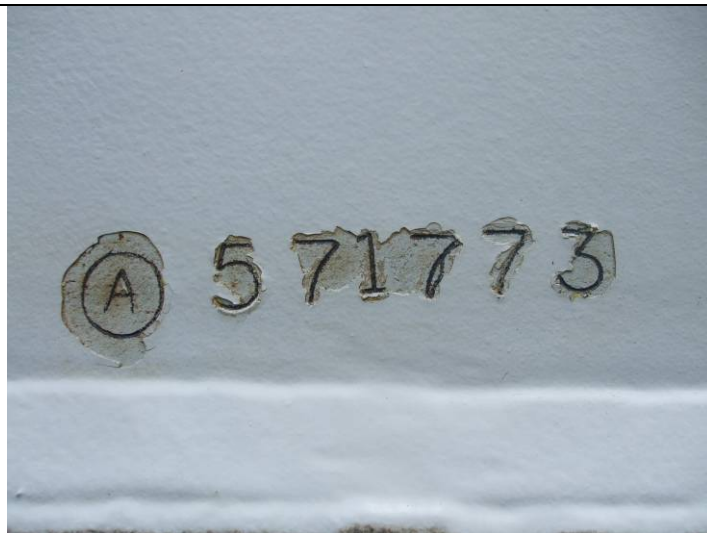
A# stamped on the shell

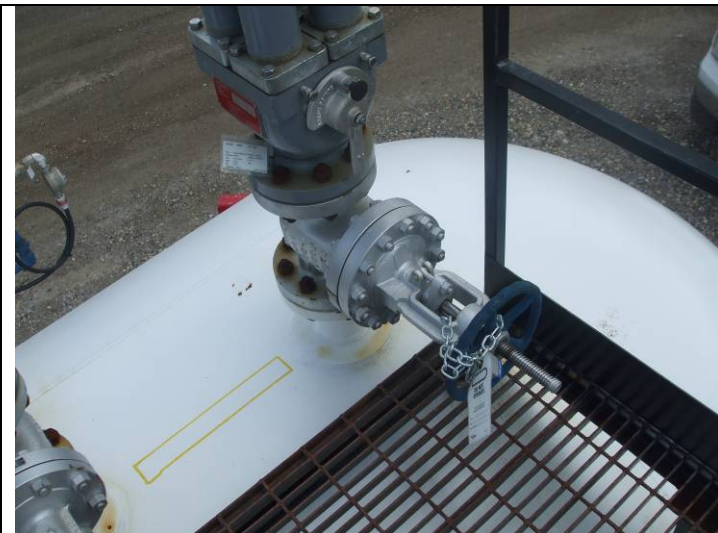
<b>Valving</b> Ensure no leaks are visible. Valves are properly supported and chained if necessary.	X				<b>Well supported – no leaks.</b>
<b>PSV</b> Ensure PSV is set at pressure at or below that of vessel.	X				<b>Located on Top Shell - set at the LPG Bullet's MAWP. Discharge piping is four 2" outlets. Block valve locked open. Seal is intact. PSV vents to flare.</b>
<b>NDE methods</b> Was UT/ MPI done on vessel (MI coordinator to review results)	X				<b>Ultrasonic thickness survey carried out-no metal thickness detected below nominal.</b>
<b>Other</b>					
<b>Recommendations or corrective actions : Vessel is Fit for Service or describe corrective actions required)</b> (MIC to review corrective actions with Operations, discuss with Chief Inspector where necessary, and get remedial action implemented) <b>Recommendations: 1. No recommendations at this time.</b> <b>Summary:</b> This vessel is in good over all condition, visual external and ultrasonic thickness survey carried out-no metal thickness detected below nominal. <b>Vessel is fit for service.</b>

PSV location – B/V Locked open

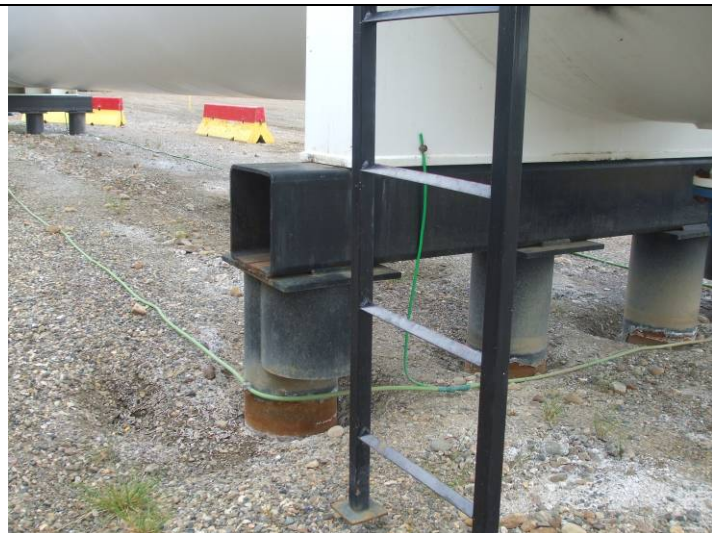
<b>External Inspection Items</b>	G	F	P	N/A	<b>Comments</b>
<b>Insulation</b> Verify sealed around manways, nozzles, no damage present, and there is no egress of moisture.				X	<b>Vessel is not insulated.</b>
<b>External Condition</b> Assess paint condition, areas peeling, record any corrosion, damage, etc (record location, size and depth of corrosion or damage)		X			<b>Paint is in fair overall condition – Minimal chipped paint less than 5% with exposed metal - no previous corrosion.</b>
<b>Leakage</b> Record any leakage at flanges, threaded joints, weep holes on repads, etc.	X				<b>No leaking detected.</b>
<b>Saddle</b> Assess condition of paint, fire protection, and concrete. Look for corrosion, buckling, dents, etc. Look at vessel surface area near supports. Verify no signs of leakage at attachment to vessel and attachment welds are acceptable. Ground wire attached?	X				<b>No distortion to saddles – no leaks at saddle to shell welds. No exposed metal – no corrosion. Ground cable firmly attached to skirt &amp; pilings.</b>

Grounded – Skirt & Piling

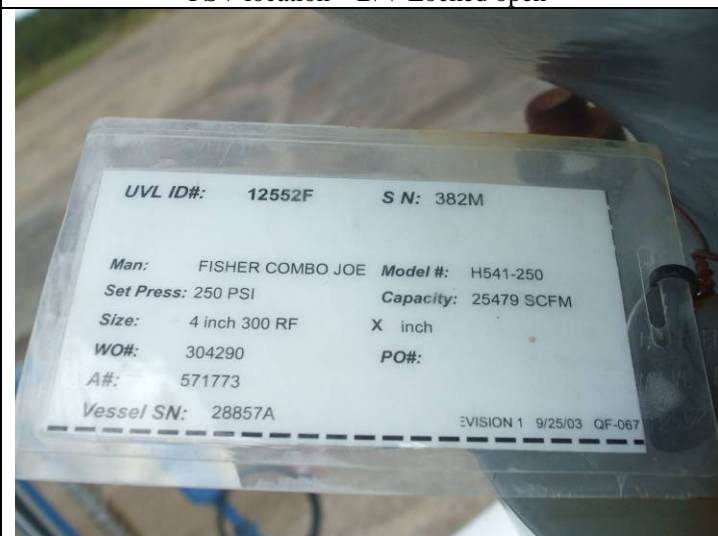
PSV service tag – last service 11-2007
