Bootis Hill Integrity Management Inc	Installation Inspection Form (Electronic)	Form No. 001
Revision # 1		Effective Date: 2013-02-18

Owner	Yoho Resources	Location	10-09-079-05W6
		Field	Howard
Vessel Data			
Vessel Description	Flare Knockout	PWHT	NO
Manufacturer	Bilton Welding & Mfg. Ltd.	Diameter	6'
A# / NB#	A0538157	Length	20'
Serial #	13930	Radiography (RT)	
CRN #	R6405.2	Corrosion Allowance	0.125"
Date Built	2005	Shell Thickness	0.375"
MAWP	50 PSI	Shell Material	
MAWT	100 ° F	Head Thickness	0.313"
MDMT (-29C)	-20 ° F	Head Material	
PSV Data			
PSV #1		PSV #2	
PSV Location	No PSV	PSV Location	
Manufacturer(s)		Manufacturer(s)	
Serial #		Serial #	
CRN #		CRN #	
Model #		Model #	
Set Pressure	kPa	Set Pressure	
Capacity	scfm	Capacity	
Service or Built Date		Service or Built Date	
Service Company		Service Company	
Inlet Size		Inlet Size	
Outlet Size		Outlet Size	
Inlet Type	Threaded	Inlet Type	
Outlet Type	Threaded	Outlet Type	
PSV Outlet Trapped	NO	PSV Outlet Trapped	
PSV Inlet Restricted	NO	PSV Inlet Restricted	
PSV Outlet Restricted	NO	PSV Outlet Restricted

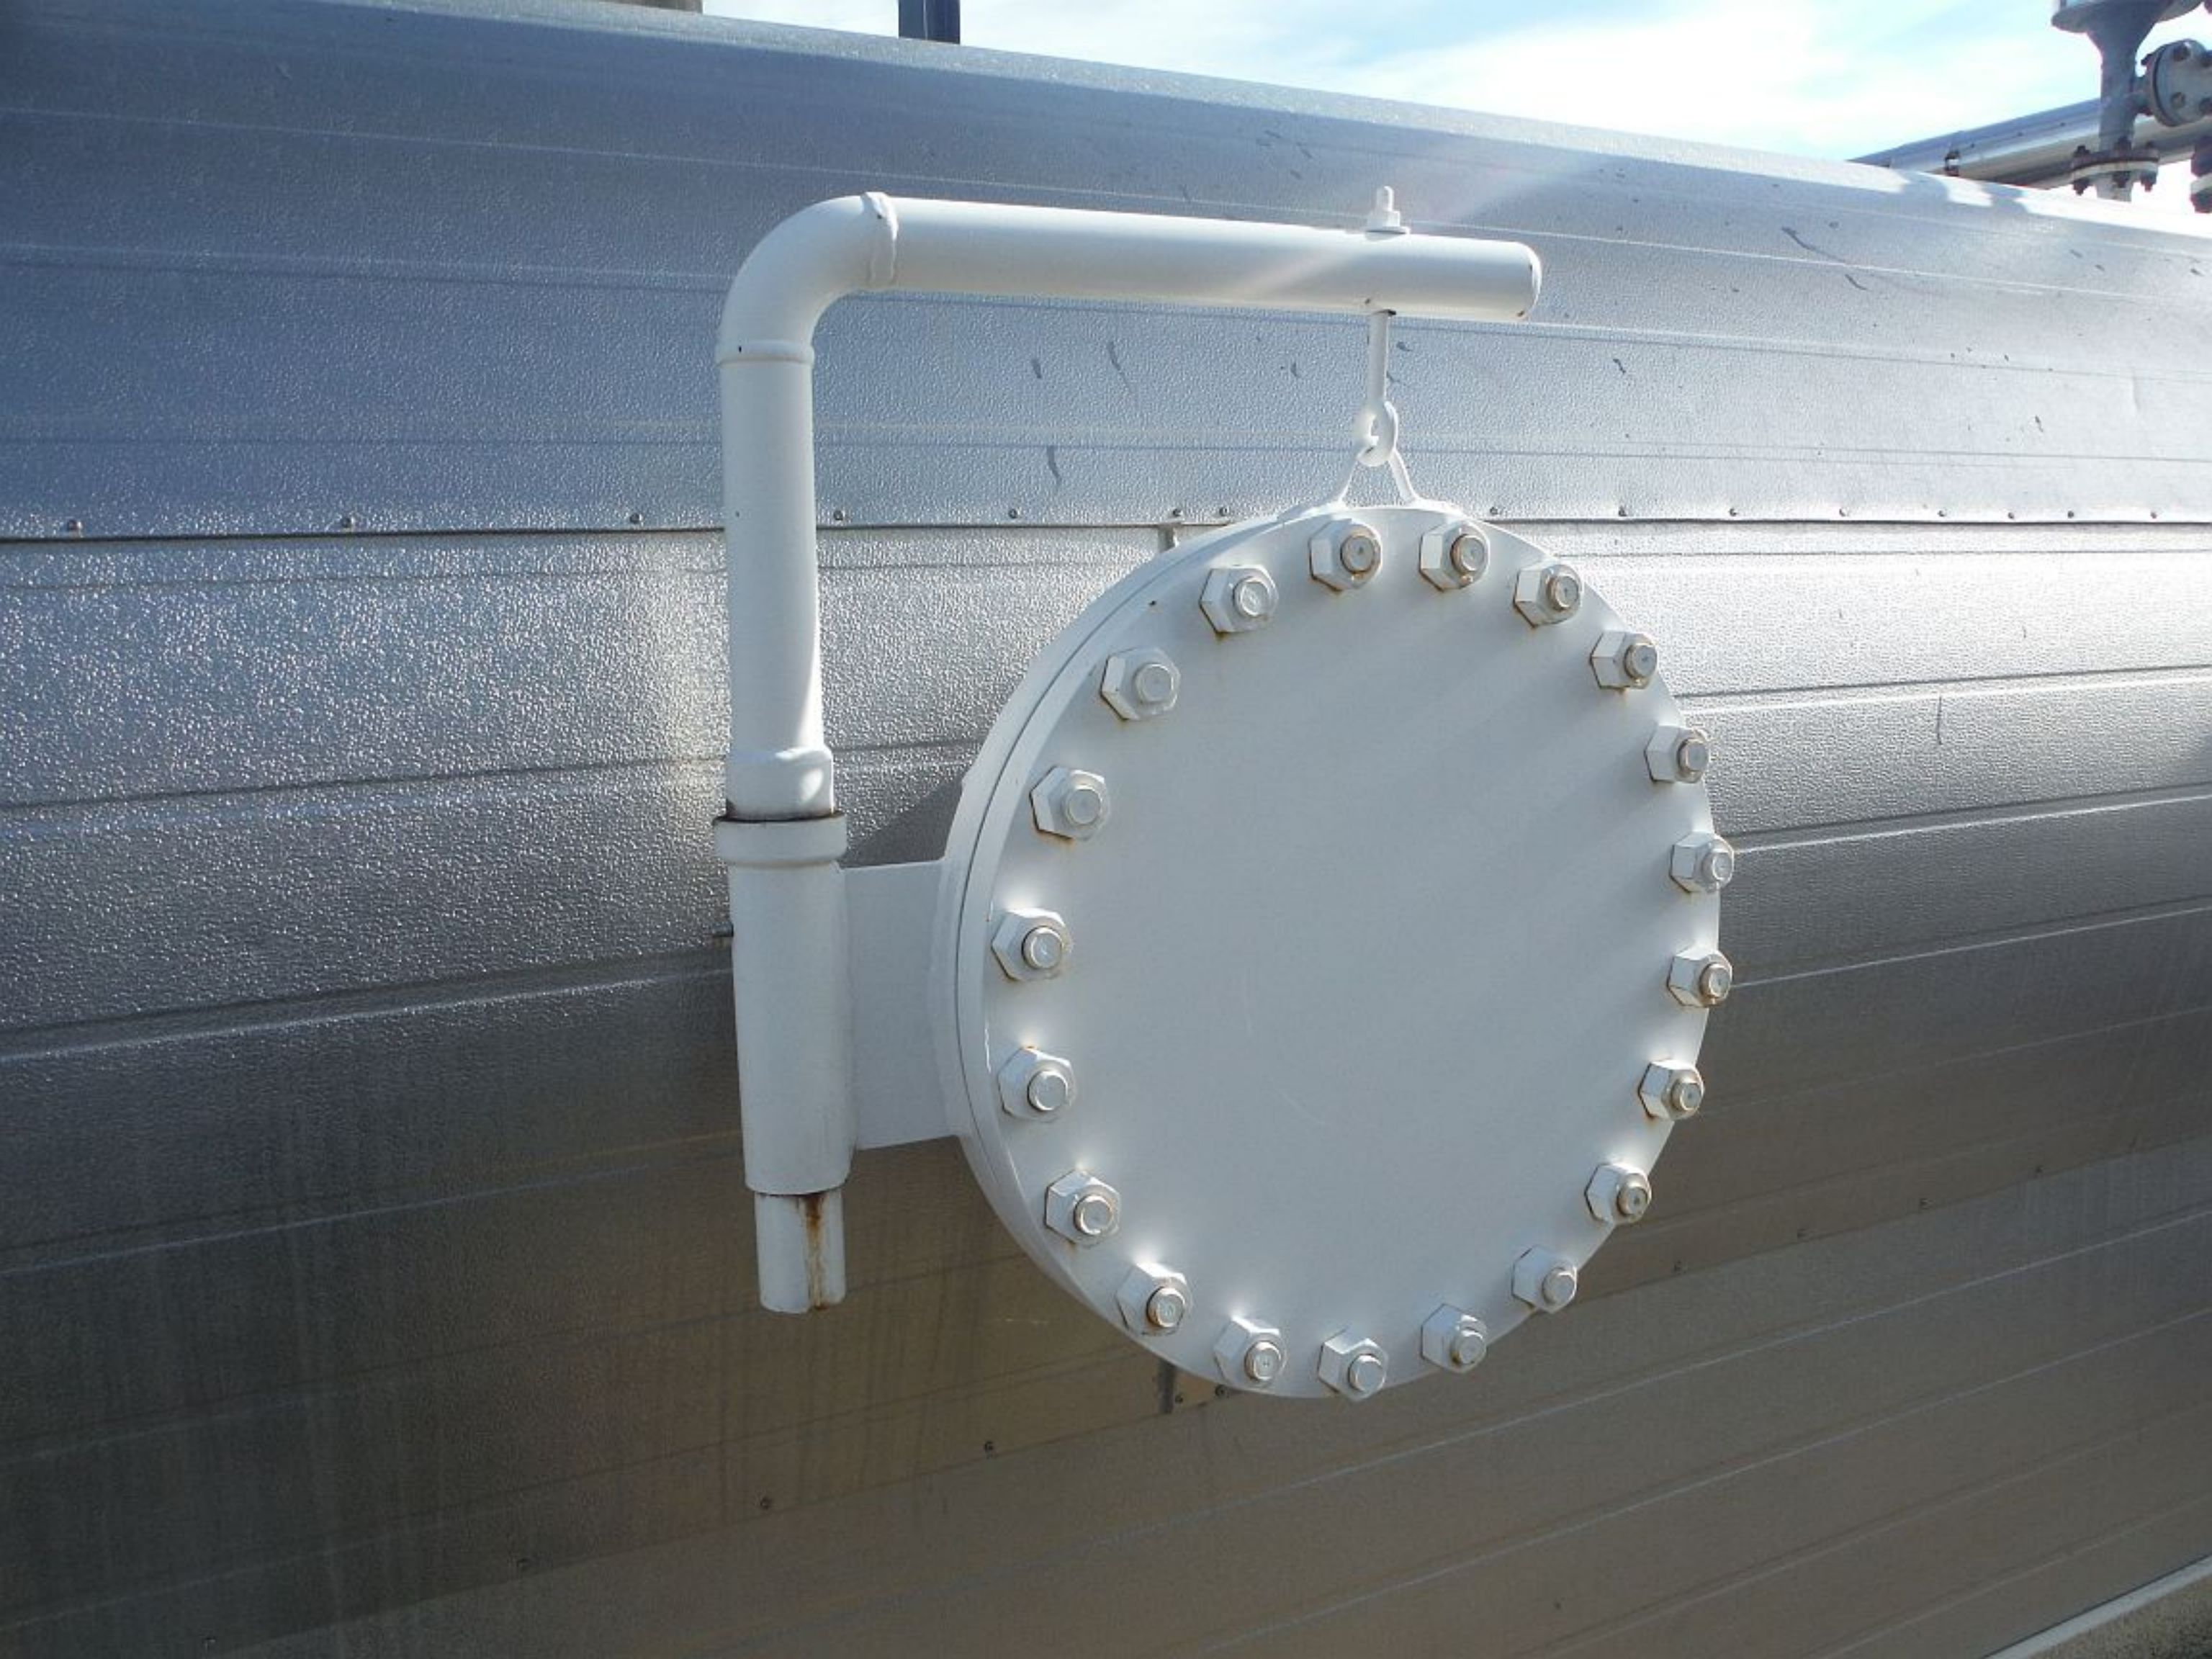
MAW.P. 50 PSI 345 KPA AT 100 °F 38 °C

MD.M.T. -20 °F -29 °C AT 50 PSI 345 KPA

SERIAL NO 13930 YEAR BUILT 2005

C.R.N. R6405.2 U538157

DESC. 72" X 20" KNOCKOUT DRUM

SHELL THK 0.375" MIN. HD. THK 0.313" MIN.

CORR. ALLOW 0.125"
