TANK INSPECTION REPORT

Report # **TK- ET10AUG2015b**

Facility	Drayton Valley	Location	Warehouse / Boneyard	Date	Aug 10, 2015
Serial #	STTK-QJ-T2-15675	PW Equipment #	PWA - 19577	Capacity	400 bbl
Manufacturer	Bilton	Year	2011	Product Stored	
Tank Location	Construction <input checked="" type="checkbox"/> Steel <input type="checkbox"/> Fibreglass Other: _____

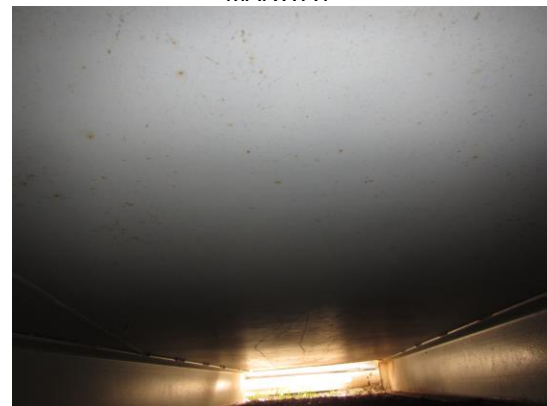
FLOOR UNDERSIDE

Comments/Recommendations: Floor underside 100% visible. No corrosion or damage noted. Floor topside coated, coating in good condition. No failures noted. UT scans found no evidence of wall thinning.

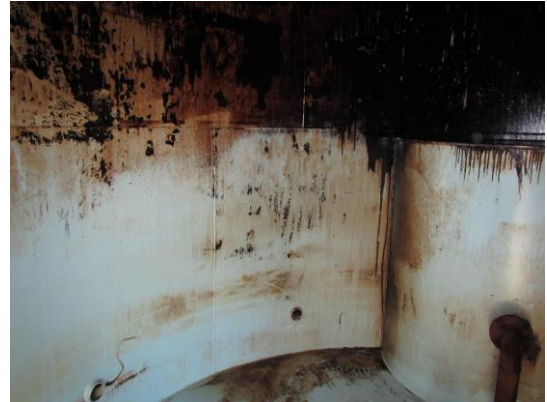
SHELL OVERVIEW

Comments/Recommendations: Shell foam insulated externally. No visual performed. Foam insulation in good condition. Shell coated internally, coating in acceptable condition, with no failures noted.

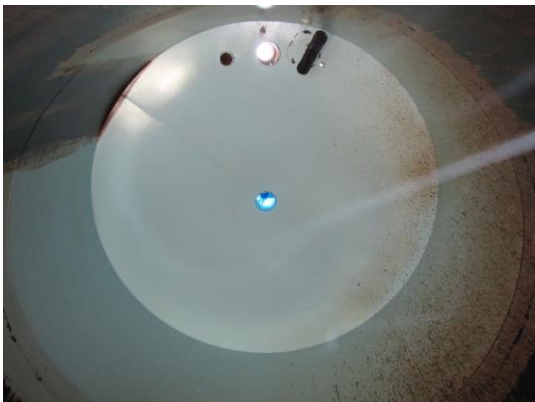
ROOF OVERVIEW

Comments/Recommendations: Roof foam insulated on external side. No visual performed. Roof coated internally, coating in acceptable condition, no signs of failure noted.

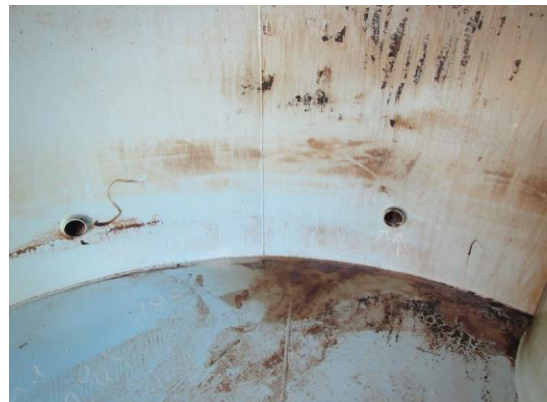
NOZZLES

Comments/Recommendations: Nozzles foam insulated externally. Nozzles coated internally. Several small coating failures noted on one nozzle. No corrosion or damage noted internally.

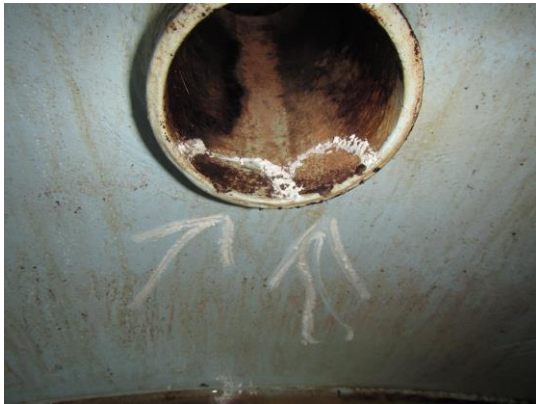
NOZZLE COATING FAILURE
