TANK INSPECTION REPORT

Report # **TK- ET10AUG2015d**

Facility	<u>Drayton Valley</u>	Location	<u>Warehouse / Boneyard</u>	Date	<u>Aug 10, 2015</u>
Serial #	<u>STTK-QG-T2-15574</u>	PW Equipment #	<u>PWA - 20729</u>	Capacity	<u>400 bbl</u>
Manufacturer	<u>Bilton</u>	Year	<u>2011</u>	Product Stored	_____
Tank Location	Construction <input checked="" type="checkbox"/> Steel <input type="checkbox"/> Fibreglass Other: _____

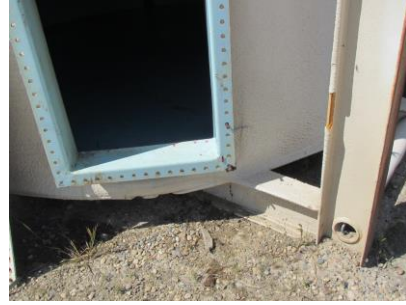
TANK SKIDDED

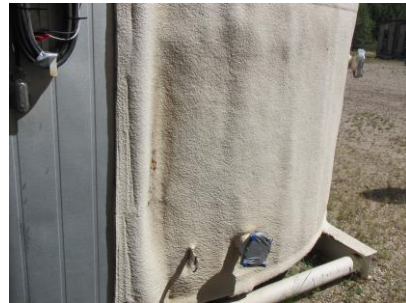
NOZZLES

Comments/Recommendations: Nozzles foam insulated externally. Nozzles coated internally. No coating failures, corrosion or damage noted internally. One coating failure on manway found, no corrosion at failure location.

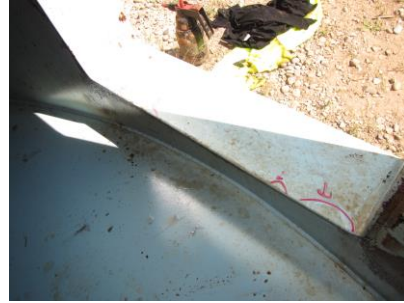
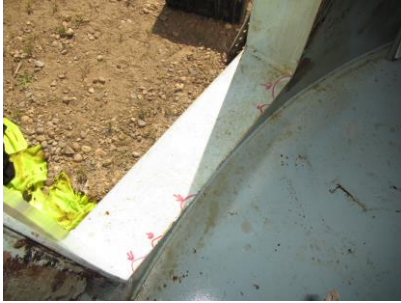
MANWAY COATING FAILURES

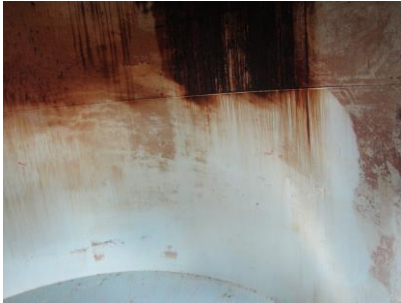
Comments/Recommendations: Shell foam insulated externally. No visual performed. Foam insulation in good condition. Shell coated internally, with no failures noted.

SHELL OVERVIEW

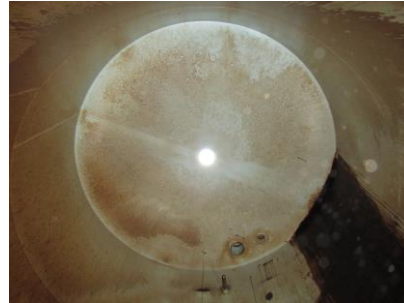
Comments/Recommendations: Roof foam insulated on external side. No visual performed. Roof coated internally, coating in acceptable condition, no signs of failure noted.

ROOF
