PRESSURE VESSEL & COLUMN INSPECTION REPORT

LSD: b-49-C/93-P-2 Date: June 16th 2014 SAP Equipment ID: 66156026

INSPECTION SUMMARY

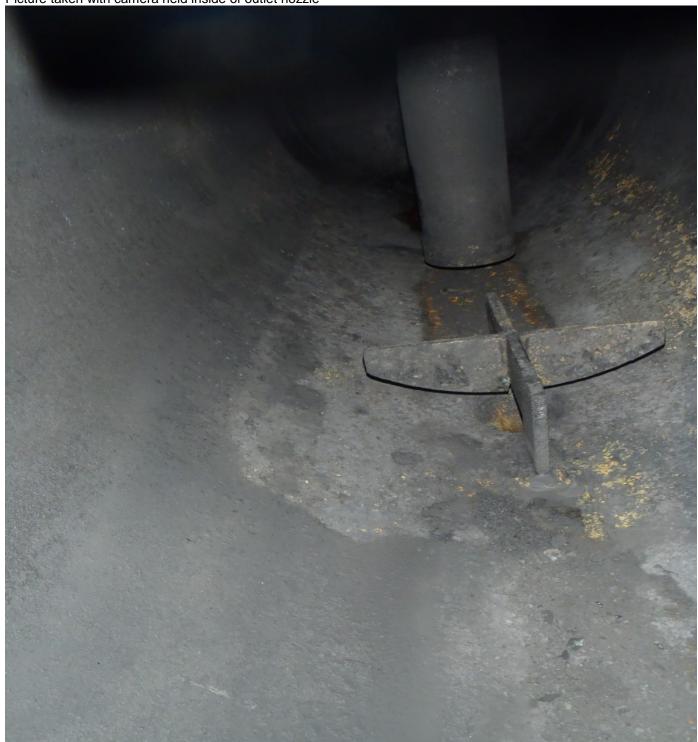
Picture taken with camera held inside of outlet nozzle
