STORAGE TANK INSPECTION REPORT

Date: 27-Jun-17 Equipment ID: N/S
 Report #: IR170627SAFc Bar Code #: N/S
 Facility: Fawcett River

Plant	Fawcett River	Op Unit	16-11-078-25W4M	System	Emulsion	
Asset #	N/S	Equipment ID	N/S	Asset Type	Tank	
Description	1000 BBL Production Tank		Serial #	021198-1	Year Built	2011
Manufacturer	Corlac Industries					
Code	API 650 Mod	Fluid Service	Emulsion	Sweet	MDMT	N/S °C
Internal Access	Yes	Insulated	Yes		Internal Coating	No

REPORT No.: **UT - 1-3754 - 03 - SA**

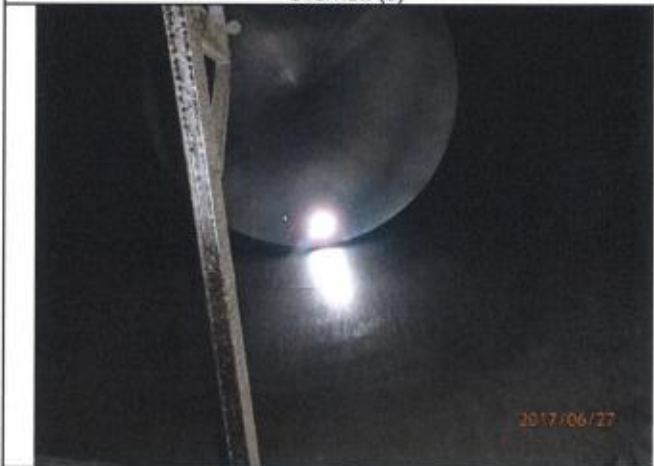
Roof Overview

- Tank was out of service and sitting in boneyard.
- Tank sitting on wooden planks. Tank is fully insulated; insulation is well intact and in good condition.
- Ladder well supported and in good condition. Manway has no signs of distortion or any other visible issues.
- Truck loading piping and vault box in good condition.
- No safe access to roof due to rain.

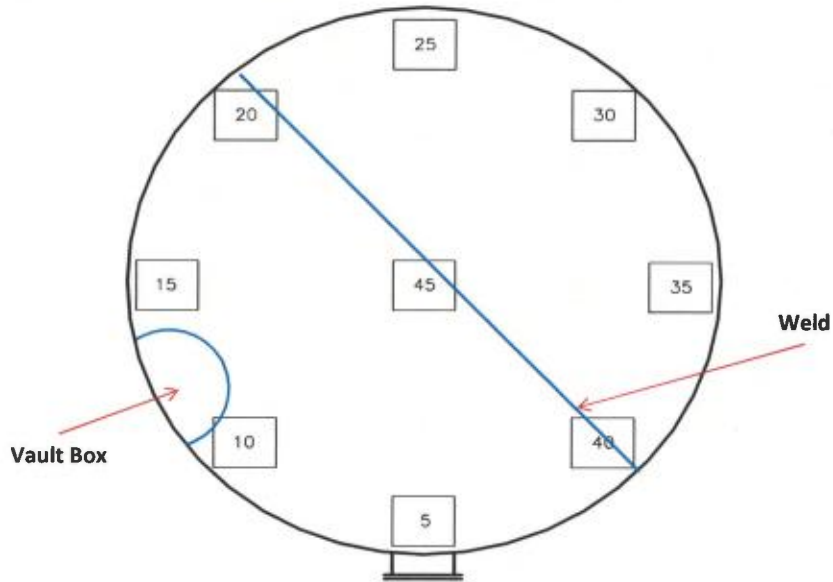
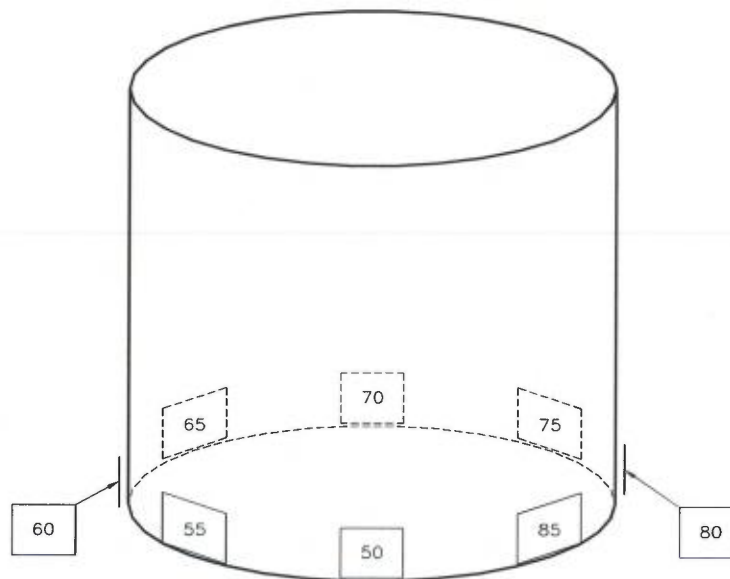
Ultrasonic Thickness location shown on page 3.
