Tank Inspection Report

Location: 15-10-51-24W3M

S/N: 028328-1 T-101

Type of Inspection: UT/Vis	Rev: N/A	Client: HUSKY OIL OPERATIONS	Date: 2020-Aug-07
Test Technique: o-deg/ Floor Scan		IRISNDT #: LYN2000727	WO #: US-062179-00-01-TI
Equipment: DMS2 /Flashlight/ MK 4 Floor scanner		Location: 15-10-51-24W3M	PO #: 8401417768
Code/Standard: Client Information		Item Inspected: T-101 Production tank	Appr# 2Z-10005709

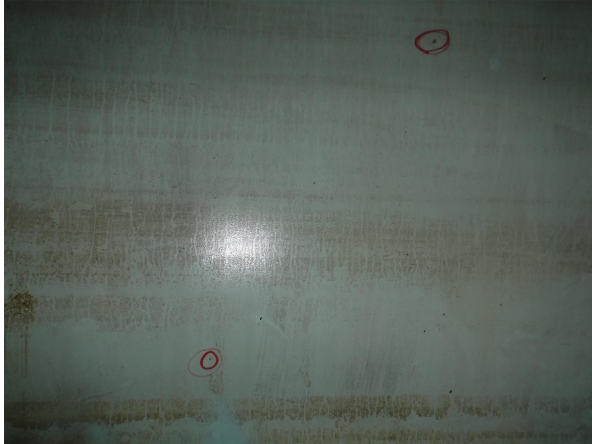
Typical Isolated internal coating failures

Patch coat 5 internal shell areas

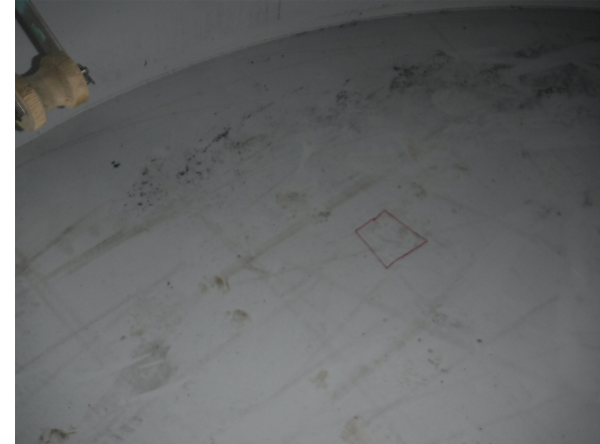
MFL examination indicated a 4" X 4" low floor thickness area 60% wall loss

Floor patch area found with MFE scan 12" Diameter

Install a 12" Diameter floor lap patch

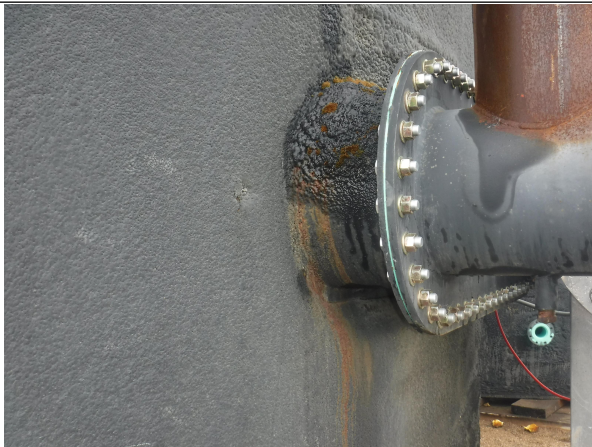
UIC suspected on fireube throat

Strip insulation from the top of the fire tube throat, Manway, vault, and 2" up the floor to shell, buff and paint black to prevent UIC

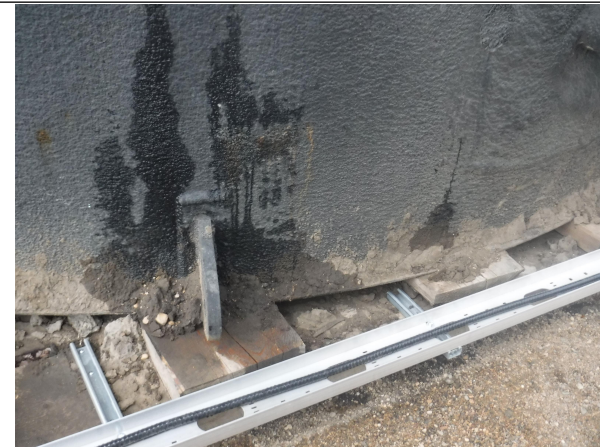
Floor to shell water/ mud saturation

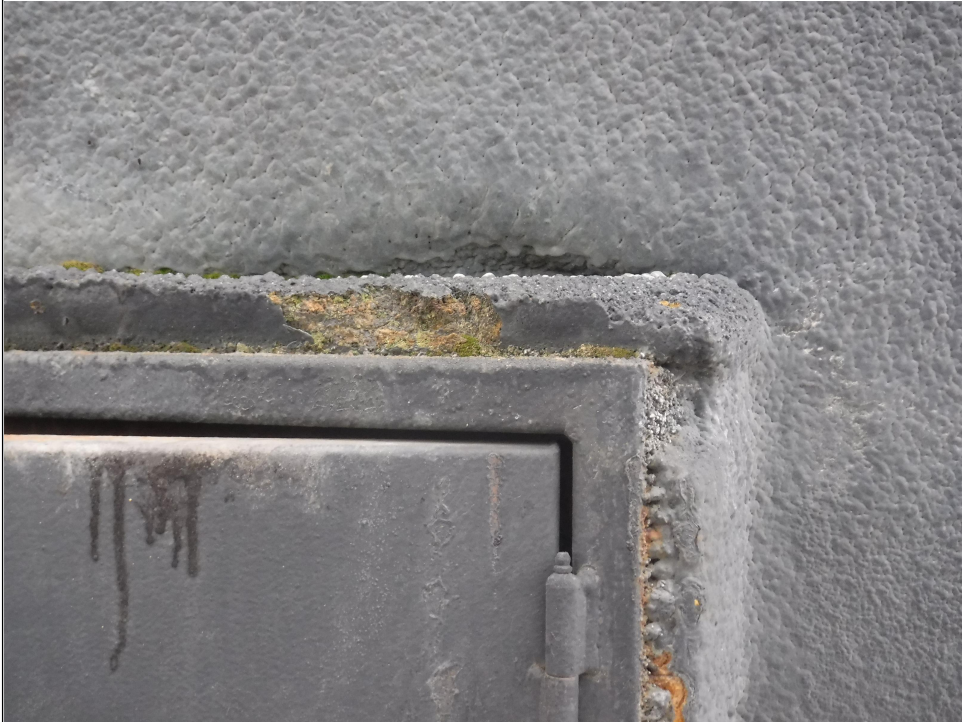
top of Vault growing moss

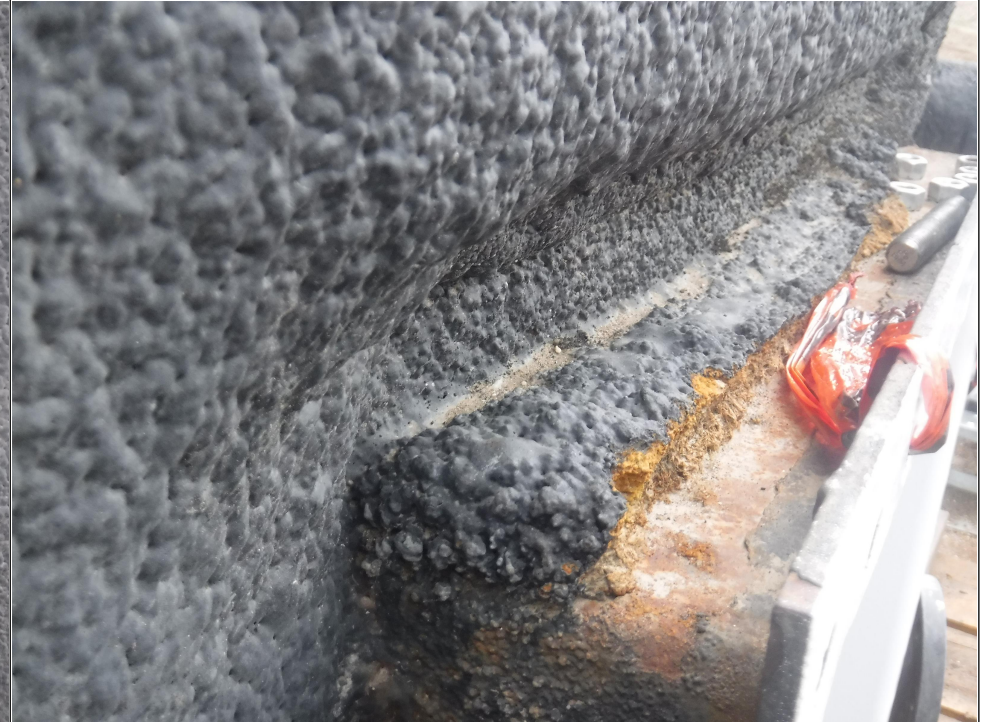
Top of manway growing moss and corroding
