S/N: 028328-4 T-104

Location: 15-10-51-24W3M

Type of Inspection: UT/vis	Rev: N/A	Client: HUSKY OIL OPERATIONS	Date: 2020-Aug-07
Test Technique: o-deg/ Floor Scan		IRISNDT #: LYN2000727	WO #: US-062179-00-01-T1
Equipment: DMS2 /Flashlight/ MK 4 Floor scanner		Location: 15-10-51-24W3M	PO #: 8401417768
Code/Standard: Client Information		Item Inspected: T-103 Production tank	Appr# 2Z-10005709

A Visual examination UT thickness and MFL floor scan was carried out on the following 1000 Bbl tank for the purpose of determining tank condition and inspection interval. See attached pages for MFE results, UT thickness readings and observations.

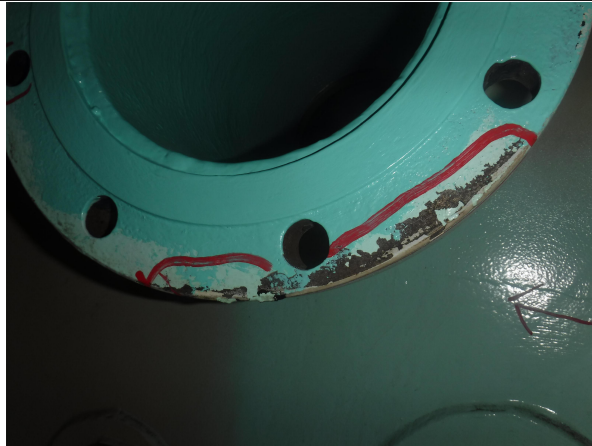
Internal Flange face with Coating damage

Patch coat 4 internal shell areas

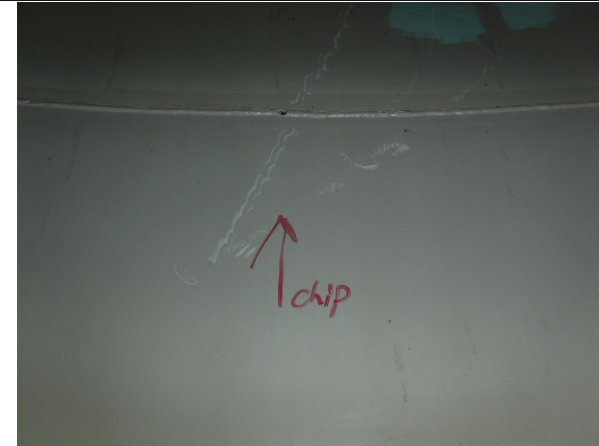
Coating chip typical for shell

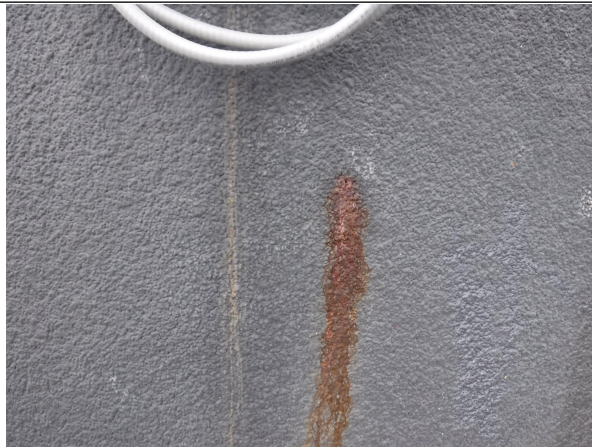
Rust rundown from insulation hole

Strip insulation from the top of the fire tube throat, Manway, vault, and 2" up the floor to shell, buff and paint black to prevent UIC

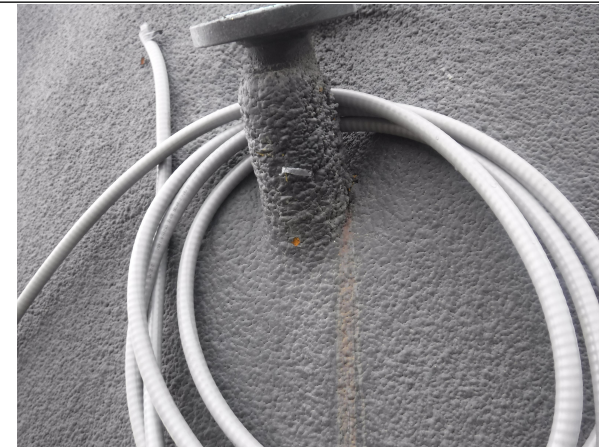
2" Scada nozzle rust rundown

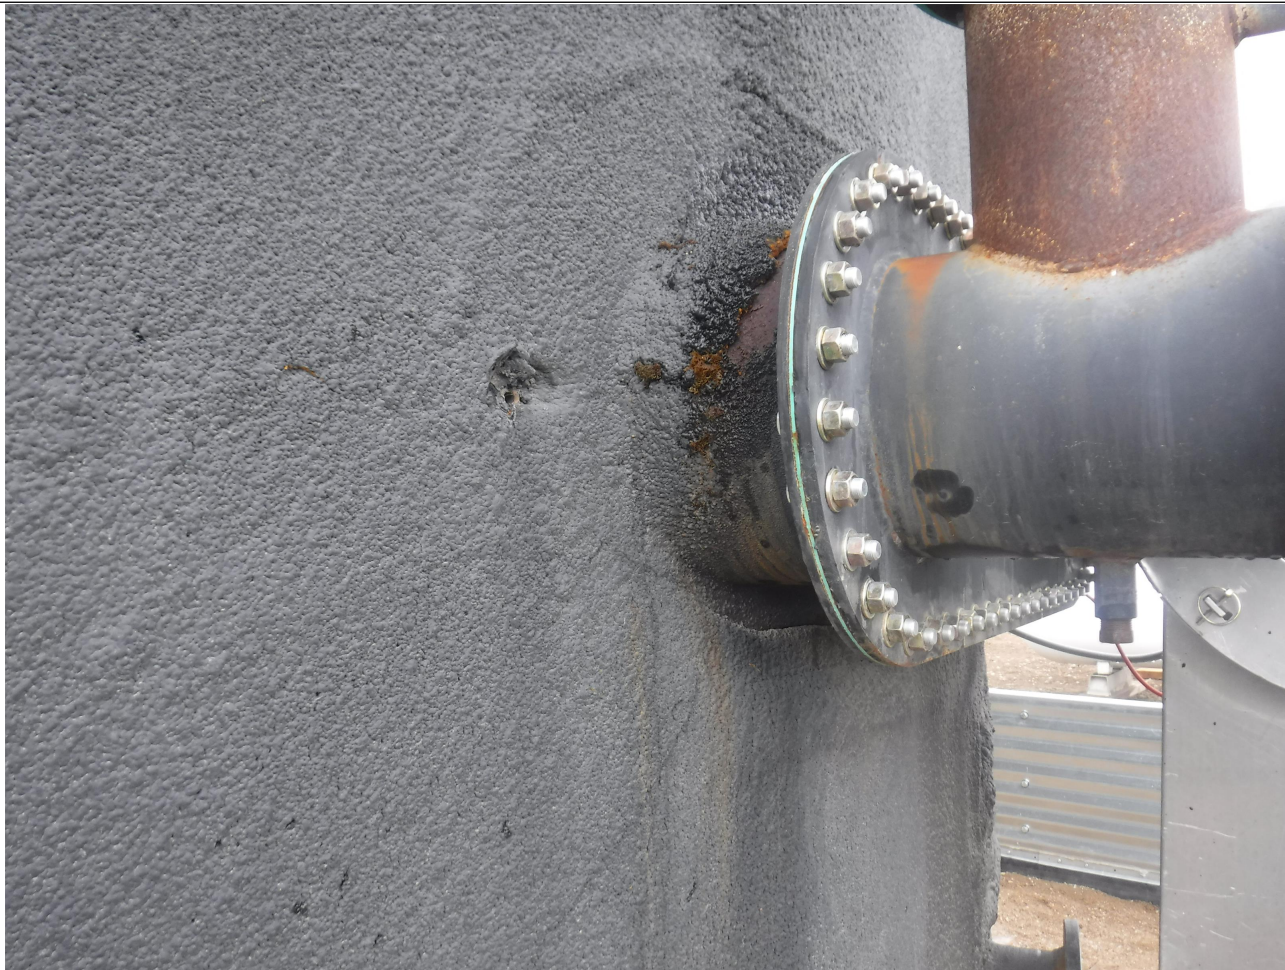
Rust/ Moisture rundown from firetube throat
