S/N: 028328-2 T-102

Type of Inspection: UT/Vis	Rev: N/A	Client: HUSKY OIL OPERATIONS	Date: 2020-Aug-07
Test Technique: o-deg/ Floor Scan		IRISNDT #: LYN2000727	WO #: US-062179-00-01-TI
Equipment: DMS2 /Flashlight/ MK 4 Floor scanner		Location: 15-10-51-24W3M	PO #: 8401417768
Code/Standard: Client Information		Item Inspected: T-102 Sales tank	Appr# 2Z-10005709

A Visual examination UT thickness and MFL floor scan was carried out on the following 1000 Bbl tank for the purpose of determining tank condition and inspection interval. See attached pages for MFE results, UT thickness readings and observations.

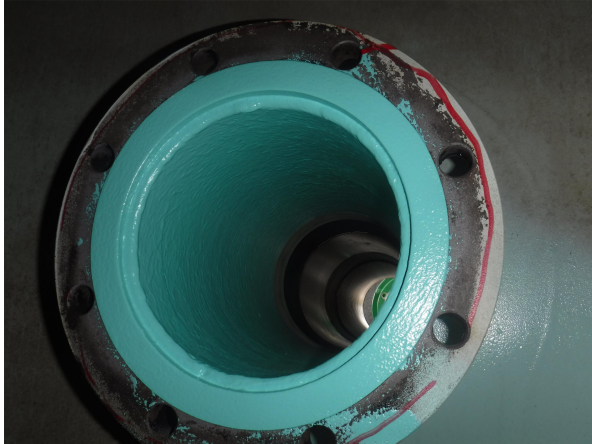
Coating missing from Internal flange

Patch coat 9 internal shell areas

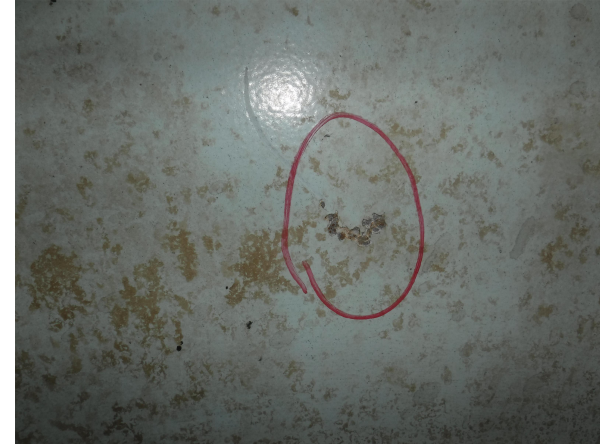
Shell coating chip

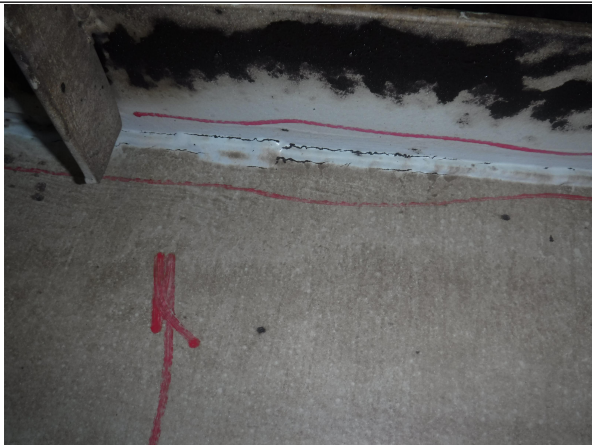
Bottom of fireube throat coating failures

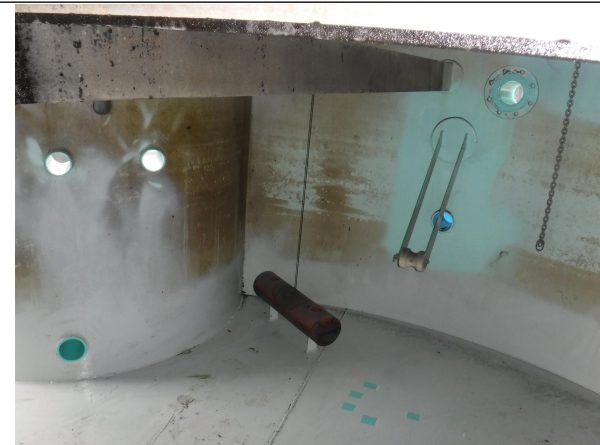
Internal float missing guide wires

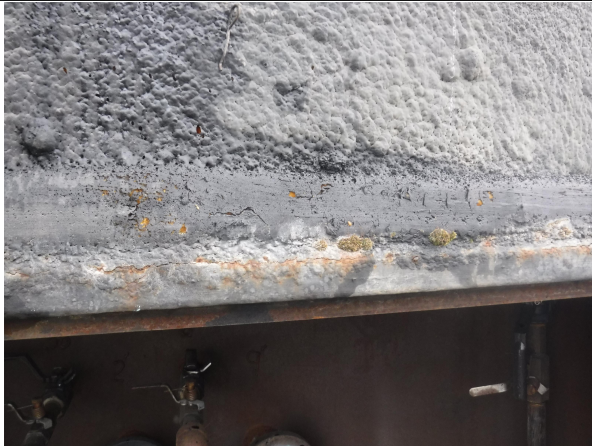
Moss growth on top of the Vault

Strip insulation from the top of the fire tube throat, Manway, vault, and 2" up the floor to shell, buff and paint black to prevent UIC

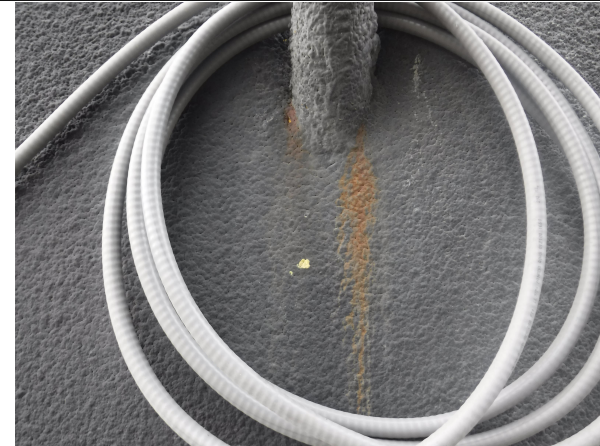
Rust rundown from 2" Scada

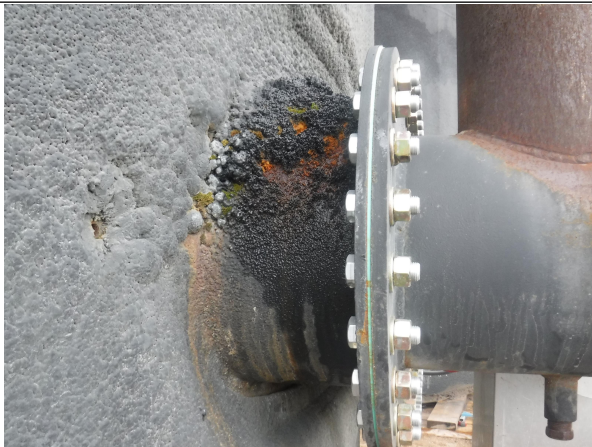
Moss Growth and rust rundown from firetube throat
