Tank Type: Production

S/N: 028328-3 T-103

CAP: 1000 bbl

Type of Inspection: UT/Vis	Rev: N/A	Client: HUSKY OIL OPERATIONS	Date: 2020-Aug-07
Test Technique: o-deg/ Floor Scan		IRISNDT #: LYN2000727	WO #: US-062179-00-01-T1
Equipment: DMS2 /Flashlight/ MK 4 Floor scanner		Location: 15-10-51-24W3M	PO #: 8401417768
Code/Standard: Client Information		Item Inspected: T-103 Production tank	Appr# 2Z-10005709

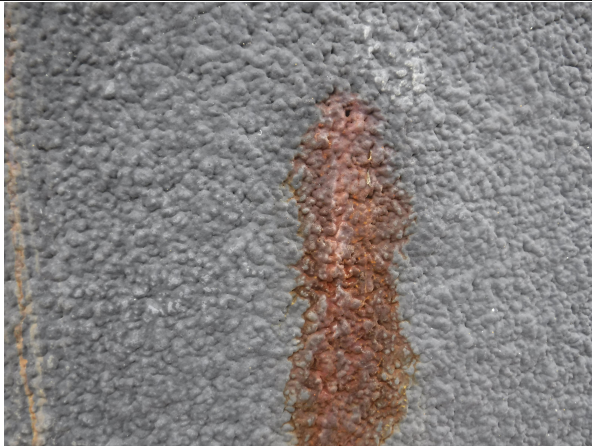
Note- 2 areas of rust rundown were noted on the shell the worst area was stripped to examine for UIC- No corrosion found- parent material was saturated with water.

Area of rundown noted

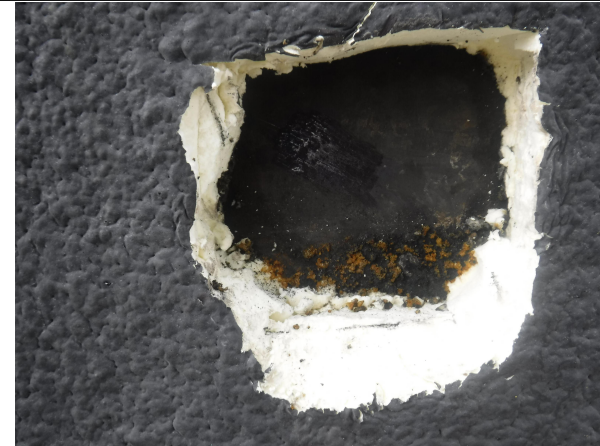
Parent material free of corrosion after stripping

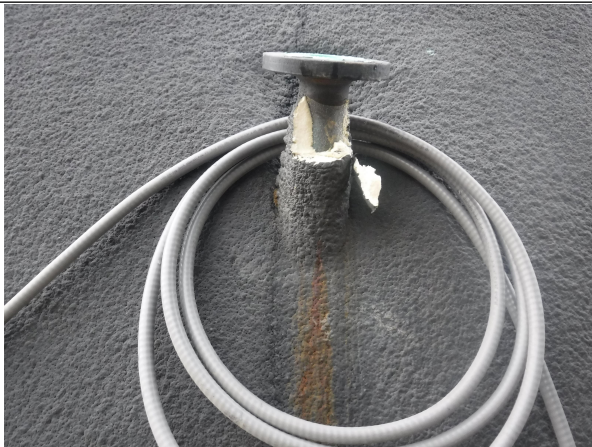
Rust rundown from 2" Scada

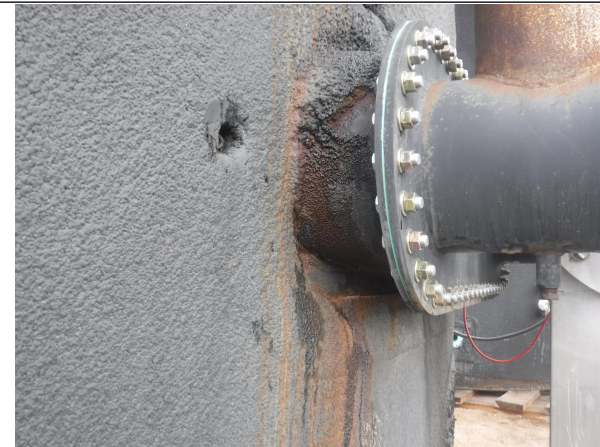
Rust rundown from firetube throat

Strip insulation from the top of the fire tube throat, Manway, vault, and 2" up the floor to shell, buff and paint black to prevent UIC

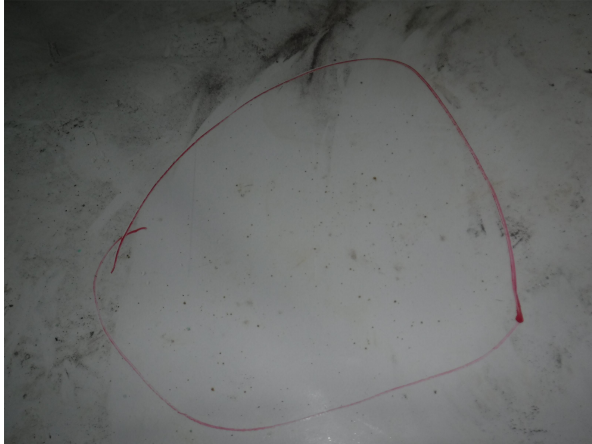
Burnt coating area on the floor

Patch coat 5 internal shell areas, 9 areas on the floor (burnt by welding)

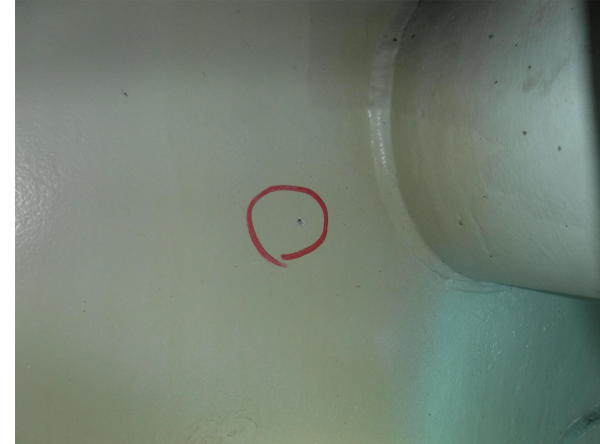
Typical coating Coating chip in shell

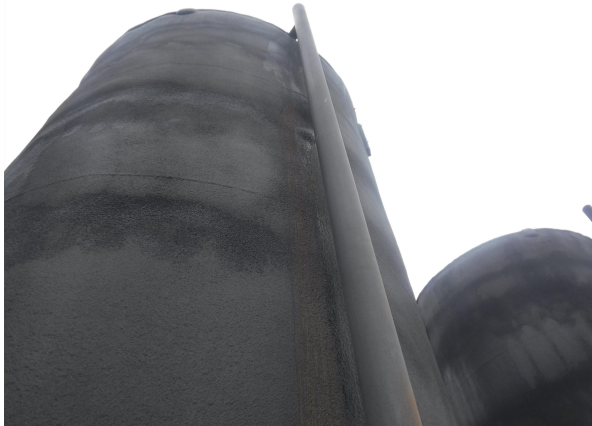
Rust rundown from Gauge board clips
