Tank Inspection Report

NONDESTRUCTIVE INSPECTION REPORT

CA1101-NDT-498

Item Inspected: 1000BBL Tank

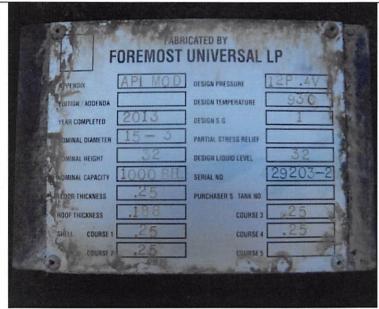
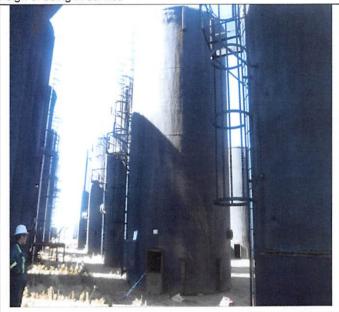
-Slight "Bulging" of insulation at roof level. Rusty seepage evident, possible sign of Corrosion Under Insulation in area - monitor roof level. There were no areas requiring immediate attention at this time - Tank is fit to return to service on a 5yr. inspection interval. -There was no sign of any underside corrosion evident with MFL floor scan inspection.

Tank in in "As New" condition - No sign of being in service

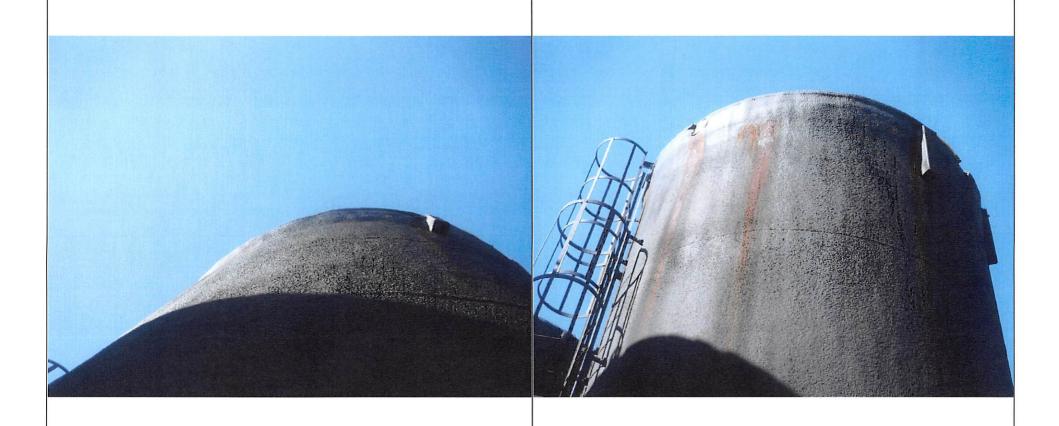
Slight "Bulging" of insulation at roof level

Rusty seepage evident, possible sign of Corrosion Under Insulation in area - monitor roof level.
