# AIR COOLED HEAT EXCHANGER INSPECTION REPORT

Report#: IR110815GMSO

Plant	Tangleflags	Op Unit	HOG - Sask. West	System / LSD:	04-18-051-25W3
Asset #	62048715	Equipment ID	169677	Asset Type	-
Description	Cooler	Prov. Insp. # A	None	SK#?	Serial # 944411.4
Manufacturer	Air Cooled Exchangers	CRN	K-2766.2	SK CRN?	Year Built 1994
MAWP	4516	KPag	@ 148	°C	MDMT -29 °C
Code	ASME U	Fluid Service	Natural Gas	Sweet	PWHT No
Internal Access	No	Insulated	No		Internal Coating No
Operating Pressure	-	KPag		Operating Temp	- °C

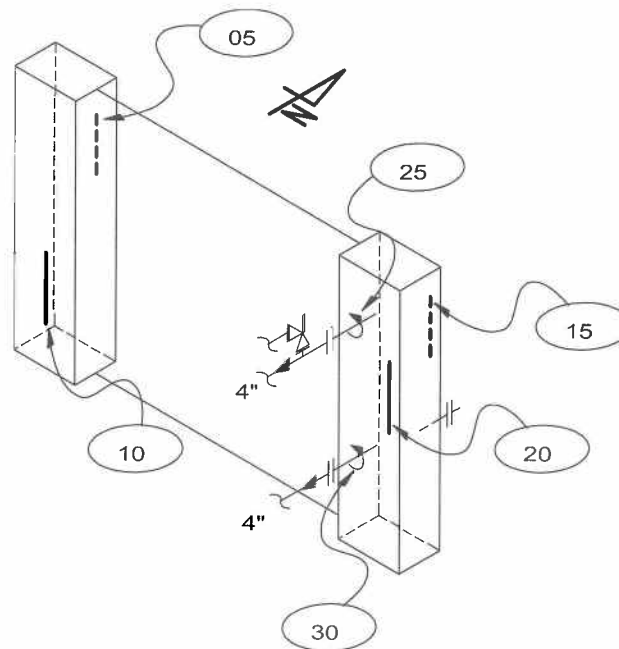
## UT DRAWING

CML	Nom. Thk	Current Reading	Short Term Corr Rate	Long Term Corr Rate	Remaining Life	Comments
005	N/A	16.6				
010	N/A	16.8				
015	N/A	16.8				
020	N/A	17.1				
025	8.6	9.3				Above nominal – no concerns.
030	8.6	9.6				Above nominal – no concerns.
