Tank Inspection Report

Location: AKG-31-51-22W3 Tank Type: Prod TK#1 Date: Jun. 3. 16
Mfg: GLM Year blt: 2005 S/N: G-05-241-58 CAP: 1000 bbl
Floor Thk: 1/4 Shell Thk: 1/4 - 3/16 Roof Thk: 3/16
Requisitioned by: ANGELA SHERMAN Approver: ANGELA SHERMAN Approver Code: 2Z-2006174
WO #: 60281429 PO#: 8401064788 CC: _____ SAP #: 66110499

A Visual / UT Inspection was carried out on 1 – 1000BBL Tank
@ A16-31-51-22w3

Tank#1 SN# G-05-241-S8**Recommendations of inspection:**

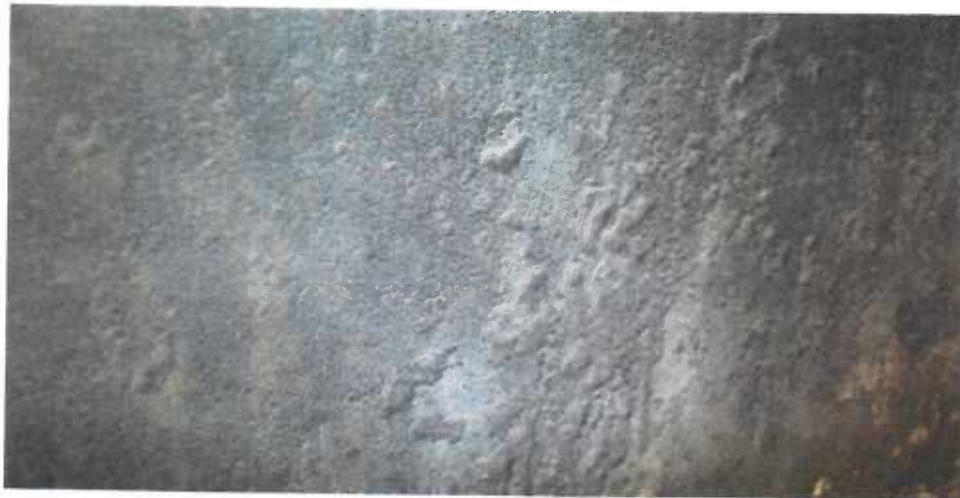
-Moderate pitting evident on Internal shell throughout tank

Primarily near door. Worst area evident was ground to base of pits and UT inspected. Low found in area = 0.203"

Picture below shows area typical of pitting in shell
