AIR COOLED HEAT EXCHANGER INSPECTION REPORT

Report # : IR141009GENh

Plant	Celtic Compressor	Op Unit	HOG	System / LSD:	10-08-052-23w3
Equipment #	1000000924	Tag #	----	Asset Type	Air Cooled Heat exchanger
Description	2nd Stage Gas cooler	Prov. Insp. #	S 09266	Serial #	905077.4B
Manufacturer	Air-x-changers	CRN	H6717.2.3	Year Built	1990
MAWP	9067	KPag	@ 149 °C	MDMT	-29 °C
Code	ASME VIII	Fluid Service	Natural Gas	PWHT	No
Internal Access	No	Insulated	No	Internal Coating	No
Operating Pressure	-	KPag		Operating Temp	- °C

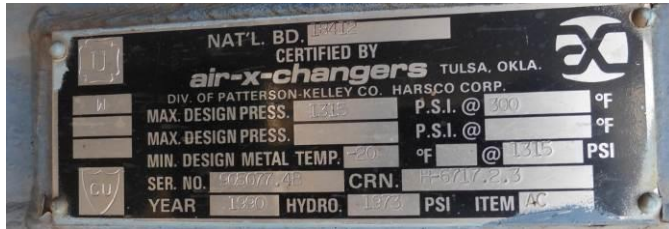
Nameplate

The nameplate is intact and legible.
