### SHELL & TUBE INSPECTION REPORT

LSD: 02-20-050-18W5M

Date: May 7, 2015

SAP Equipment ID: 66038572

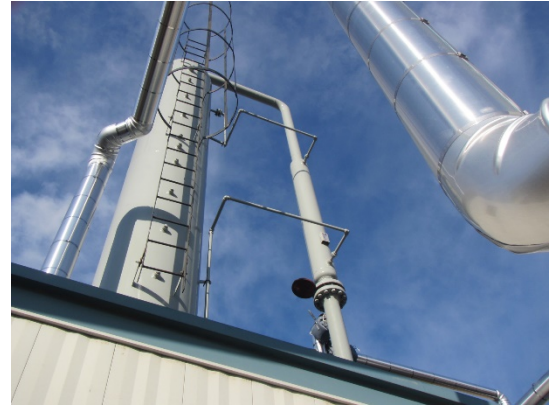
VESSEL OVERVIEW

Unsafe access above roof. Visual inspection done from ground. No access to dataplate. SN supplied on inspection list. Exchanger on train 1 glycol contactor gas outlet piping. Exchanger in good external condition. Paint in good condition. Dataplate present but not accessible. PSV off of contactor shell. PSV service up to date, vents to flare header. No UT inspection done at this time, no access without manlift or scaffolding
