PRESSURE VESSEL & COLUMN INSPECTION REPORT

LSD: 03-06-049-18w5m

SAP Equipment ID: 66129837

VESSEL STATIC DATA									
Plant Minehead Comp Stn				Op Unit			System		
Prov. Insp. # A0561919				CRN T6804.2			Equip Tag # n/a		
Equipment Description South Flare Knockout							Serial # 0602653-0001		
Manufacturer Pyramid Corp.							Vessel Class		
Internal Access: Description: 24" manway							Year Built 2006		
MAWP 100		PSI		@ 500		°F		MDMT -50 °F	
CODE :				RT : 2			PWHT : No		
Diameter 48in		Length (S/S) 120 in		OAL		in		Horizontal	
Shell Mat'l		Thickness		0.375		in		Corr Allowance 0.125 in	
Head Mat'l		Thickness		0.3125		in		Corr Allowance 0.125 in	
Nozzle Mat'l		Thickness				mm / in		Corr Allowance mm	
Internal Coating: YES				Internal Clad : NO			Capacity ft3		
Manway : YES				Inspection Port : NO			Saddle		
Nozzle Rating 300		lb ANSI		Painted : YES			Insulated YES		
PROCESS DATA									
Product Description Gas						Sweet			
Operating Pressure				PSI		Operating Temperature °F			
PSV STATIC DATA

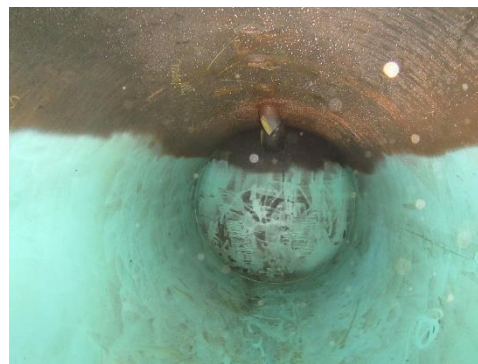
INTERNAL OVERVIEW - BOTTOM 2/3 OF VESSEL COATED

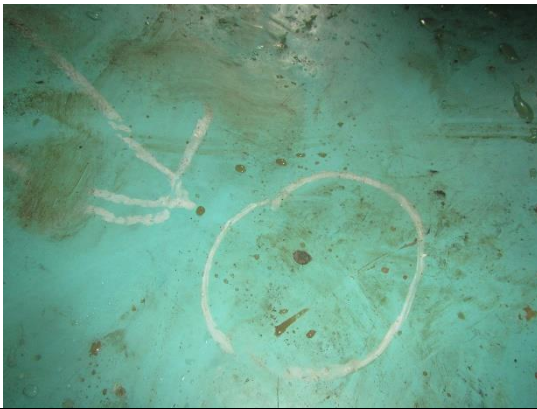
4 small coating failures noted - 3 on manway nozzle and 1 on bottom shell. No corrosion at coating failure locations.

BOTTOM SHELL SMALL COATING FAILURE

All coating failures were patch repaired with Envirolite 124 - 2 part epoxy - by Streamline Inspection.

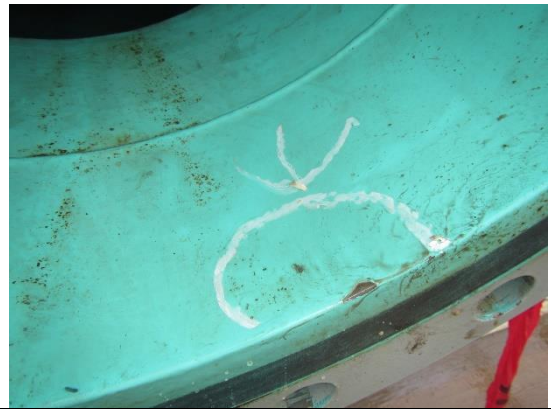
MANWAY NOZZLE COATING FAILURE

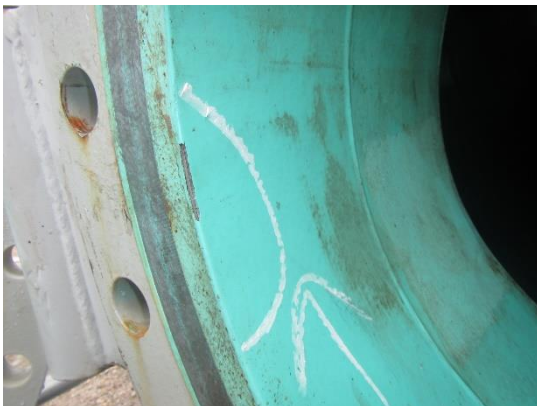
MANWAY NOZZLE COATING FAILURE

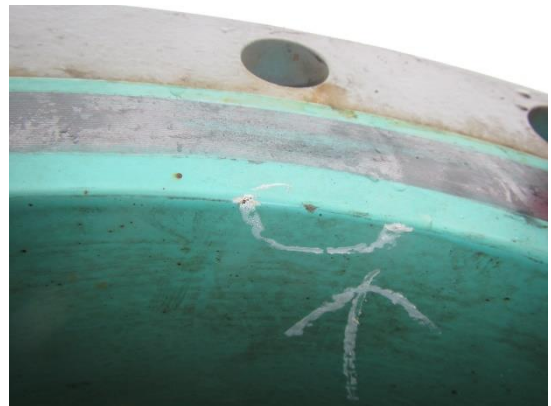
MANWAY NOZZLE COATING FAILURE
