Aerial Flare Stack Inspection Report

12th June 2018

Aerostar Drone Solutions (Aerostar) was requested to perform an Aerial Inspection on the Flare Stack (Serial Number 11170) located at Minehead 03-06-049-18 W5M Compressor Station.

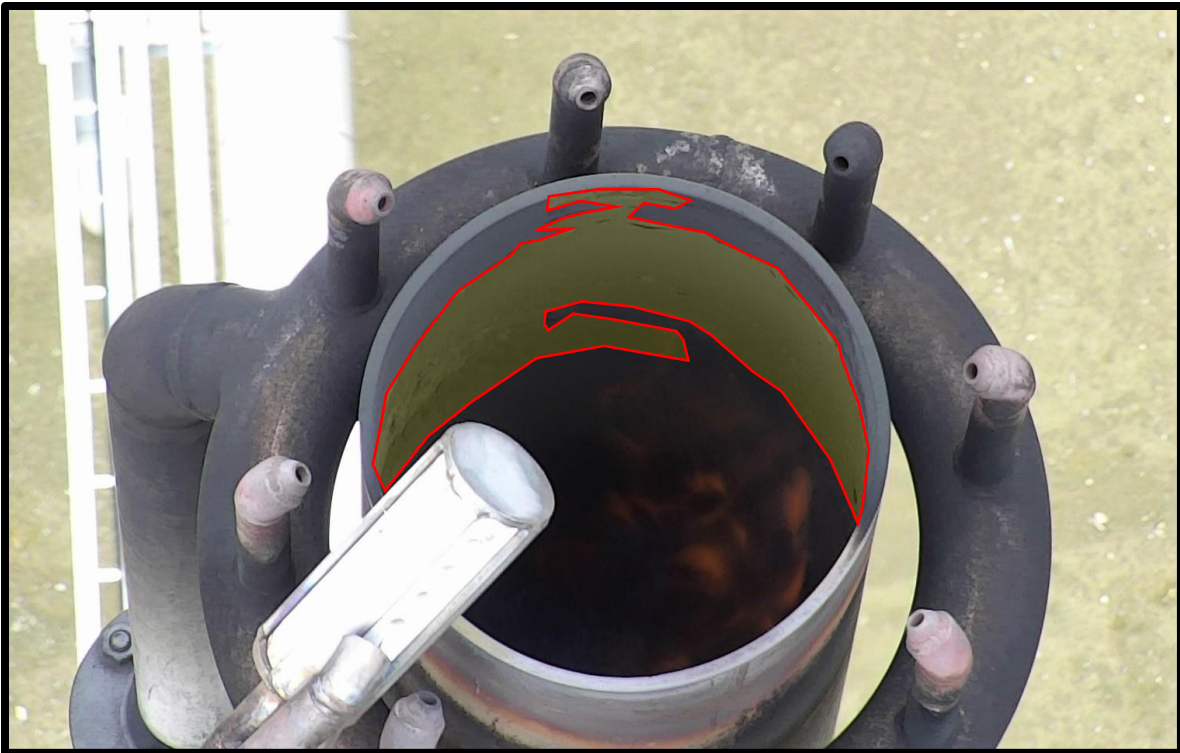
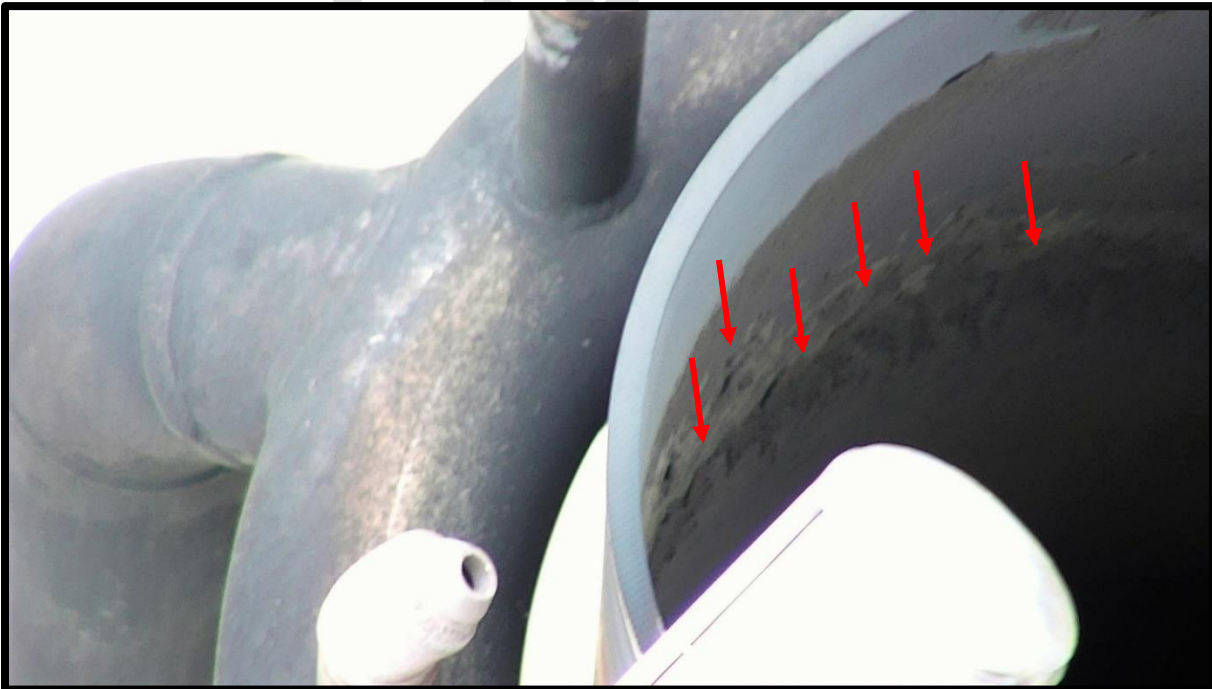
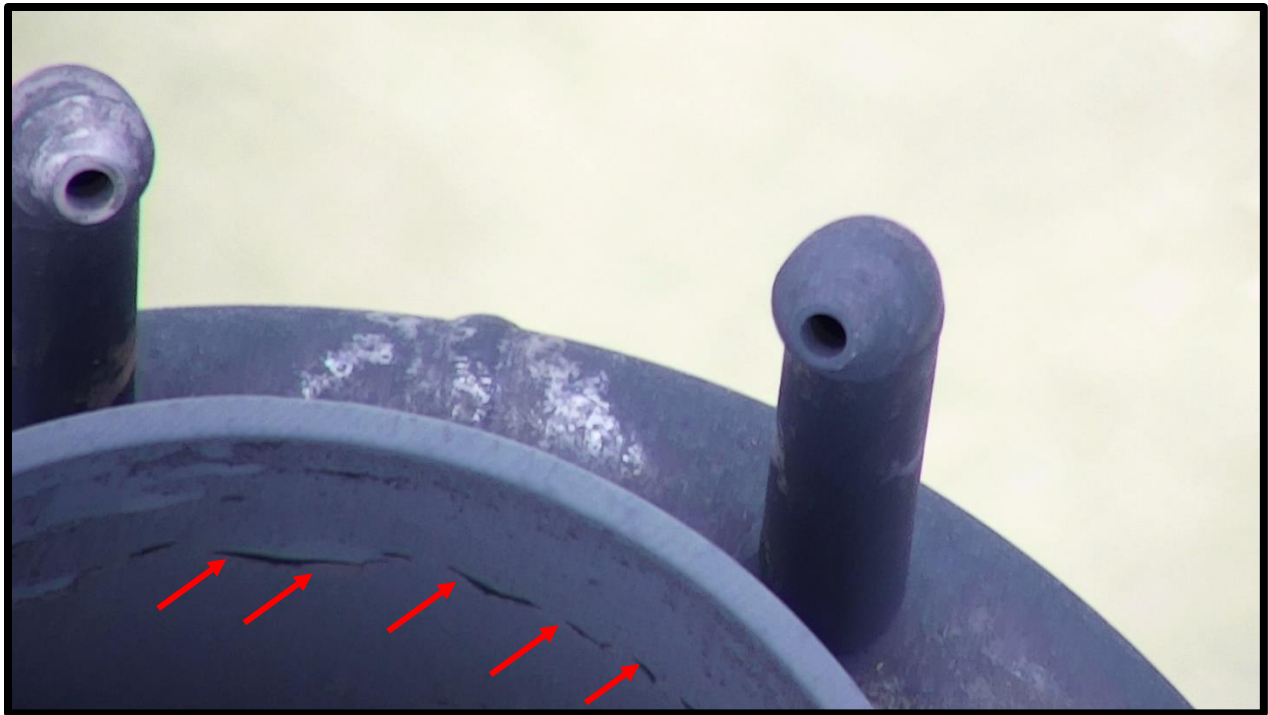
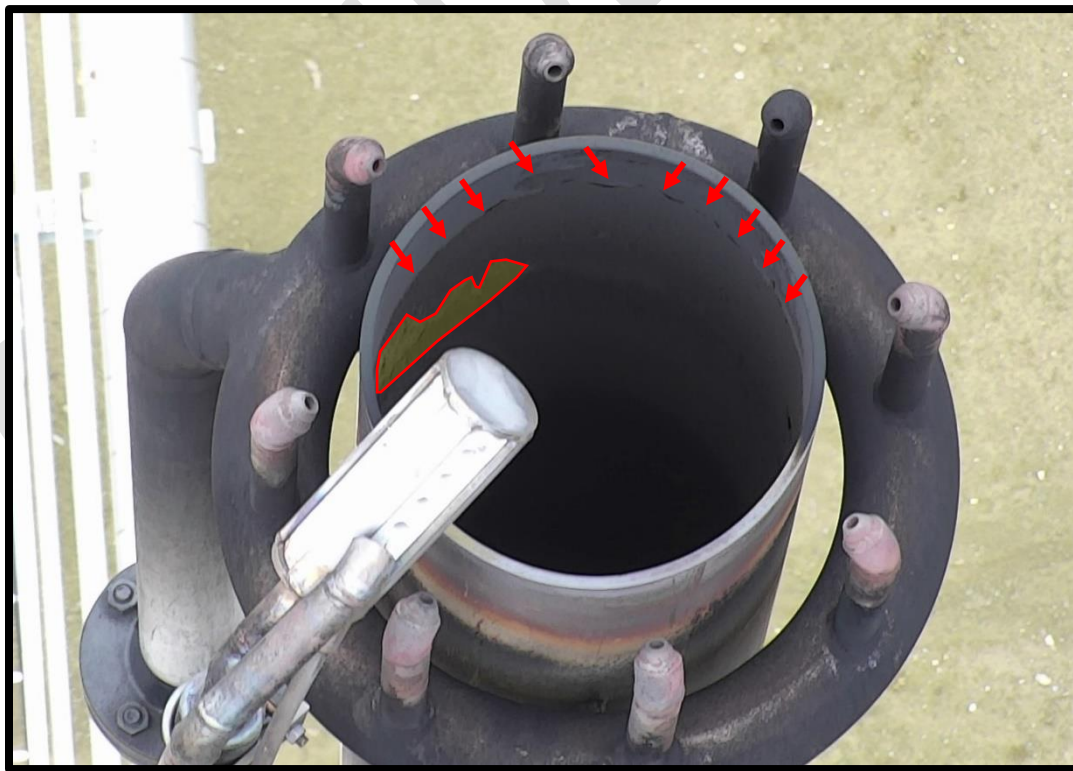
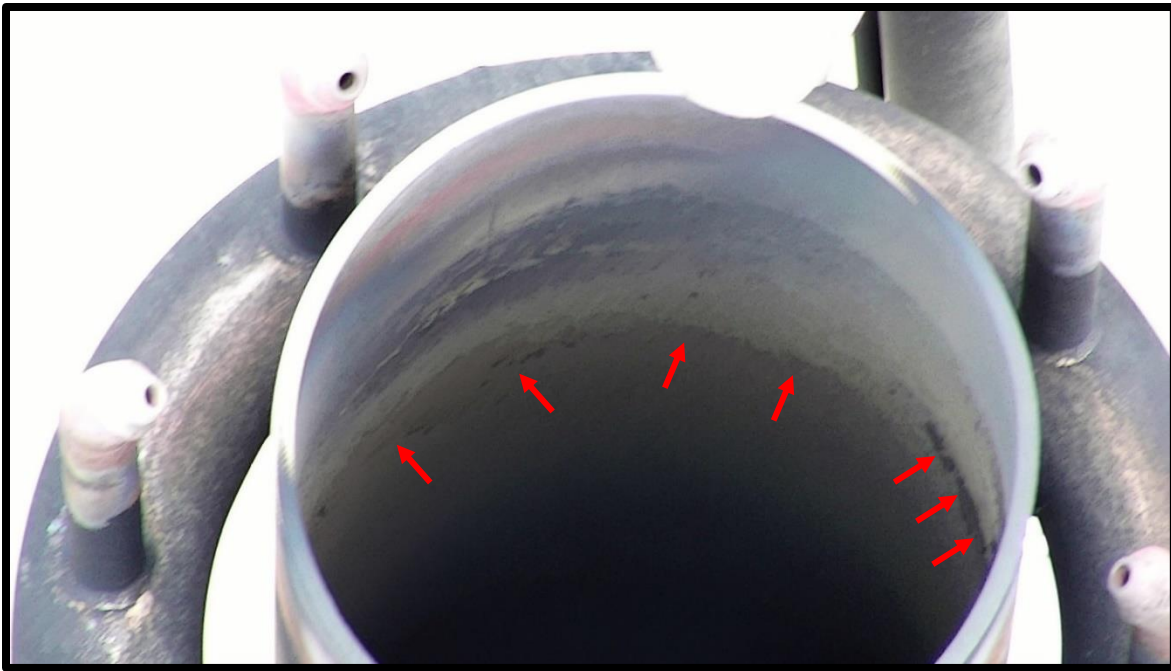
a) Carbon Deposits

Carbon Build up

It was noted during the Aerial Inspection of this Flare Stack that there were indications of minimal carbon deposition found on the flare outlet and pilot chamber (internally and external edge).

Due to the levels of deposition of carbon this would be categorized as **LIGHT**.

Therefore, the recommendation would be to continually monitor on an annual basis with additional caution to be taken during fire season.

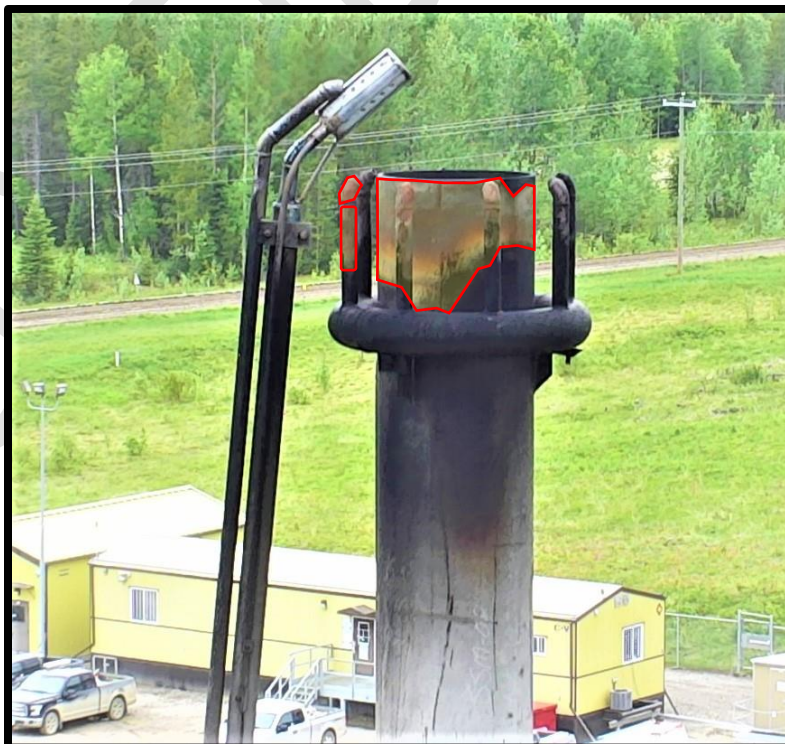
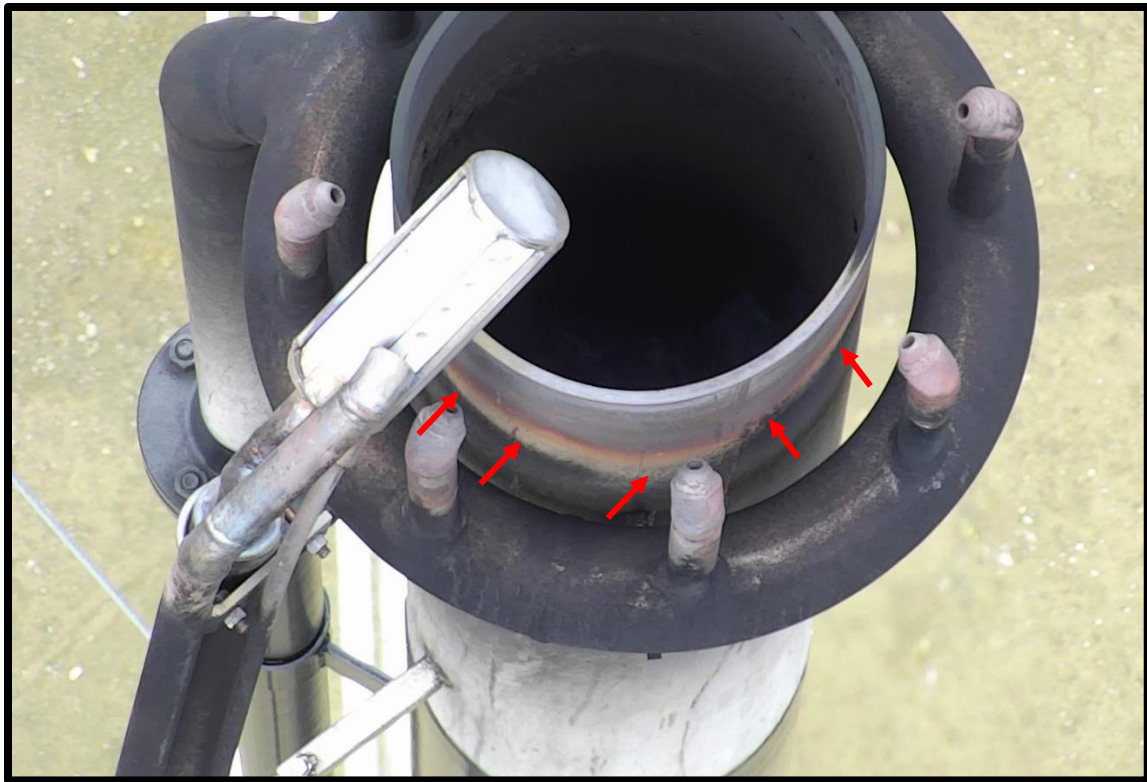
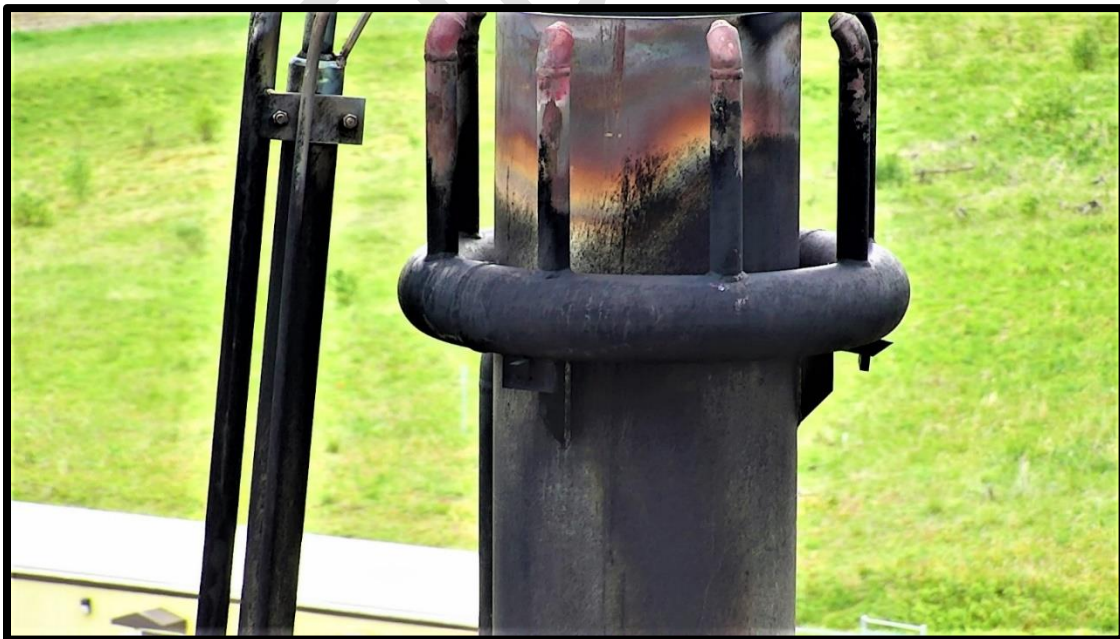
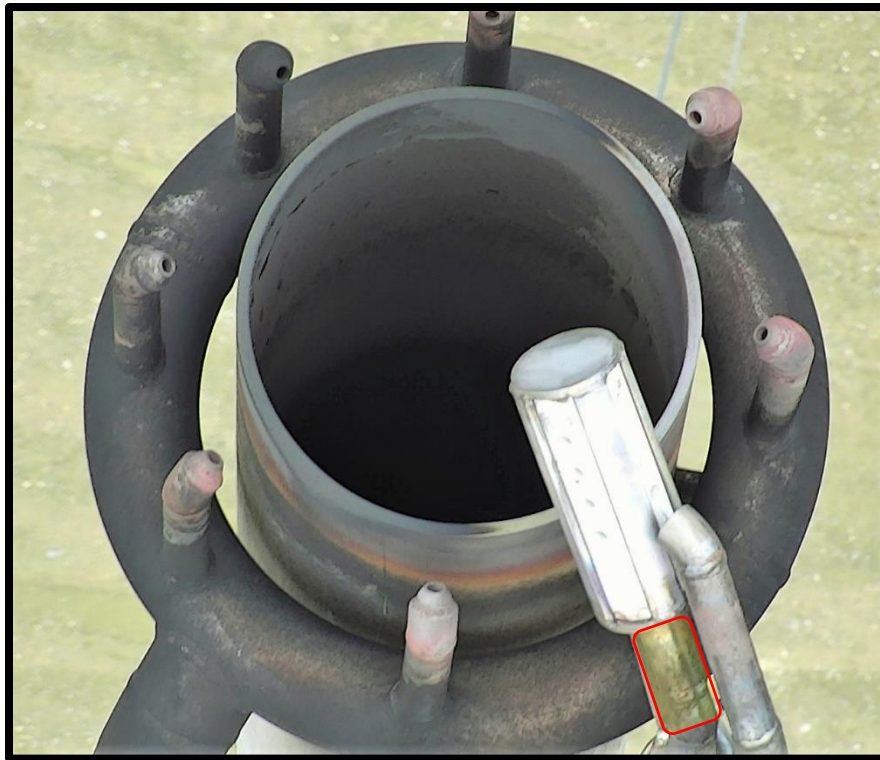
b) Burn-outs and Discolorations

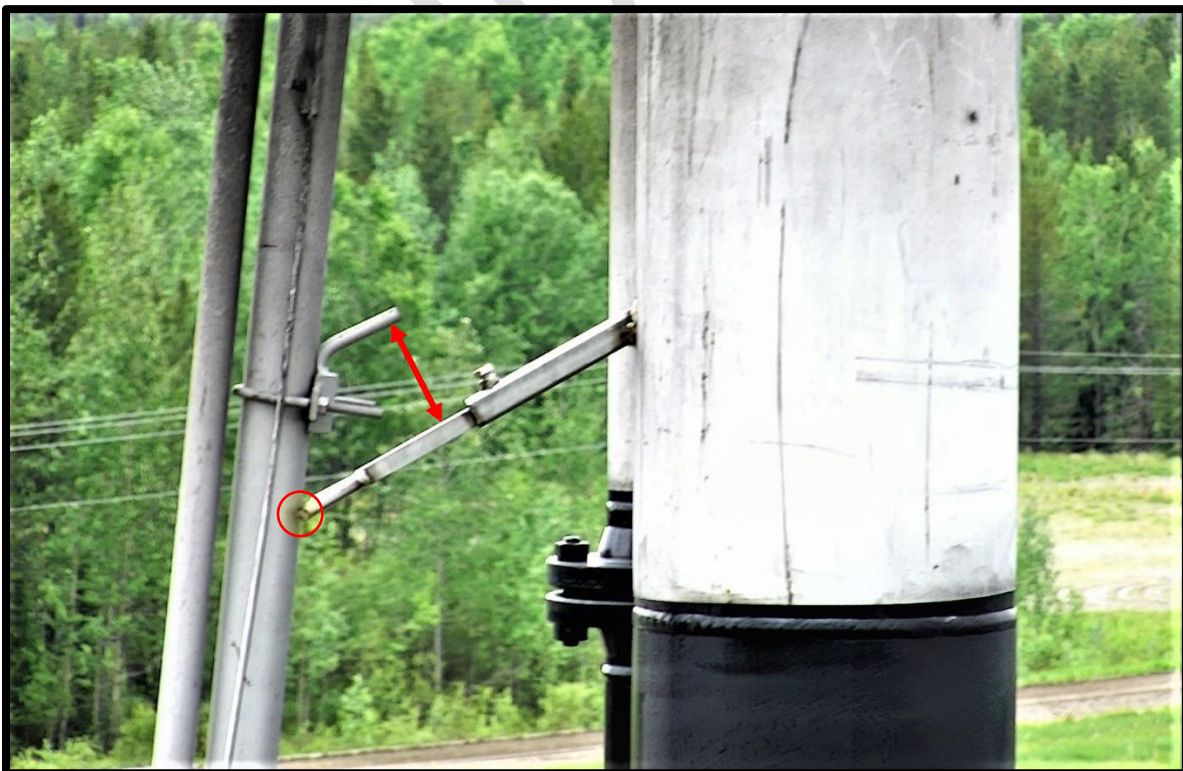
Figure 10

c) Misaligned guide

Component	Observation	Recommendation
Pilot, Ignitor and relevant components	<ul style="list-style-type: none"> Light carbon build-up 	<ul style="list-style-type: none"> continually monitor on an annual basis with additional caution to be taken during fire season
Pulley Assembly (Ground level Winch and elevated welded pulley)	Good condition	N/A
Local Control Panel - Ground	Good Condition	N/A
Anchoring Components	Good Condition	N/A
Ground Anchoring Components	Good Condition	N/A
Piping elements (Flanges and bolting)	Indications of corrosion on the base piping elements components and on the main stack flanges	Affected areas and components to be coated/painted to avoid expansion of corrosion
Flare stack	<ul style="list-style-type: none"> Abrasions and Coating anomalies Indications of burn-outs Pilot guide was found in a misaligned condition 	<ul style="list-style-type: none"> Affected areas by abrasions to be coated/painted to avoid expansion of corrosion and anomalies Pilot assembly alignment to be checked and repaired.

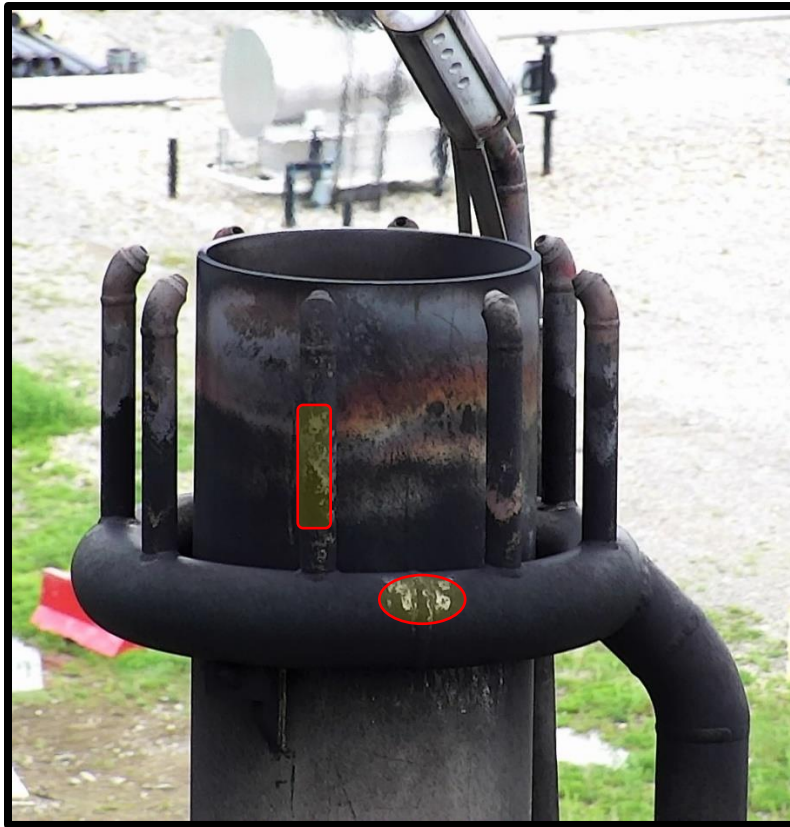
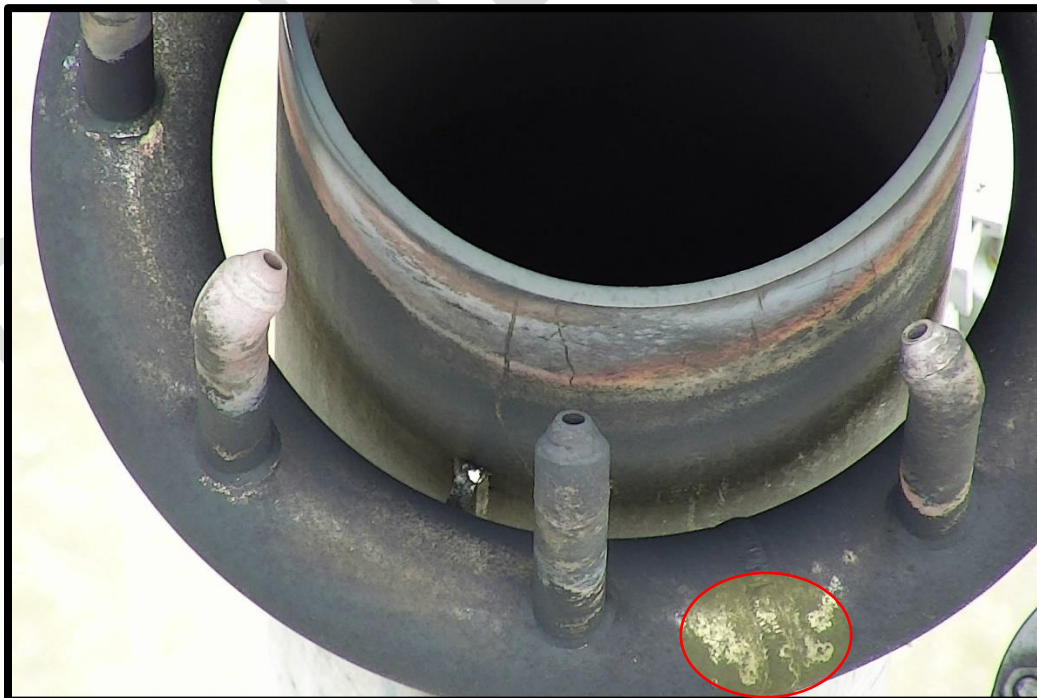
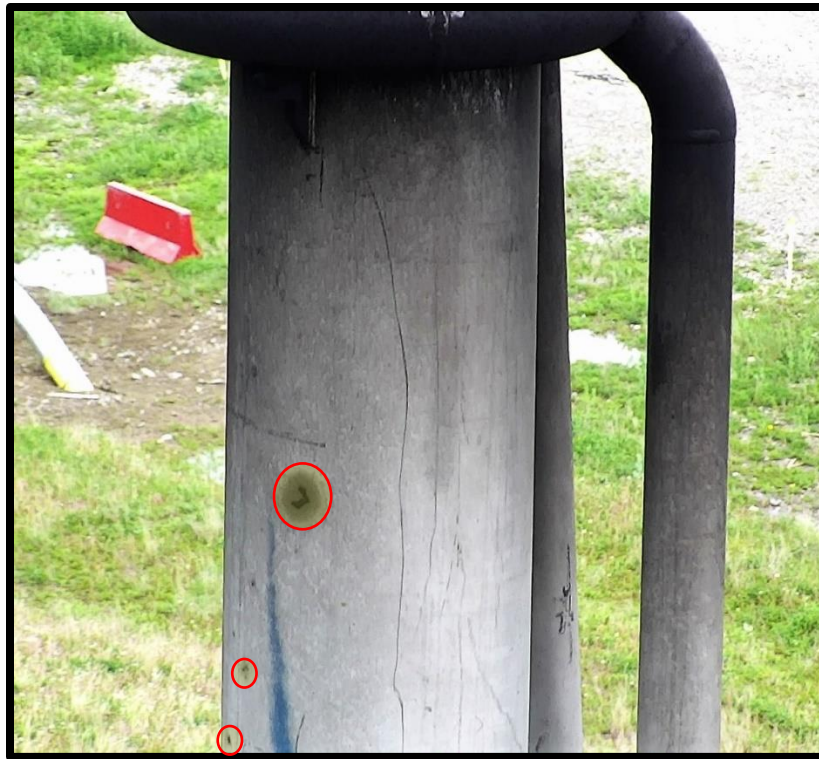
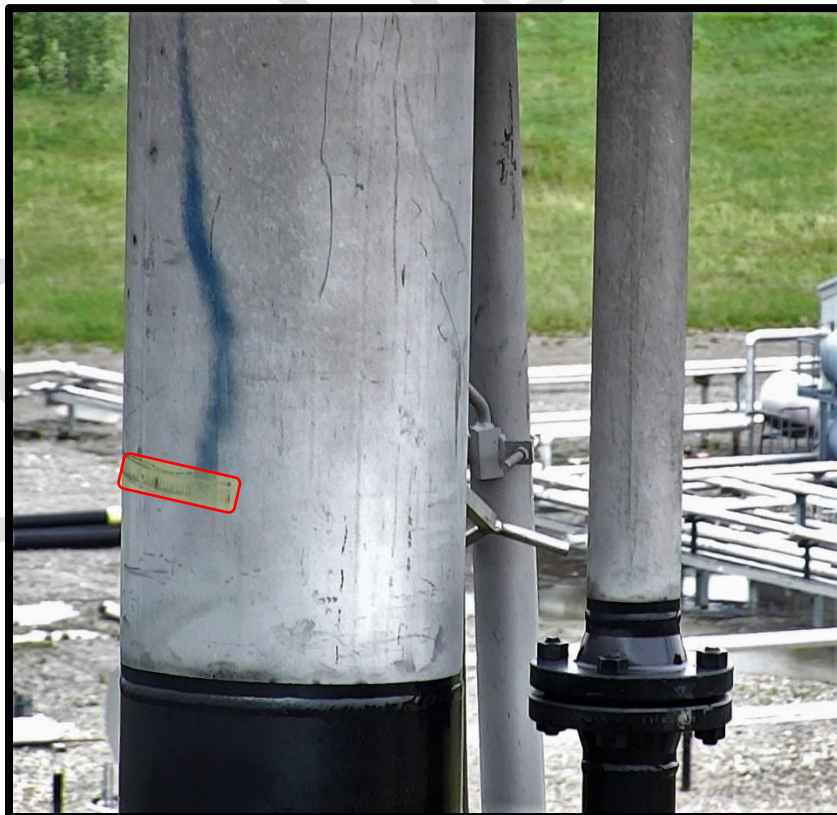
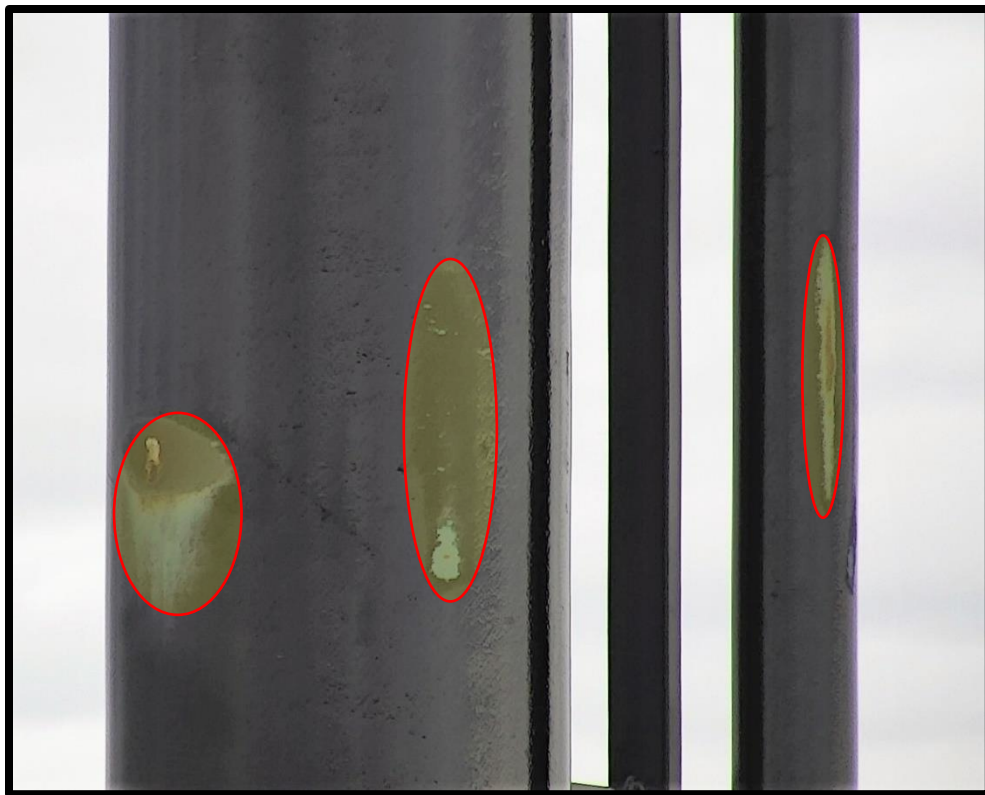
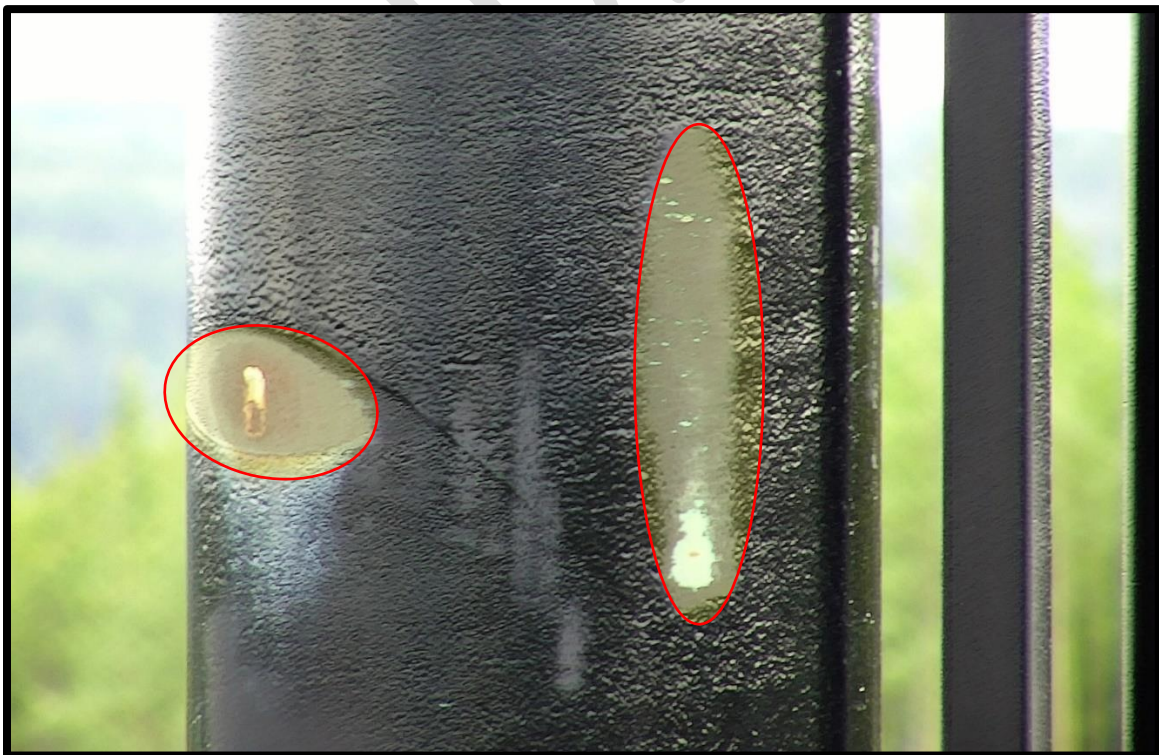
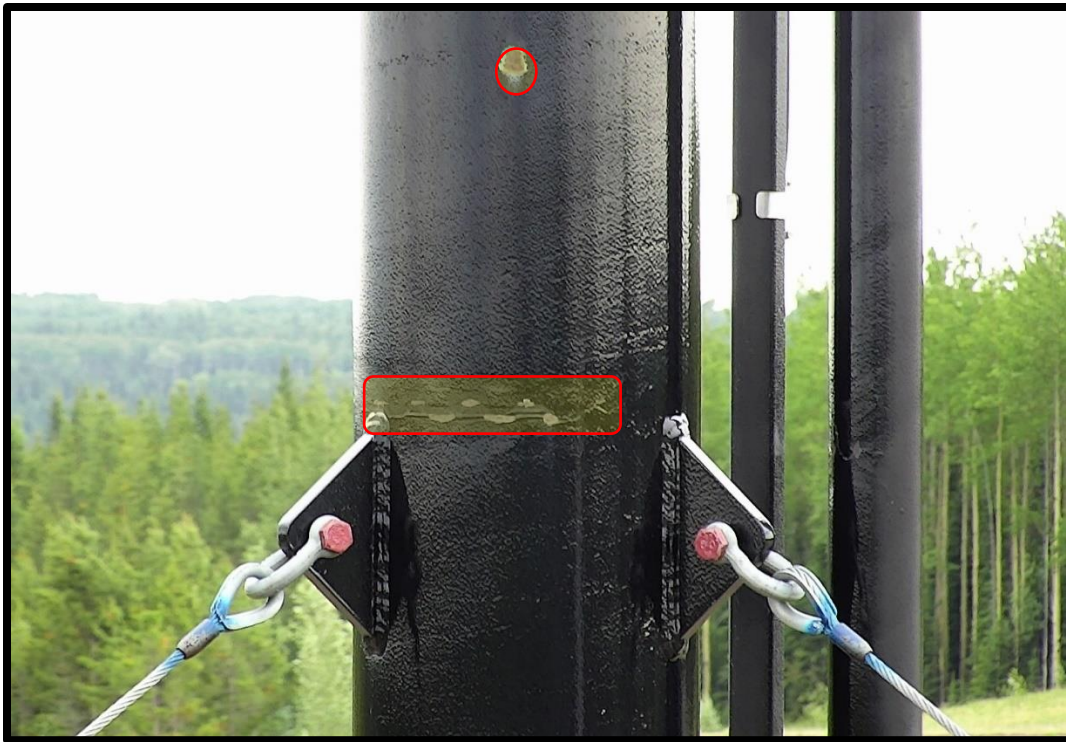
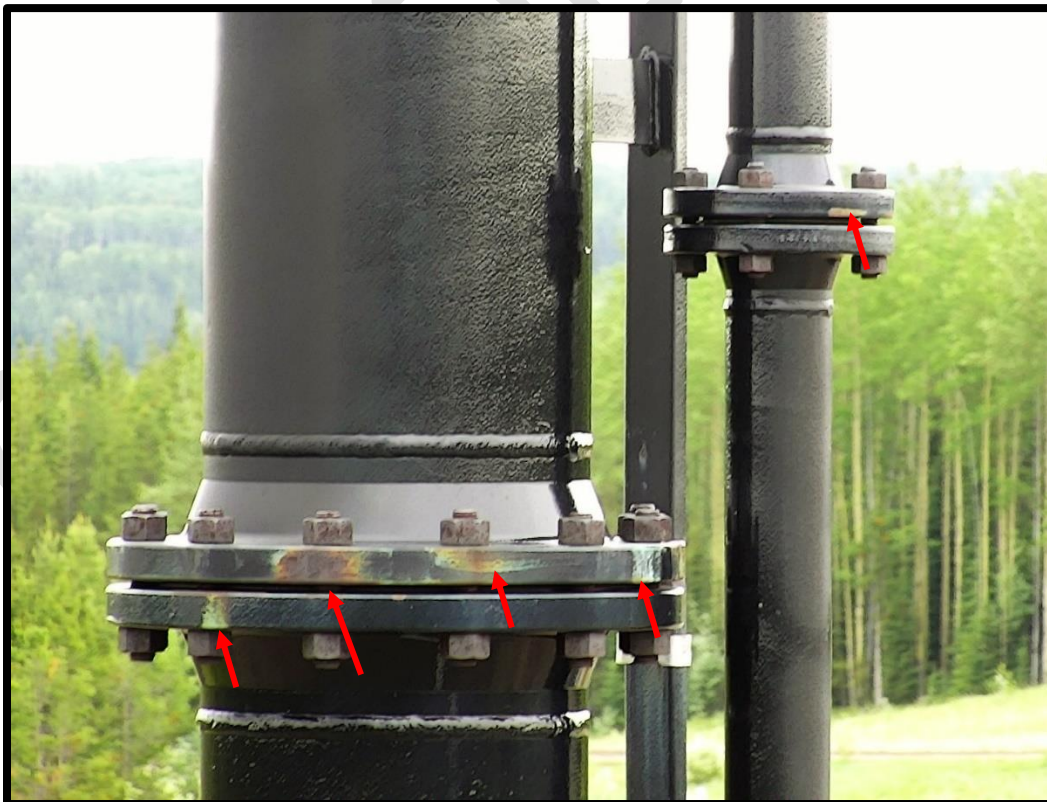
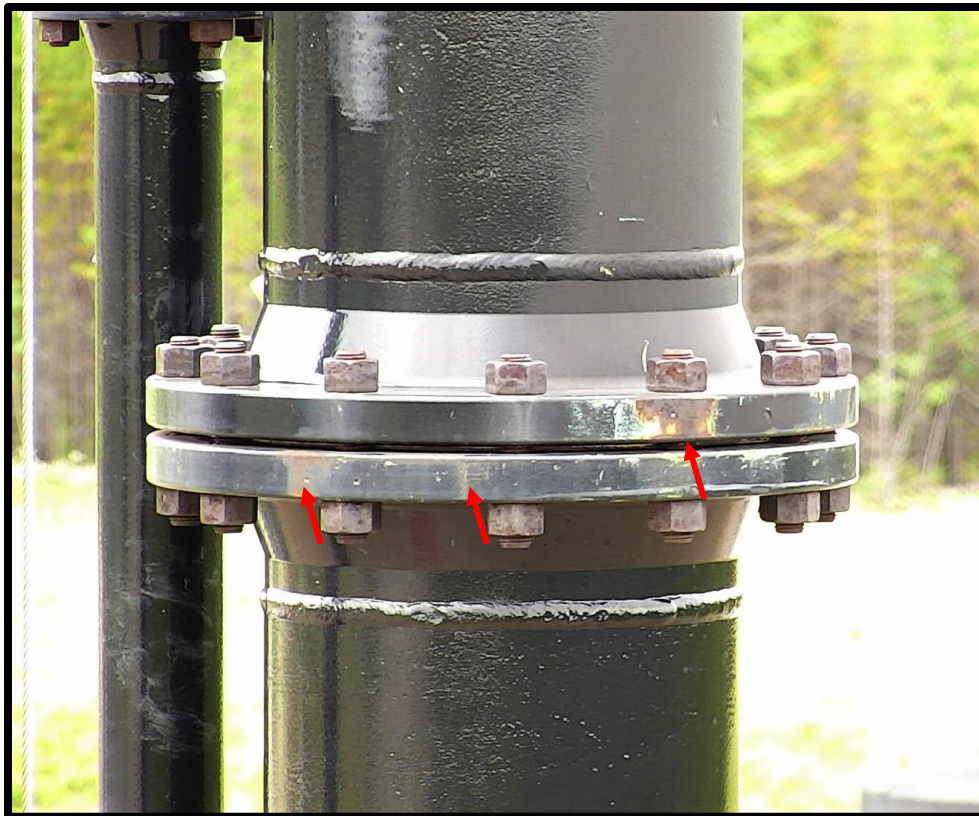
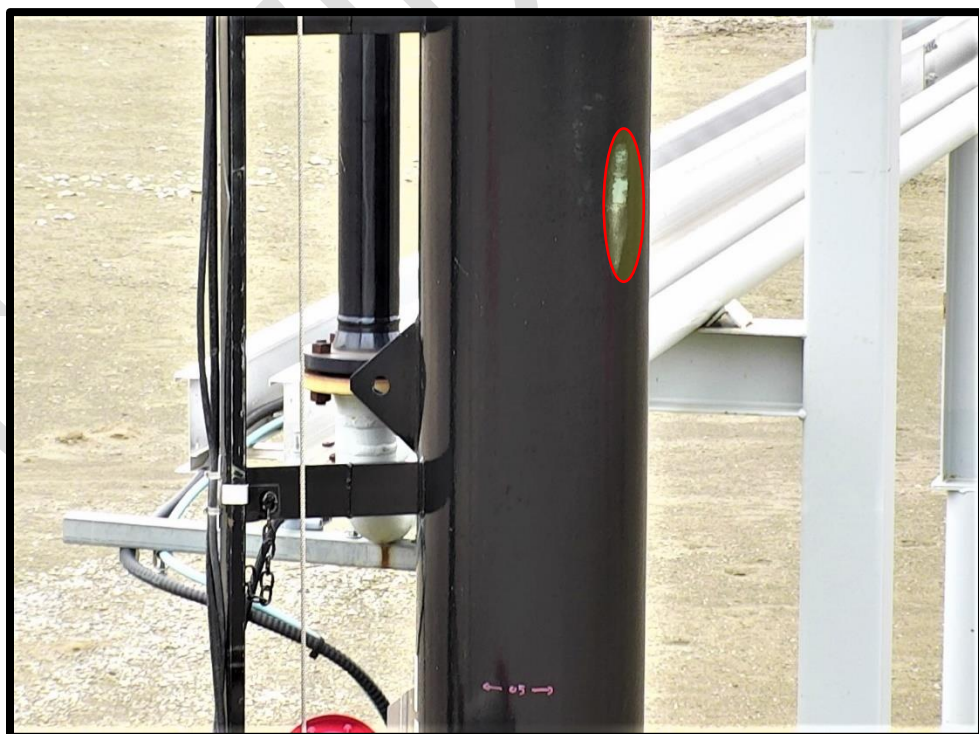
d) Abrasions, coating anomalies & signs of corrosion

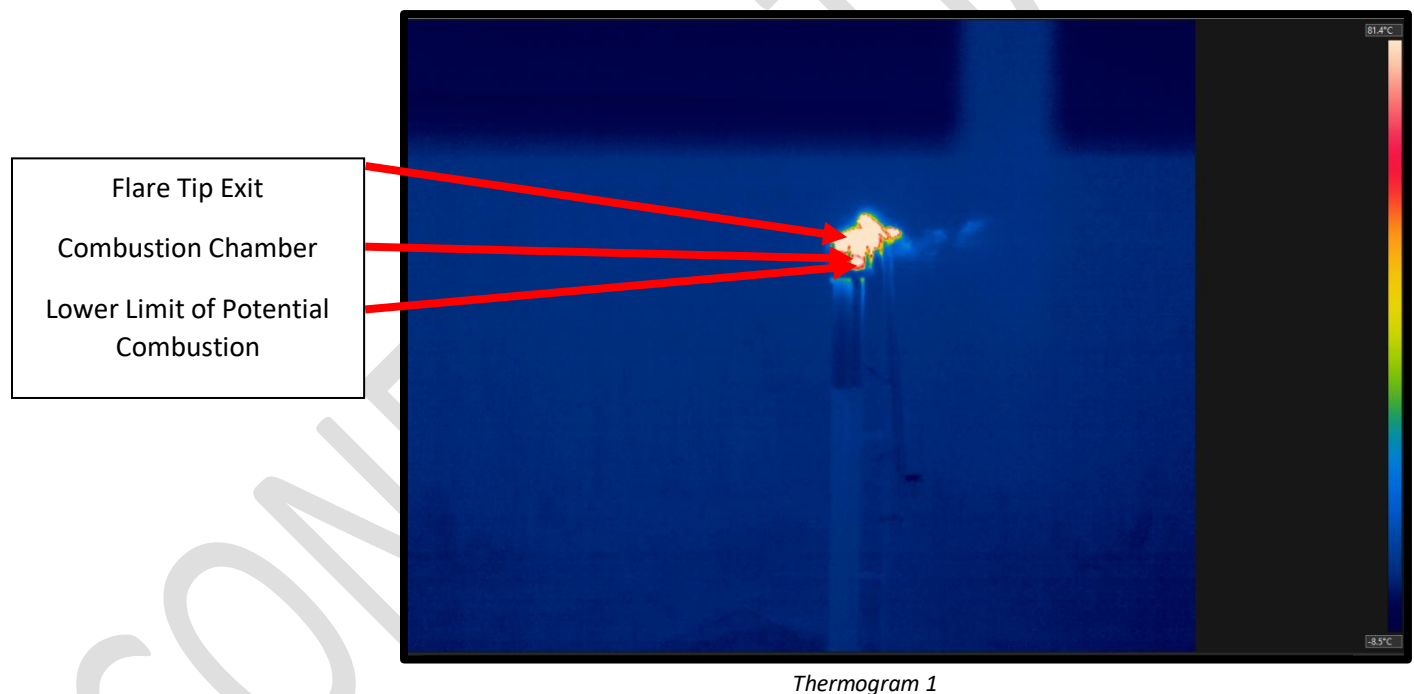
Thermal/IR Scan yielded no apparent signs of cracks or other anomalies on the Flare Tip Shroud

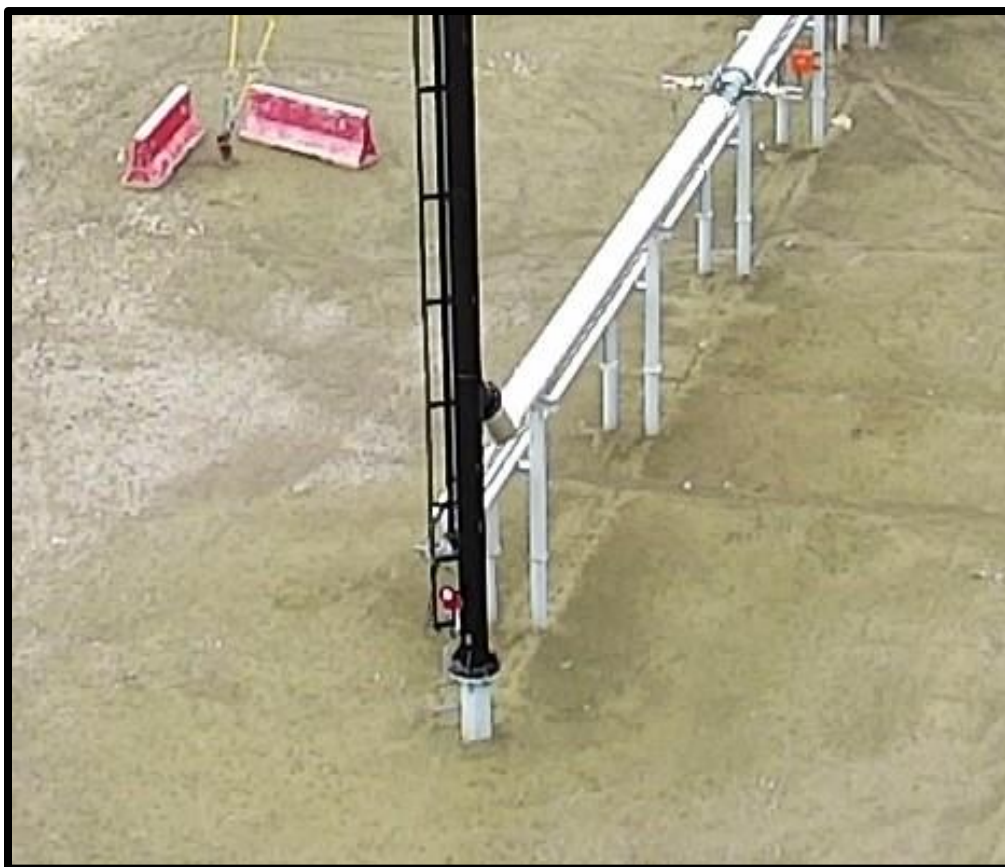
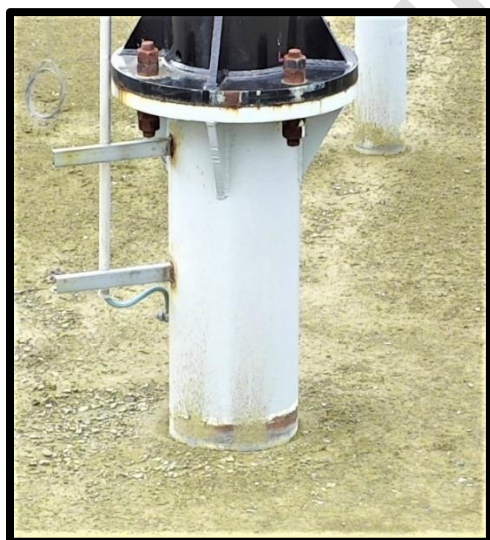
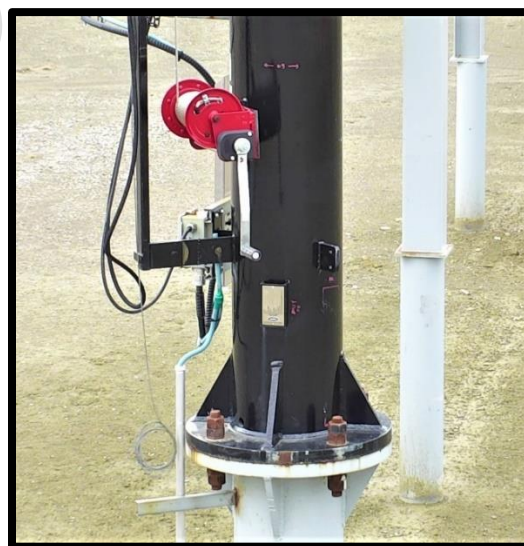
Overview of the flare base and its components

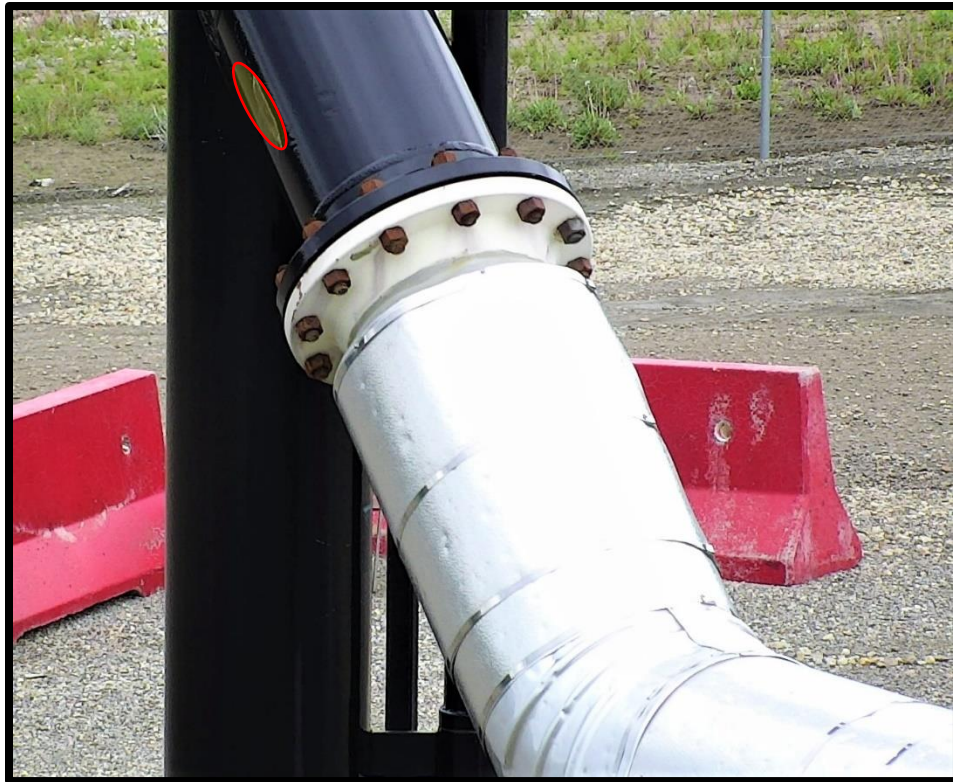
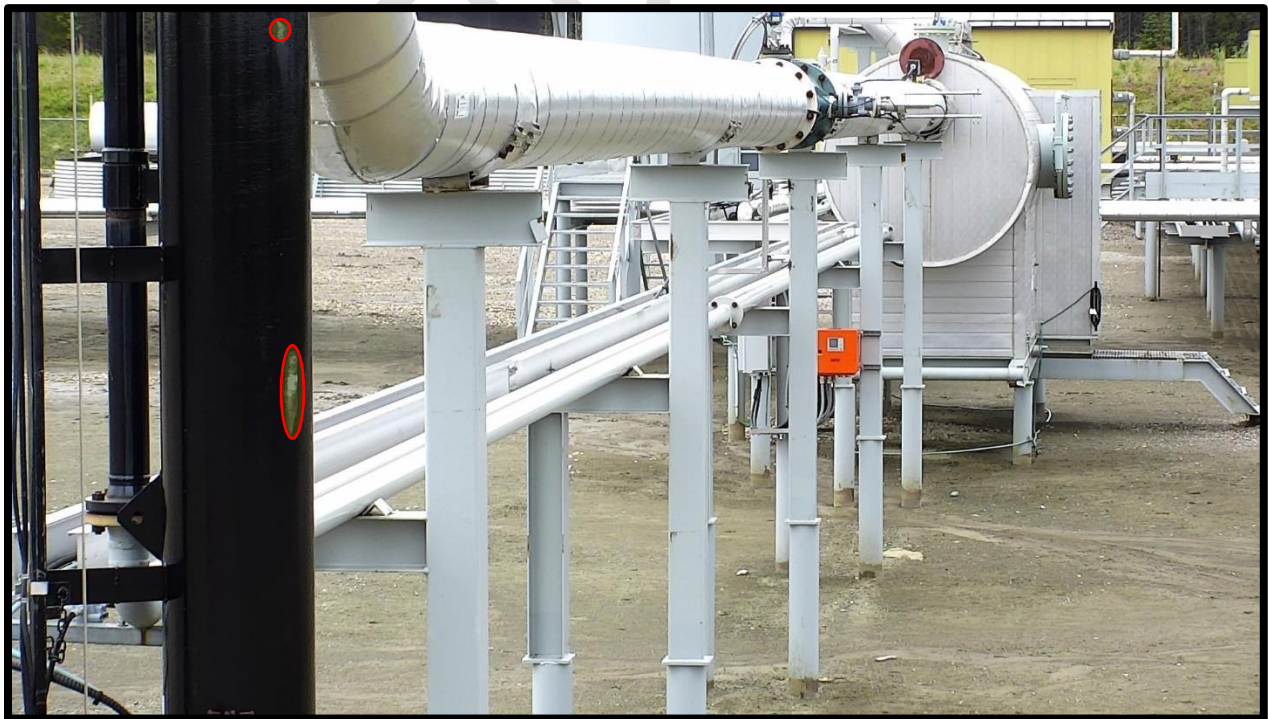
a) **Abrasions & Coating anomalies**

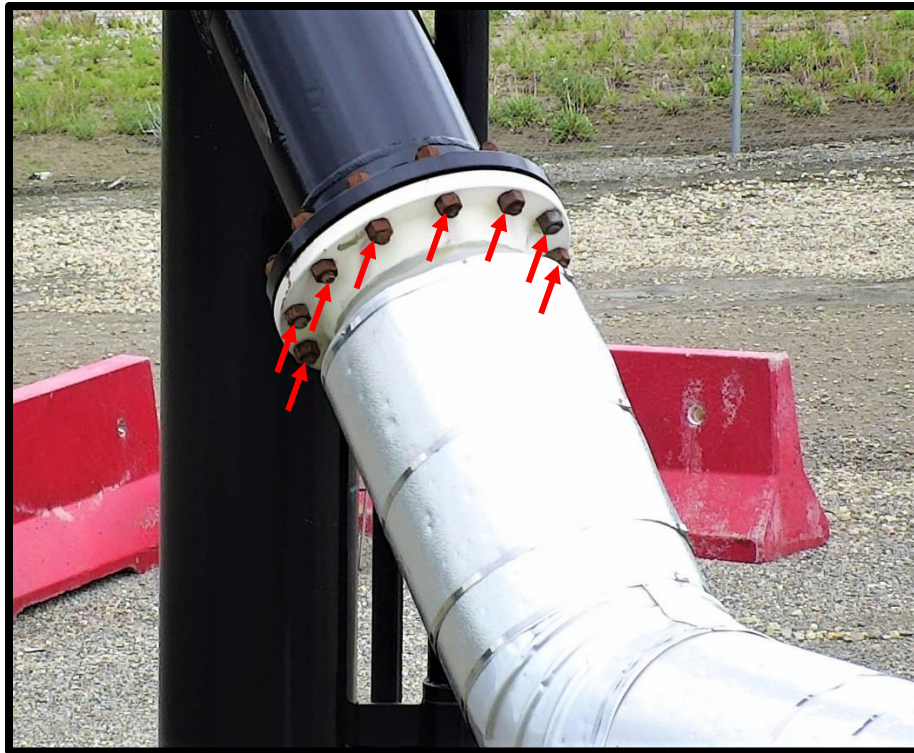
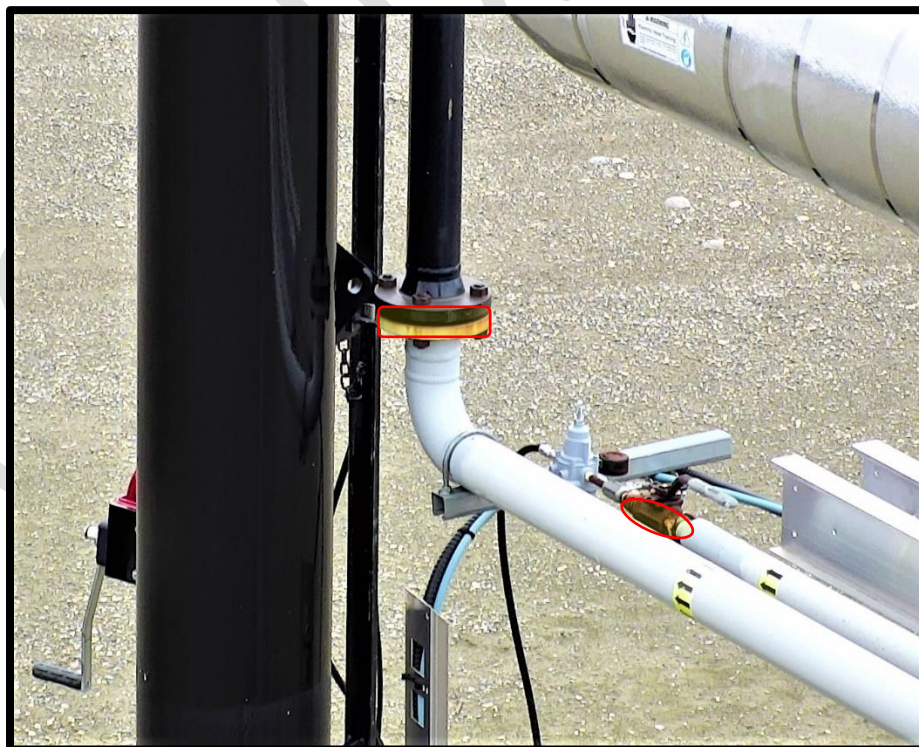
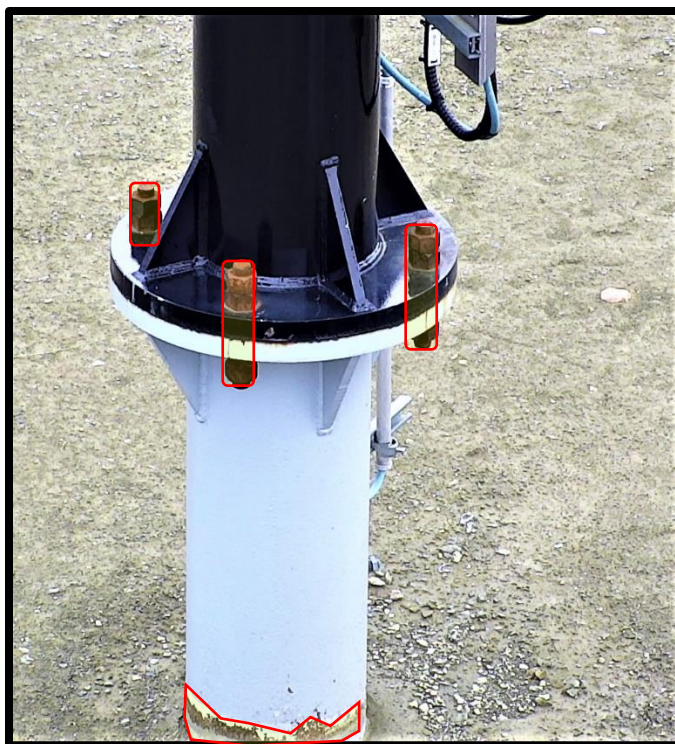
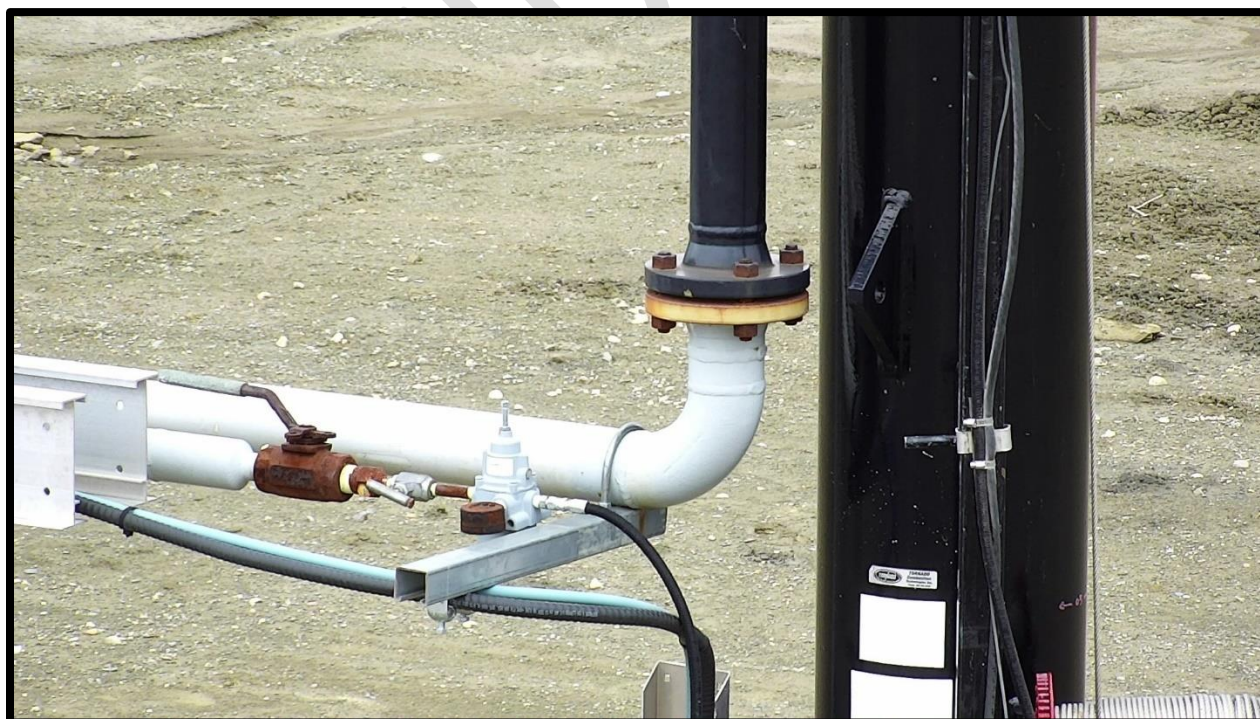
Flare Base	<ul style="list-style-type: none"> Signs of corrosion on the flare base and its components as well as won the gas supply line. Missing cable tray cover 	<ul style="list-style-type: none"> Affected areas to be coated/painted to avoid expansion of corrosion Cable tray to be covered for snow and rain
Aircraft Warning Light	N/A	N/A
Other components	Good Condition	N/A

b) Flare base & components corrosion
