Aerial Flare Stack Inspection Report

12th June 2018

Aerostar Drone Solutions (Aerostar) was requested to perform an Aerial Inspection on the Flare Stack (Serial Number 11170) located at Minehead 03-06-049-18 W5M Compressor Station.

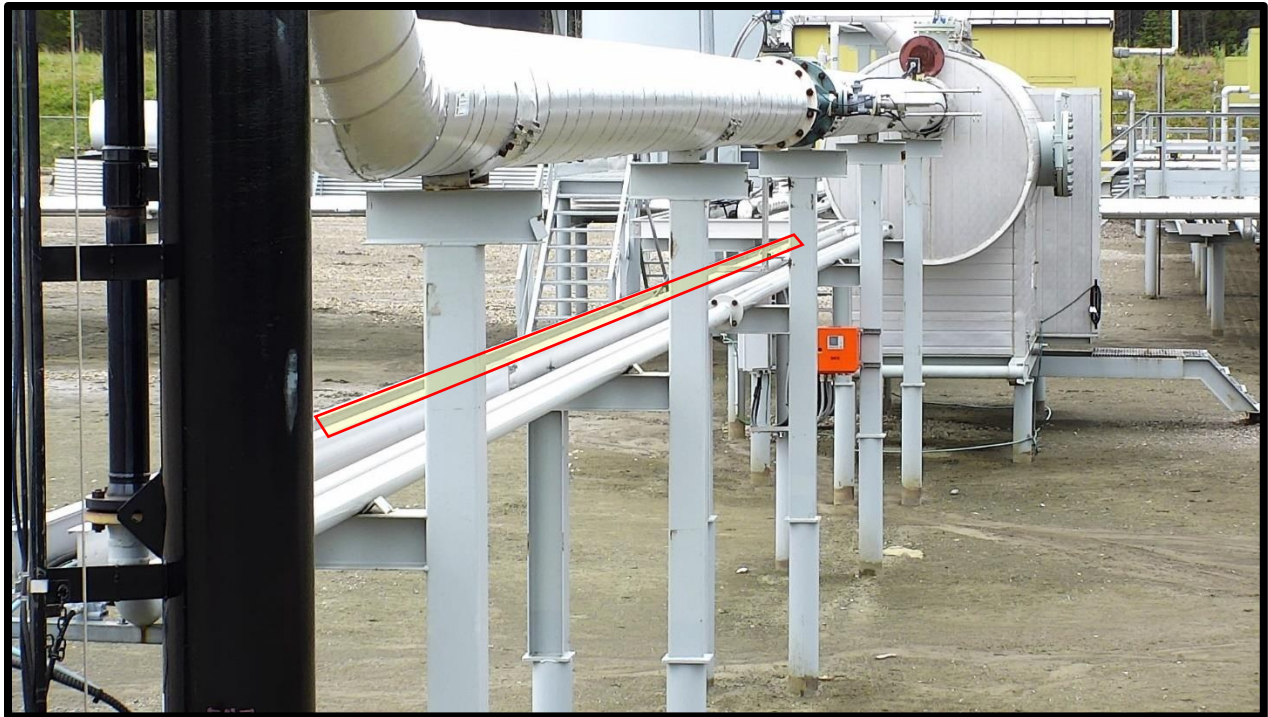
Figure 30

c) Missing cable tray cover

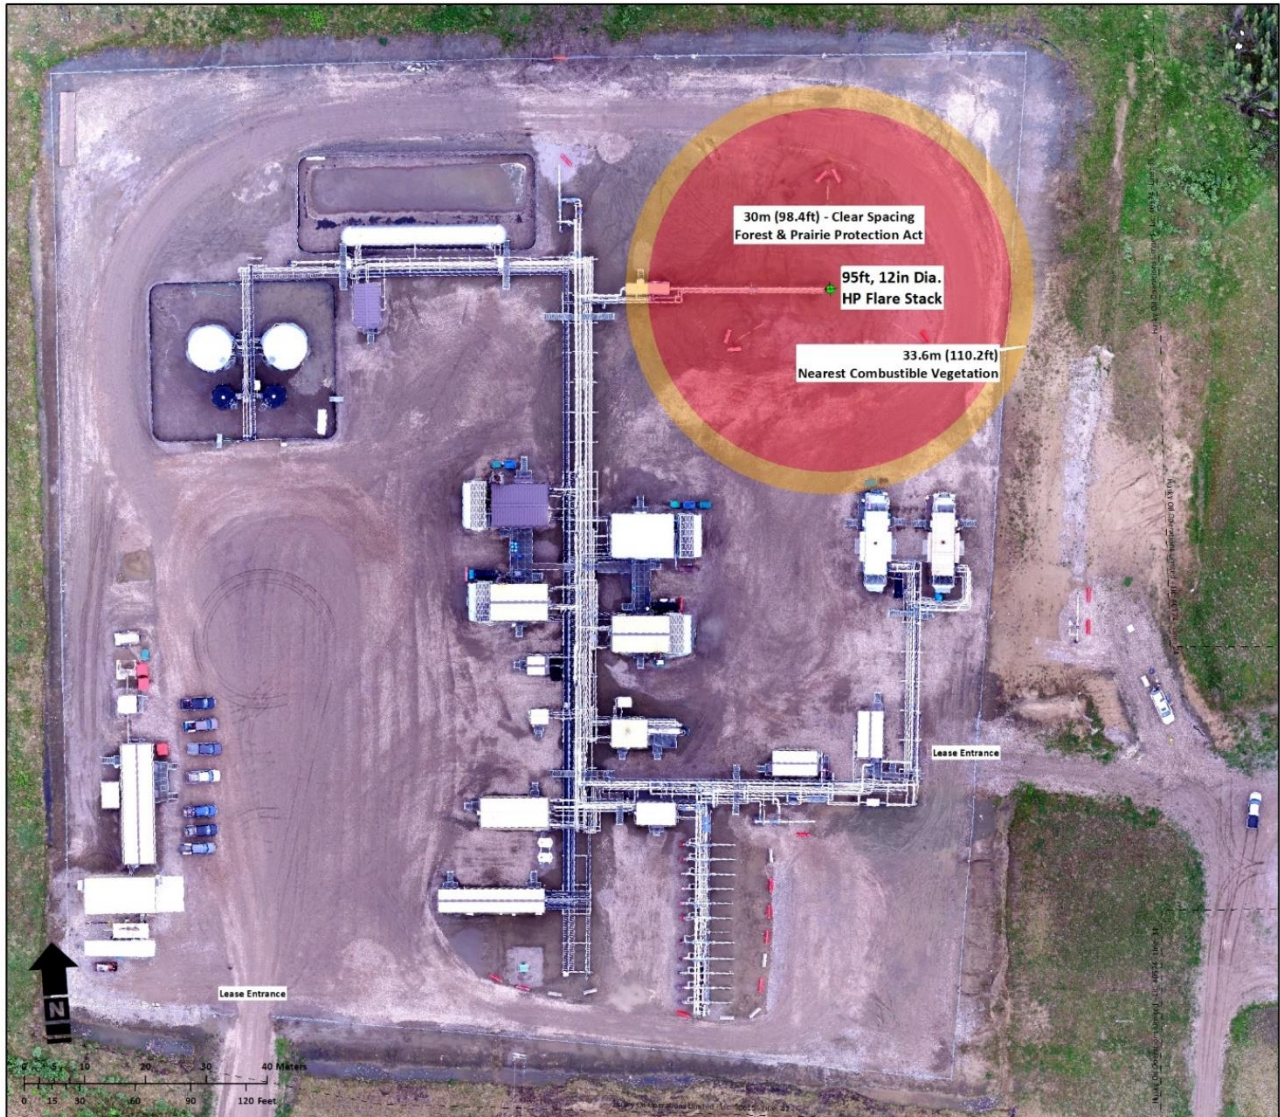
Husky Energy, Ltd. | Minehead Compressor Station 03-06-049-18 W5M | Flare Spacing Map

- Please note that in figure below the Flare Stack is shown with the respective spacing requirements
- The Alberta Forest and Prairie Protection Regulation states that “No person shall flare gas at the end of a vertical pipe unless the base of the vertical pipe is located at least 30 meters, or such other distance as may be specified by a forest officer, from any timber, vegetation or combustible material.”
The area around flares and incinerators must be free of fire hazards
- The red ring indicates the 30 meters (98.4 feet) radius required by AER.
- The yellow ring indicates the distance to the closest combustible material/vegetation of 33.6 meters (110.2 feet)

The AER recommended zone seems clear of combustible vegetation.
