Tank Visual Inspection Report

| Equipment Inspected: Lean Oil Storage Tank TK-552 WO# 60008106 | |

MFL FLOOR INSPECTION

Sylvan Lake Gas Processing Facility
01-21-38-02-W5M

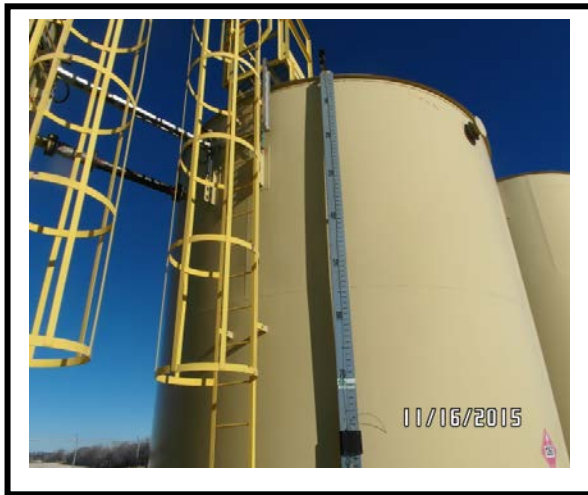
Overview

Tank is in overall very good condition with no signs of damage or leakage.

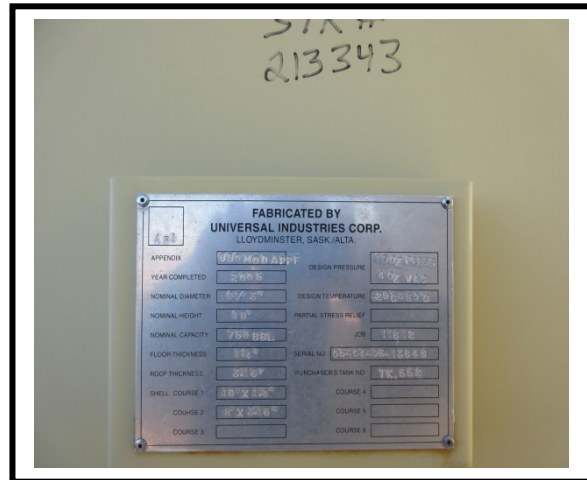
| INTERNAL | | | | | |
|---|---|---|---|---|--|
| NAMEPLATE | <input type="checkbox"/> | <input checked="" type="checkbox"/> | <input type="checkbox"/> | <input type="checkbox"/> | Intact & legible |

Nameplate.

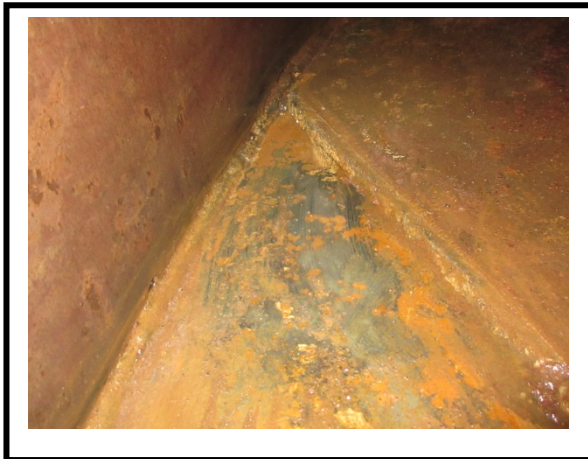
Internal - Shell, floor & roof uncoated and sufficiently cleaned for surface inspection. Majority of floor plate in good condition with accumulations of heavy scale around outer circumference. This could easily be scraped off revealing sound metal underneath with no indication of pitting. Floor lap welded seams in good condition exhibiting smooth clean profile. Streamline NDE performed MFL floor scan during inspection and results found no indication of underside corrosion or deterioration. Some areas of slight concern were proved out with UT with no issues or concerns. Composite material gageboard float displacer moves freely within guide cables anchored to floor and appears to function as designed. Shell/walls clean & in good condition. Minor scale deposits adhering in all areas of shell, however, easily scraped off and revealing sound un-corroded material below. Internal roof as viewed from floor appears in satisfactory condition with no obvious issues or structural deformation noted. Original manufacturing markings still visible on shell sections as seen in photos. Level indication provided by radar transmitter as well as local gage board and Hi-Level float trip in upper shell nozzle. Other internal nozzles, flange faces, siphons & standpipe all in good condition with no indications of corrosion or deterioration.

Surface scale scraped away leaving smooth original plate finish.

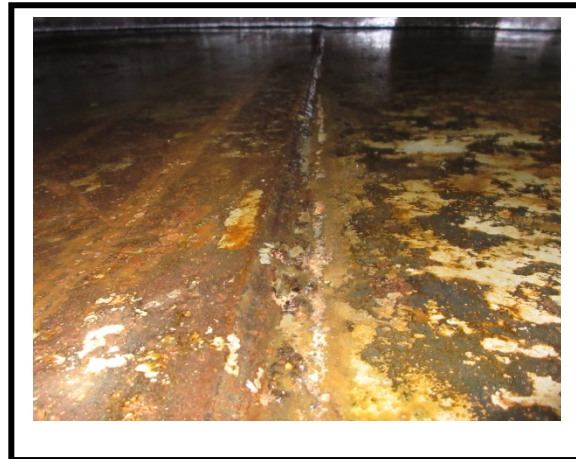
Floor lap joint fillet weld.

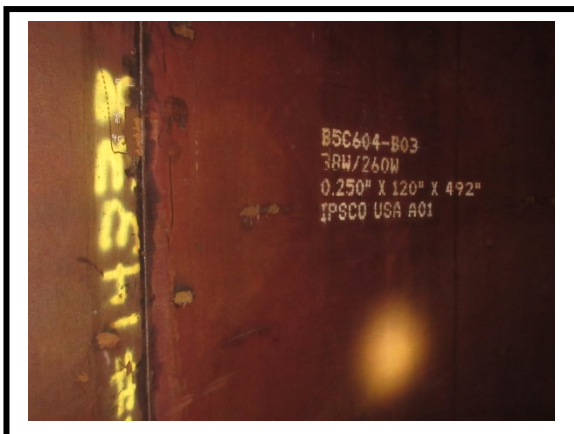
| INTERNAL | | | | | |
|---|---|---|---|---|--|
| COATING / PAINT | <input type="checkbox"/> | <input checked="" type="checkbox"/> | <input type="checkbox"/> | <input type="checkbox"/> | Good Original Condition |

Original paint & inventory markings still visible on shell.

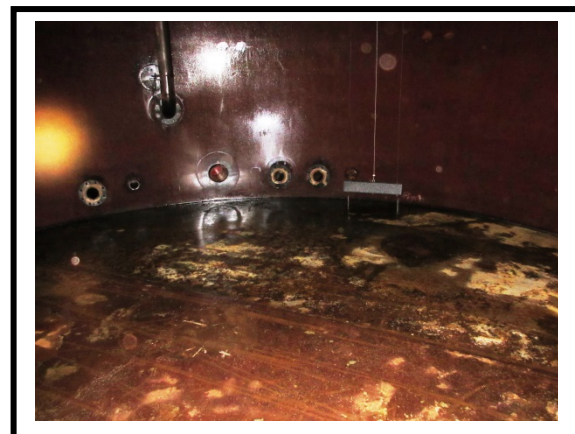
| INTERNAL | | | | | |
|---|---|---|---|---|--|
| NOZZLES | <input type="checkbox"/> | <input checked="" type="checkbox"/> | <input type="checkbox"/> | <input type="checkbox"/> | Clean - no corrosion or pitting observed |

Overall floor & internal nozzles. No pitting or corrosion found.

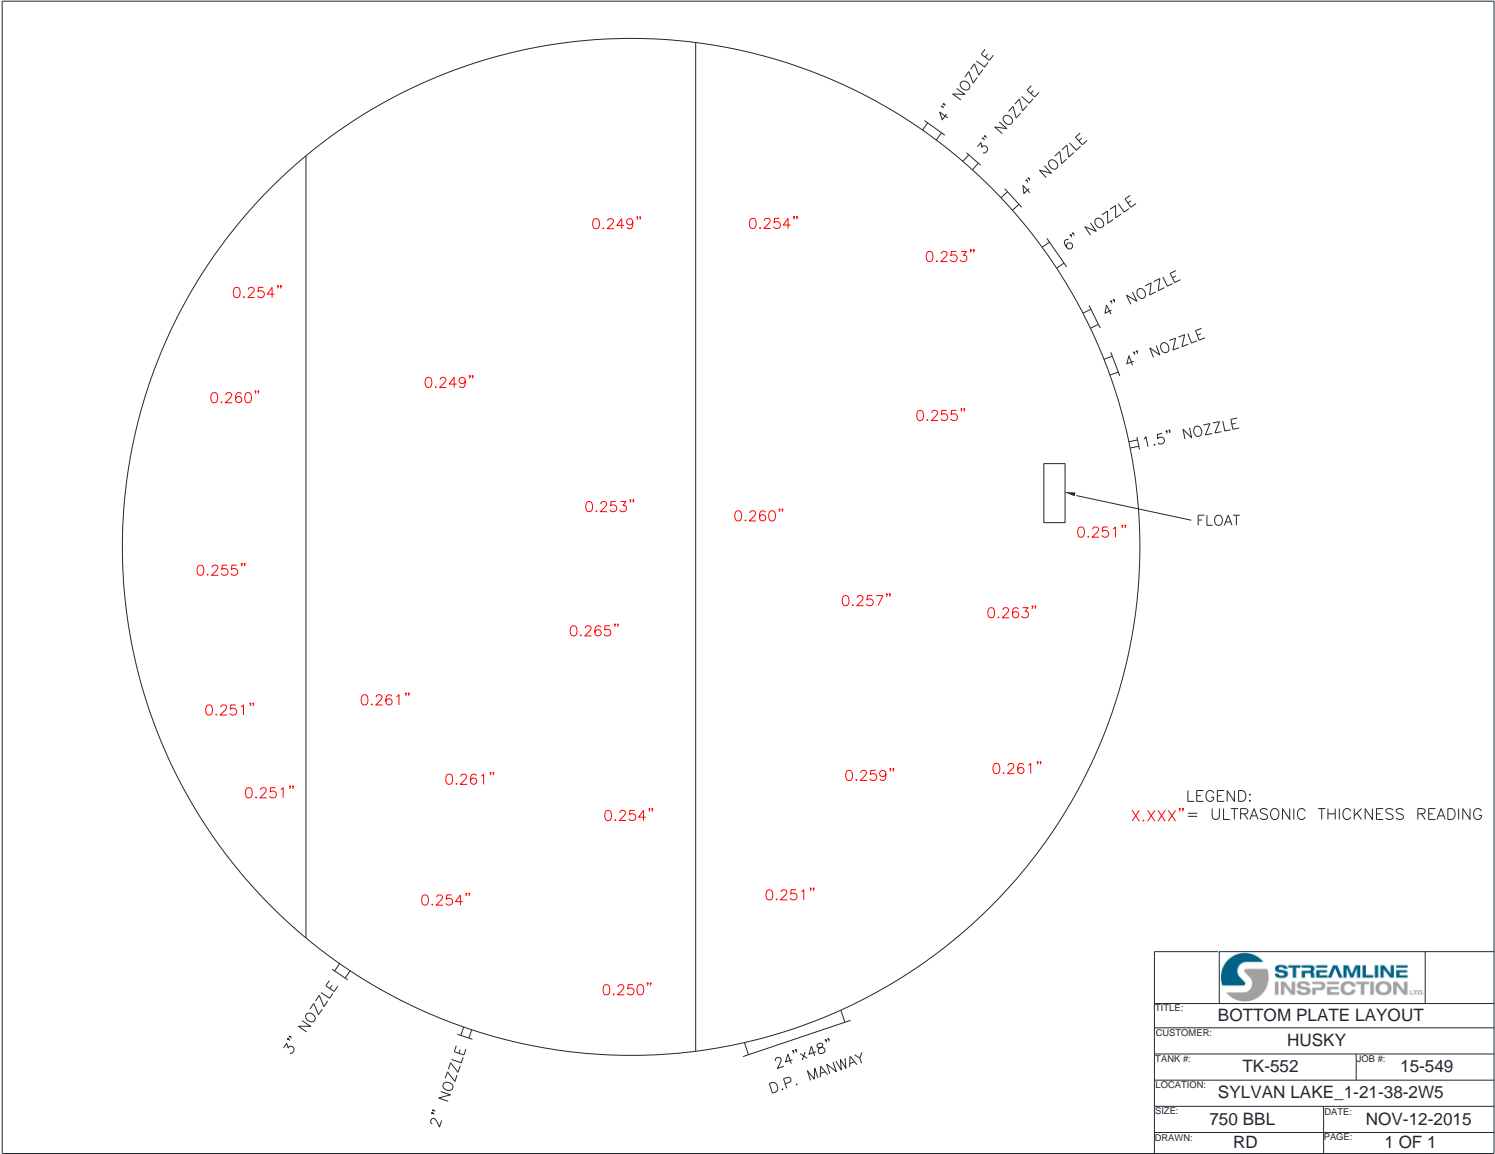
FIGURE 1 BOTTOM PLATE LAYOUT

An MFL floor scan was performed on all bottom plates where accessible. As a result of the floor scan, zero (0) underside indications were observed at time of inspection.

Random UT was conducted throughout, no major thickness loss was observed as a result.

A nominal thickness of 0.250 inch was recorded.

There are no recommendations at this time of inspection.
