## Tank Visual Inspection Report

| Equipment Inspected: Lean Oil Storage Tank TK-552 WO# 60008106 | |

# MFL FLOOR INSPECTION

Sylvan Lake Gas Processing Facility  
01-21-38-02-W5M

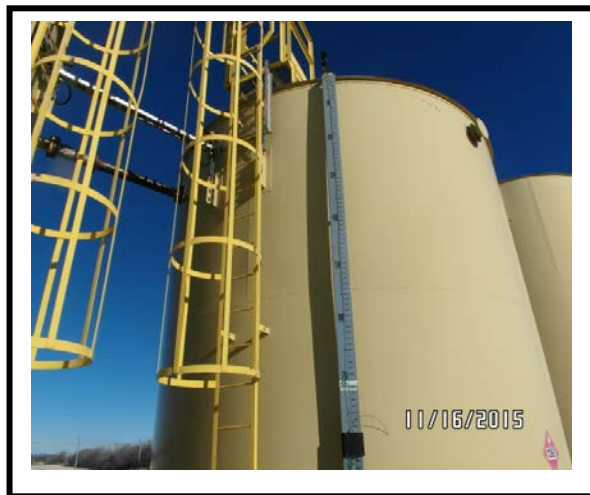
Overview

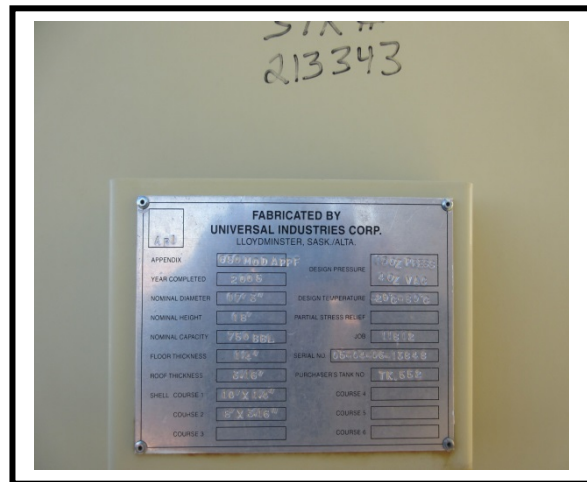
Nameplate.

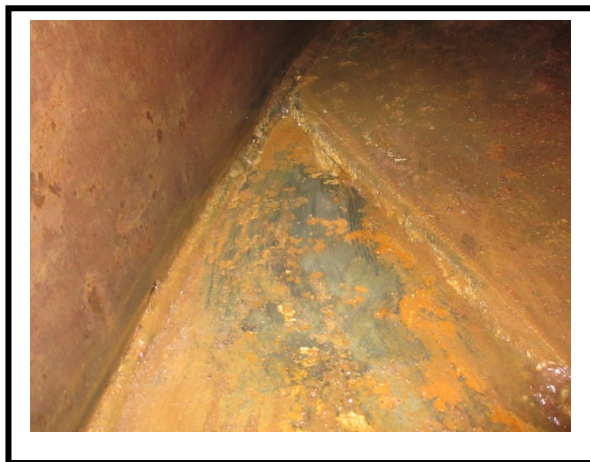
Internal - Shell, floor & roof uncoated and sufficiently cleaned for surface inspection. Majority of floor plate in good condition with accumulations of heavy scale around outer circumference. This could easily be scraped off revealing sound metal underneath with no indication of pitting. Floor lap welded seams in good condition exhibiting smooth clean profile. Streamline NDE performed MFL floor scan during inspection and results found no indication of underside corrosion or deterioration. Some areas of slight concern were proved out with UT with no issues or concerns. Composite material gageboard float displacer moves freely within guide cables anchored to floor and appears to function as designed. Shell/walls clean & in good condition. Minor scale deposits adhering in all areas of shell, however, easily scraped off and revealing sound un-corroded material below. Internal roof as viewed from floor appears in satisfactory condition with no obvious issues or structural deformation noted. Original manufacturing markings still visible on shell sections as seen in photos. Level indication provided by radar transmitter as well as local gage board and Hi-Level float trip in upper shell nozzle. Other internal nozzles, flange faces, siphons & standpipe all in good condition with no indications of corrosion or deterioration.

Surface scale scraped away leaving smooth original plate finish.

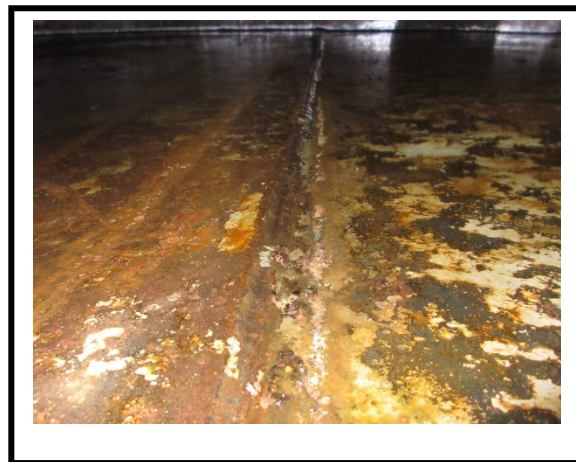
Floor lap joint fillet weld.

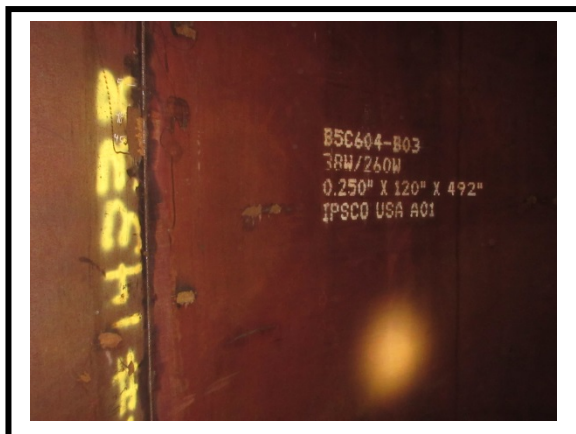
Original paint & inventory markings still visible on shell.

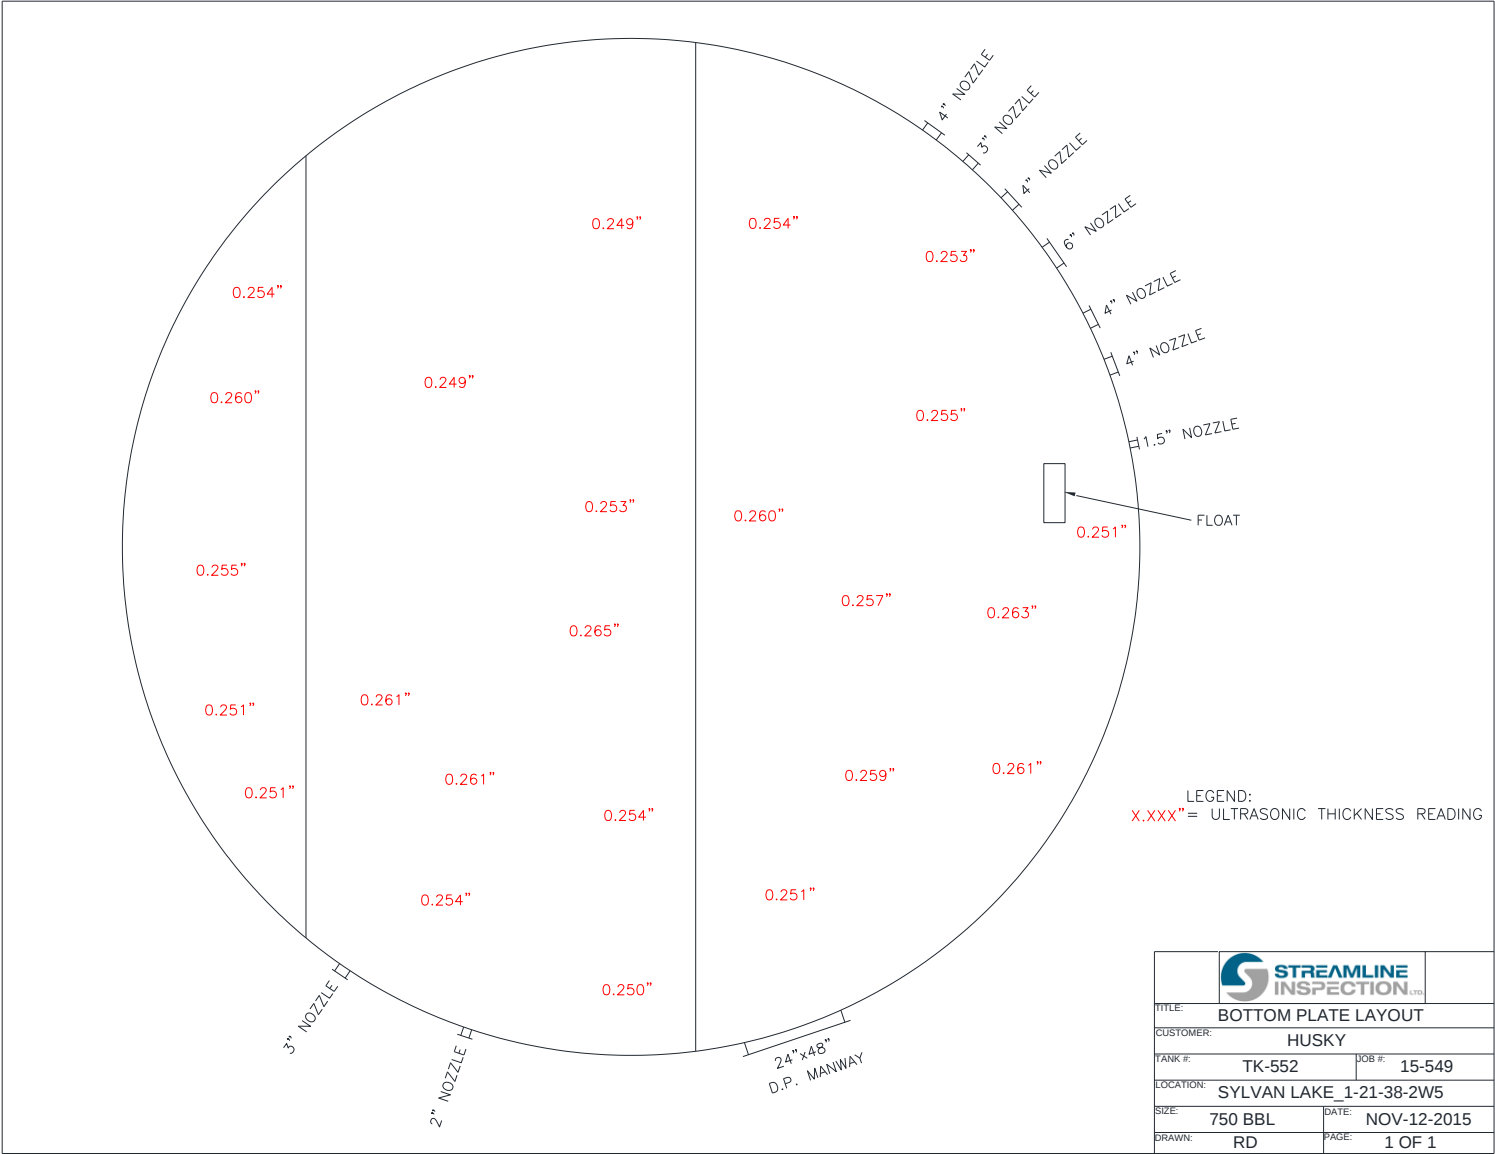
FIGURE 1 BOTTOM PLATE LAYOUT

An MFL floor scan was performed on all bottom plates where accessible. As a result of the floor scan, zero (0) underside indications were observed at time of inspection.

Random UT was conducted throughout, no major thickness loss was observed as a result.

A nominal thickness of 0.250 inch was recorded.

There are no recommendations at this time of inspection.
