Tank Visual Inspection Report

Foreman: J. Grocock	Location: 01-21-038-02W5M
Area: Sylvan Lake Plant	Operations Rep: Dustin Conly
Inspector: N. Schmidt	Inspect Date: Nov 12, 2015
STATIC DATA	
Equipment Inspected: Lean Oil Storage Tank TK-553 WO# 60084663	
Process: Lean Oil	Volume: 750 BBL - 119.2 m3
Manufacturer: Universal Industries Corp.	Mfr. Date: 2005
Construction Code: API 650	Roof Girder System: Internal <input type="checkbox"/> External <input type="checkbox"/> N/A <input checked="" type="checkbox"/>
Serial #: 05-04-06-13849	SAP# 66096451 INV. #: 213344
Double Wall: Y <input type="checkbox"/> N <input checked="" type="checkbox"/>	Insulated: Y <input type="checkbox"/> N <input checked="" type="checkbox"/>
Roof Thick: 3/16" - 4.76 mm	Material: A36
Wall Thick: 1/4" - 6.35 mm	Material: A36
Floor Thick: 1/4" - 6.35 mm	Material: A36
Elevated: Y <input type="checkbox"/> N <input checked="" type="checkbox"/>	Secondary Containment Type: Steel Wall with liner

MFL FLOOR INSPECTION

SAP-66096451

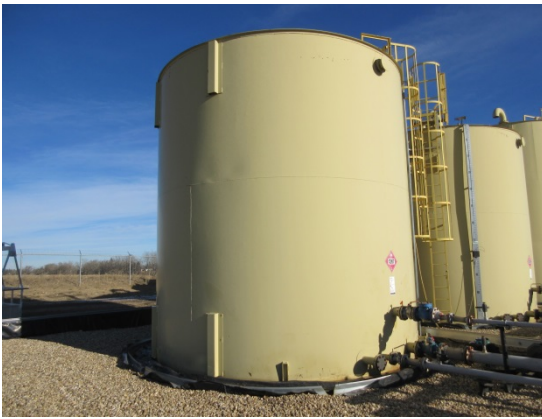
Overview on gravel base.

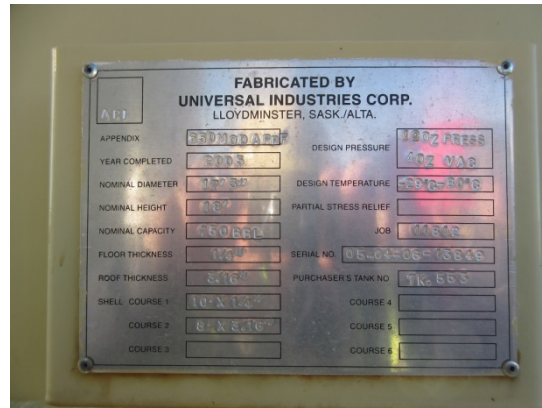
Nameplate.

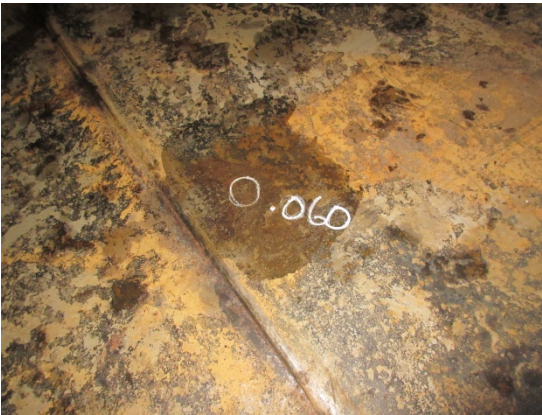
Internal - Shell, floor & roof uncoated and sufficiently cleaned for surface inspection. Majority of floor plate in good condition with widespread pitting to depths ranging from 0.020 - 0.060" from nominal of 0.250". This does not affect floor integrity or containment capability at this point but needs to be monitored with mitigation activities planned for next inspection. Floor lap welded seams in good condition exhibiting smooth clean profile. Streamline NDE performed MFL floor scan during inspection and results found no indication of underside corrosion or deterioration. Composite material gageboard float displacer moves freely within guide cables anchored to floor and appears to function as designed. Shell/walls clean & in good condition. Minor scale deposits adhering in all areas of shell, however, easily scraped off and revealing sound un-corroded material below. Internal roof as viewed from floor appears in satisfactory condition with no obvious issues or structural deformation noted. Original manufacturing markings still visible on shell sections as seen in photos. Level indication provided by radar transmitter as well as local gage board and Hi-Level float trip in upper shell nozzle. Other internal nozzles, flange faces, siphons & standpipe all in good condition with no indications of corrosion or deterioration.

Tank is in overall very good condition with no signs of damage or leakage. Floor plate pitting is evident and occurring which will need to be monitored during future inspections. Mitigation measures include possible epoxy coating application at next or future internal inspections.

Random clusters of pitting throughout floor plate at 0.020" – 0.060" in depth.

Review Date: Nov 16, 2015	Next Inspection Date: 2020
Comments / Recommendations: This 750 BBL Lean Oil tank is fit for continued service in it's present application. Based on this condition an inspection interval has been set at 5 years for the next thorough inspection unless the tank is moved or the service conditions change at which time an internal may be required. Continue external monthly inspection as required. Monitor internal floor corrosion & pitting. Plan & prepare for possible epoxy coating at next inspection if results warrant this mitigation strategy.

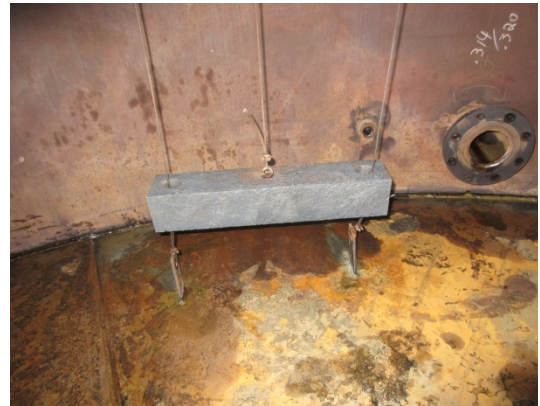
Level indication in good condition. Composite float moves freely within guide cables.

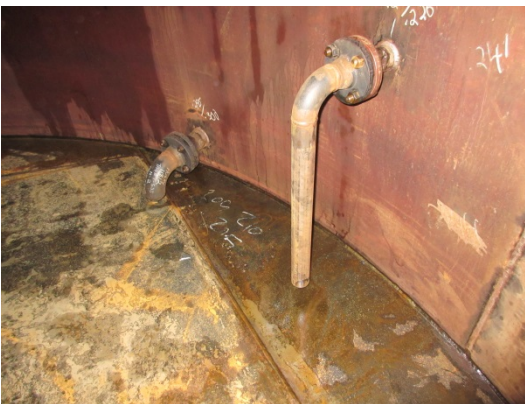
All internal piping, nozzles, siphon & standpipe in good clean uncorroded condition.

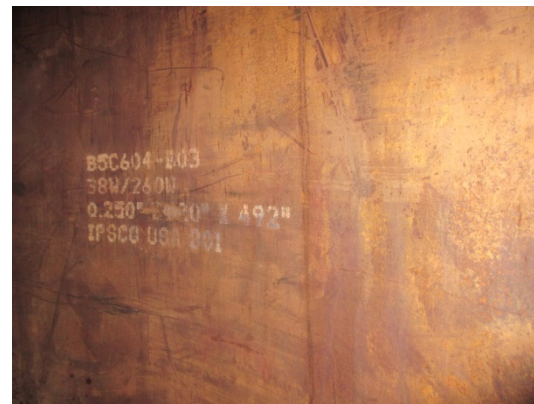
Original manufacturers plate markings.

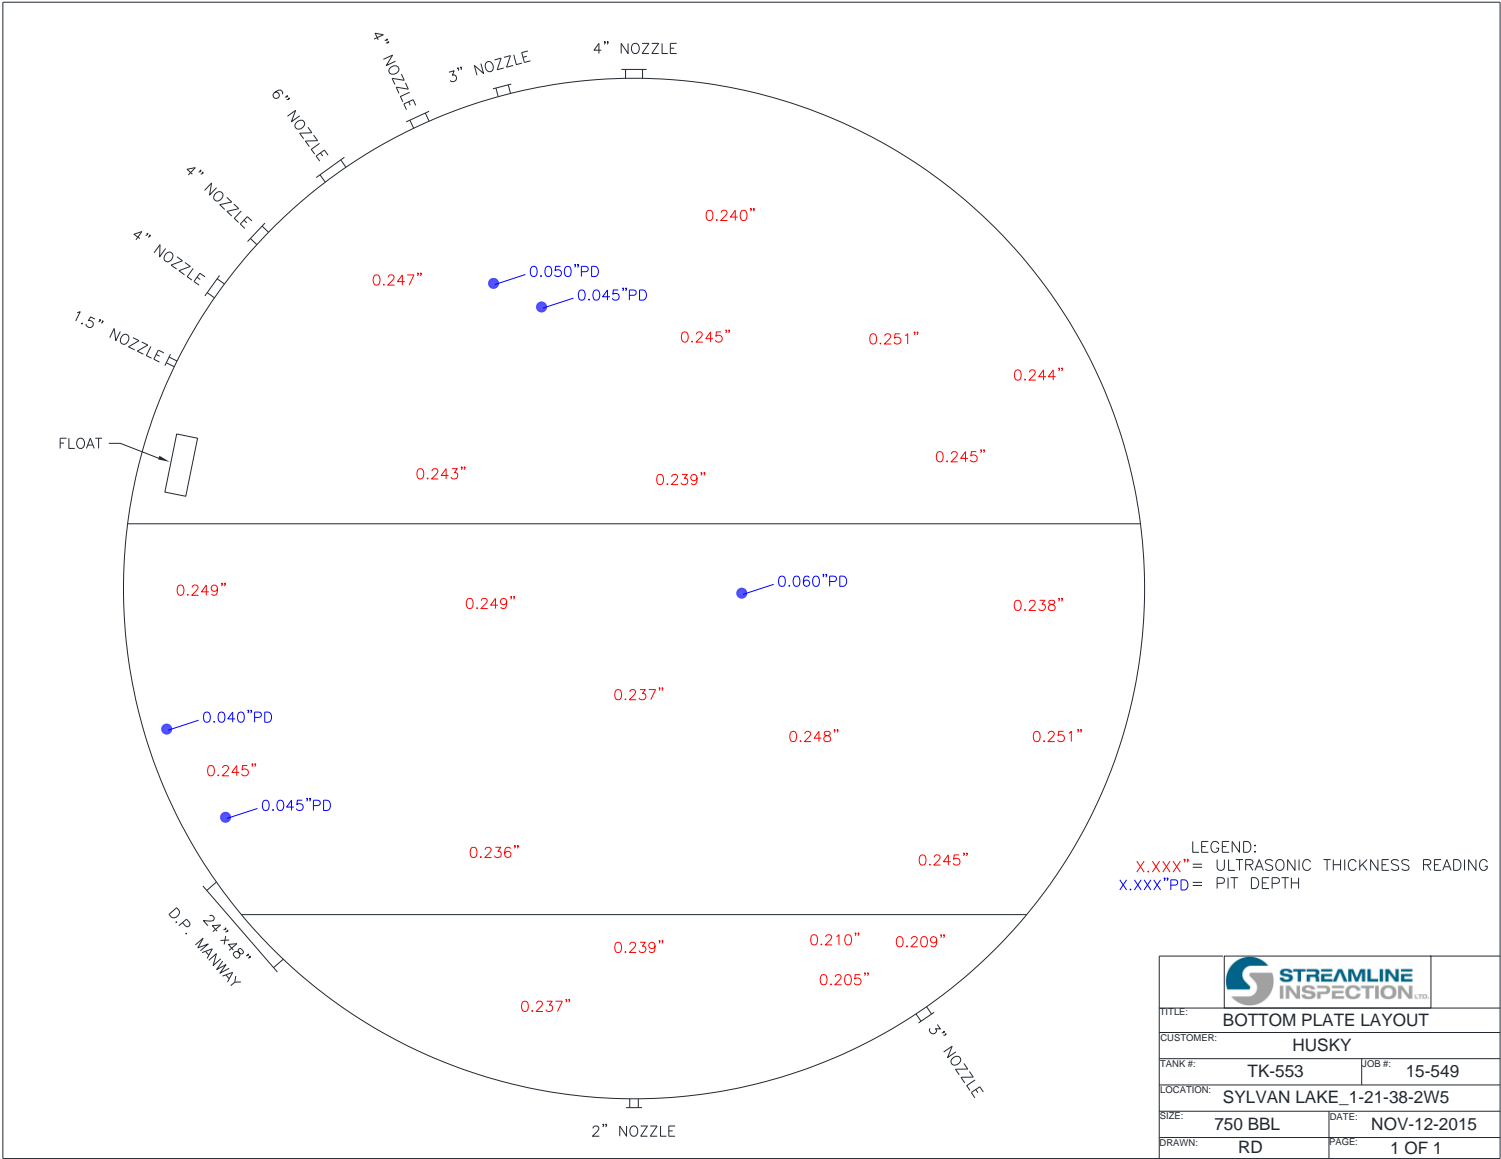
FIGURE 1 BOTTOM PLATE LAYOUT

An MFL floor scan was performed on all bottom plates where accessible. As a result of the floor scan, zero (0) indications were observed at time of inspection.

Random UT was conducted throughout the bottom plates and in the areas where the floor scanner was not accessible, as a result, isolated pitting was observed with a low of 0.205 inch remaining recorded.

An internal visual inspection was performed, as a result, general pitting was observed. Pitting ranged from 0.020 inch – 0.060 inch in depth.

There are no recommendations at this time of inspection.
