Out of Service Tank Inspection

Tank #: **TK-553**

Terminal: **Sylvan Lake Gas Plant**

October 20, 2010

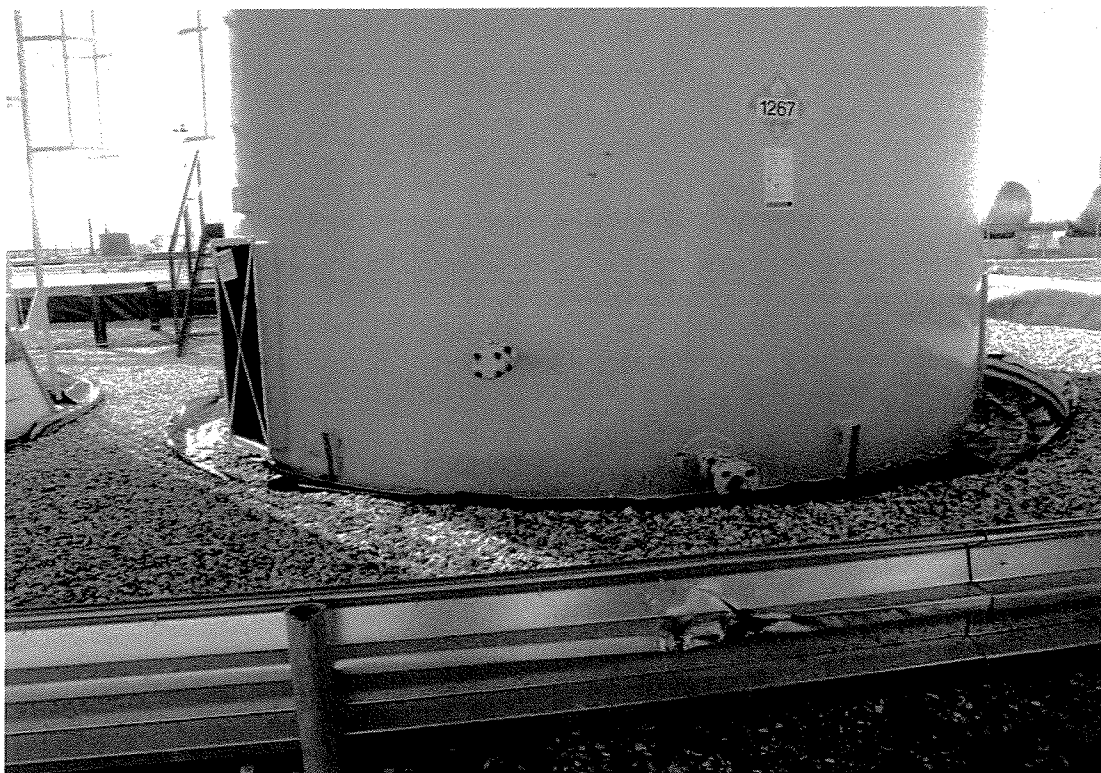
Work Performed
<p>A visual inspection was performed on the internal and external nozzles. The visual inspection was performed to determine the integrity of the coating and identify any areas of concern where leaking, corrosion or mechanical damage may be occurring.</p>
Observations
<p>The autogauge assembly is in good working condition and appears as though it should function correctly under actual operating conditions. Anchor points on the tank are not being utilized likely because the tank is sitting on an earth foundation and not on a concrete pad. The containment area and foundation in general do not appear to slope in a fashion which would provide proper drainage (see Photo 17) but internal and external UT show no signs of corrosion on the bottom of the tank. Buildup of soil is present in areas around the bottom of the tank as seen in Photo 17. Photos 4 and 5 show damage on the containment area which appear to be mechanical damage.</p>

Photo #4: Containment damage area

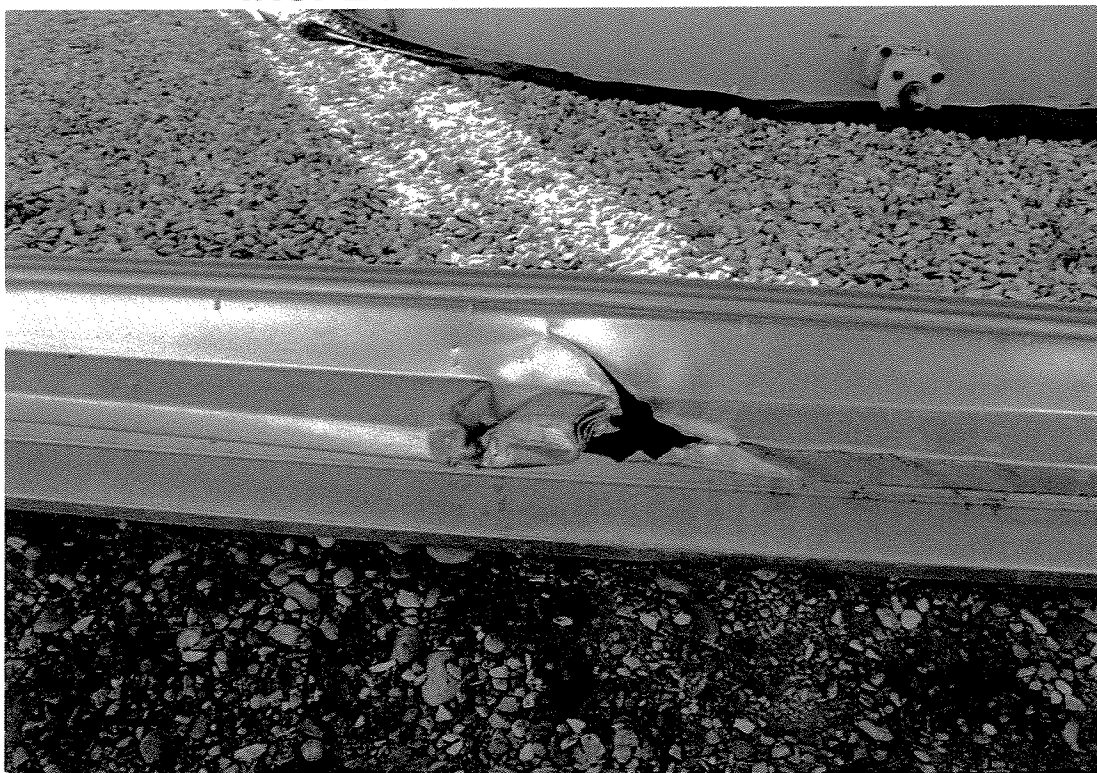
Photo #5: Closeup of containment damage

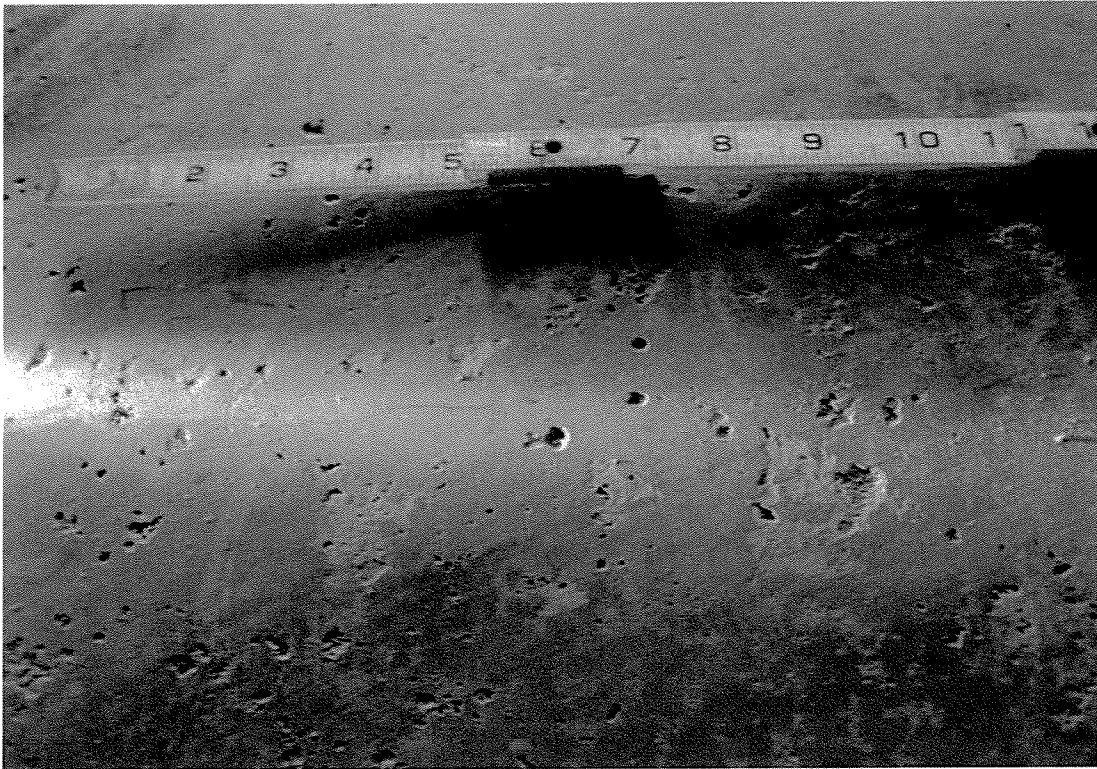
Topside pitting was identified as seen in Photos 7 and 8. This pitting measured an internal depth of 0.050" with no bottom side corrosion present. Actual remaining thickness of the floor plates is 0.198", considering a t-min of 0.100" the remaining life of the tank floor would be 9.8 years as shown in the calculations below.

Corrosion Rate =	$\frac{\text{Material Loss}}{\text{Time}}$	Material Loss = 0.05 Time (years) = 5 Corrosion Rate = 0.01 / Year
Rem Corr Allowance =	$t_{\text{actual}} - t_{\text{min}}$	$t_{\text{actual}} = 0.198$ $t_{\text{min}} = 0.1$ Rem Corr All = 0.098
Rem Service Life =	$\frac{t_{\text{actual}} - t_{\text{min}}}{\text{Corrosion Rate}}$	$t_{\text{actual}} = 0.198$ $t_{\text{min}} = 0.1$ Corrosion Rate (year) = 0.01 Remaining Life = 9.8 / Years

Photo #7: Internal floor pitting

No repairs were recommended at the time of this inspection.

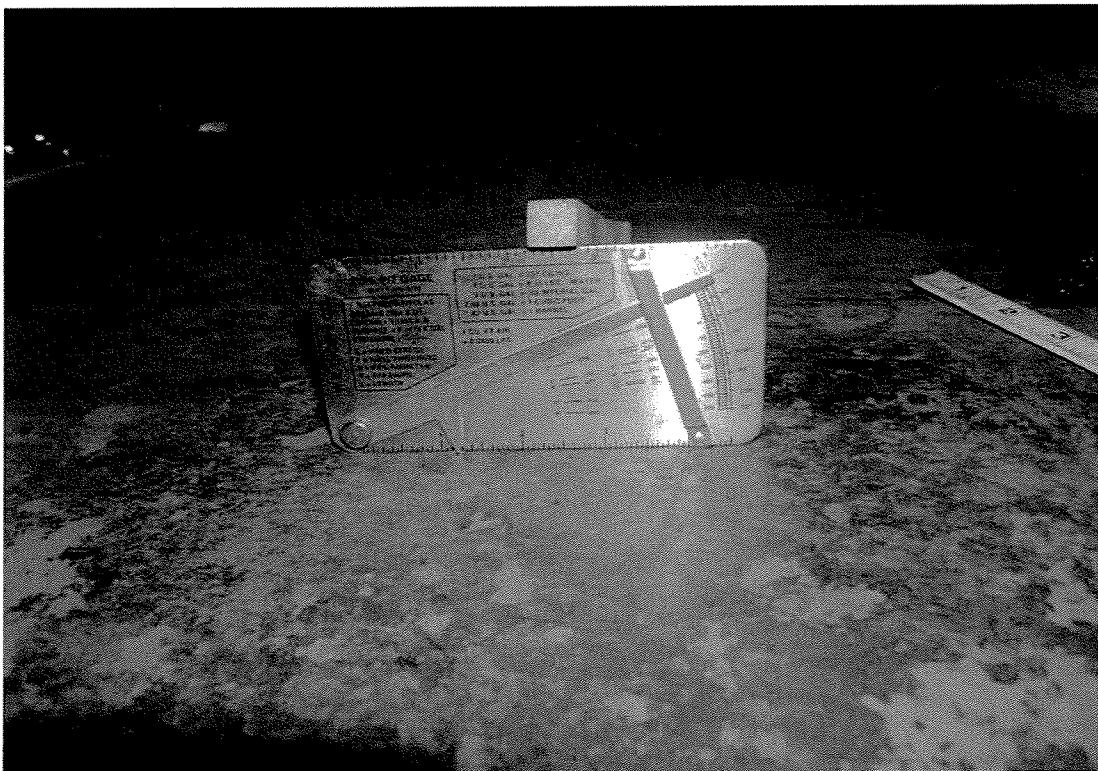
Photo #8: Pit gauge showing 0.050" pitting

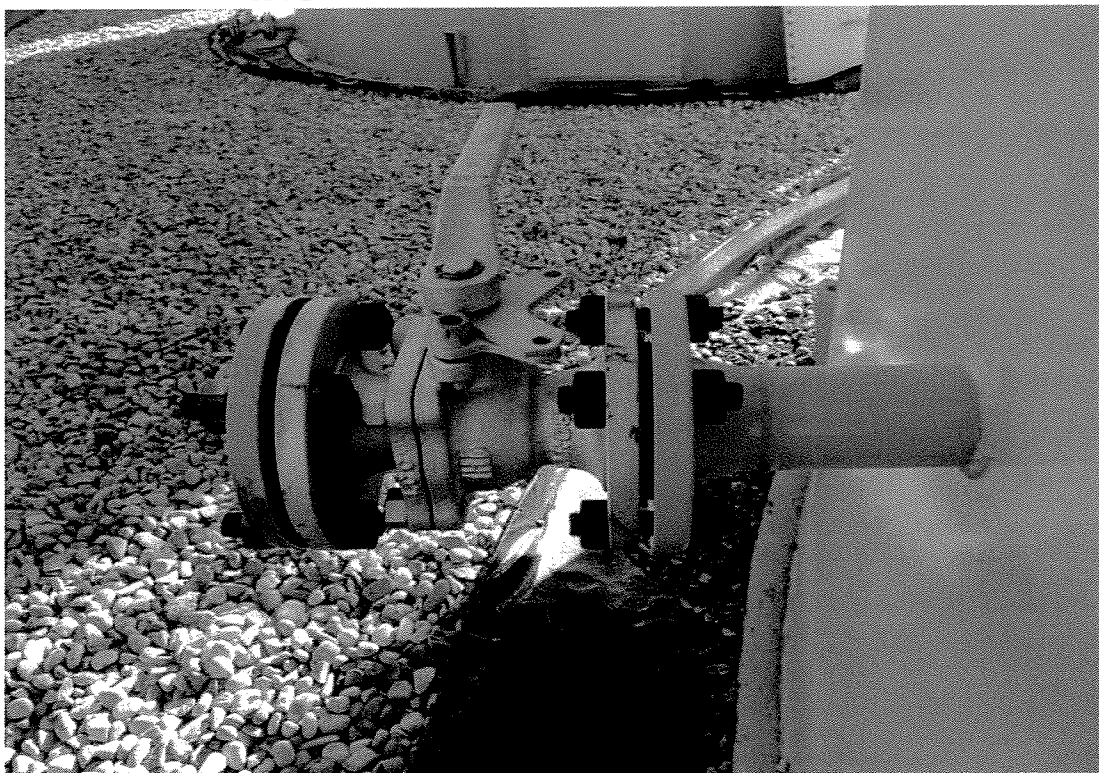
Photo #11: Nozzle showing no indications of leaks

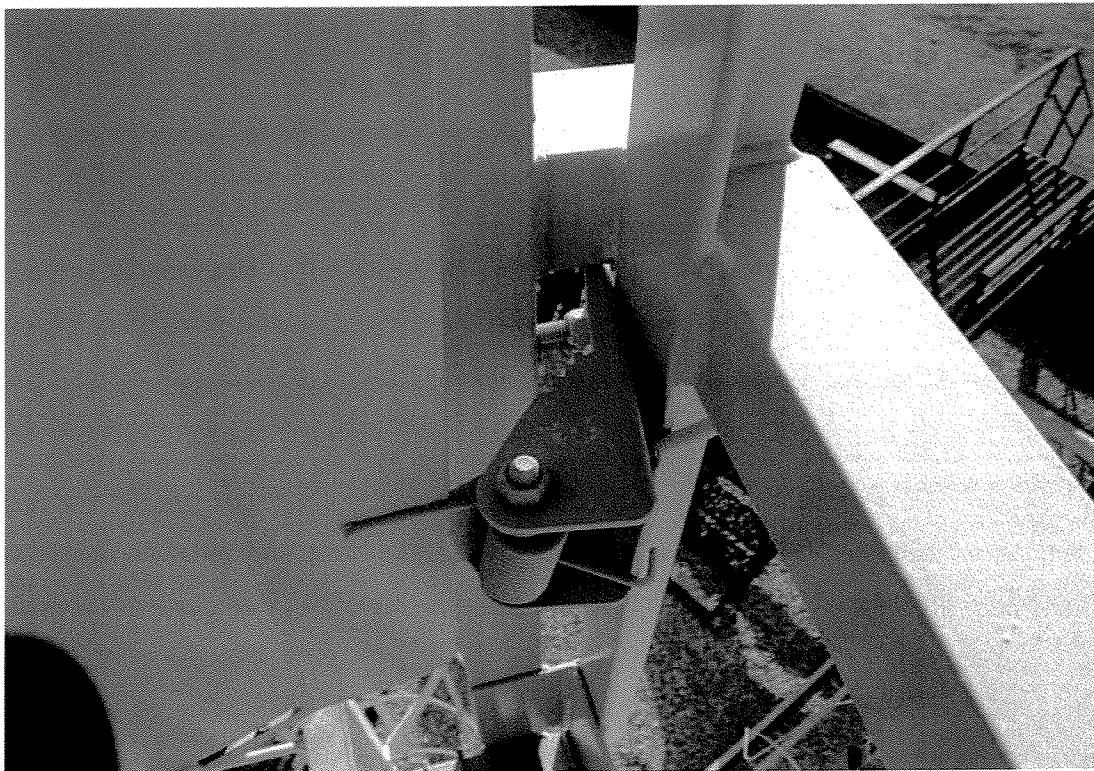
Photo #13: Loose hinge on safety gate

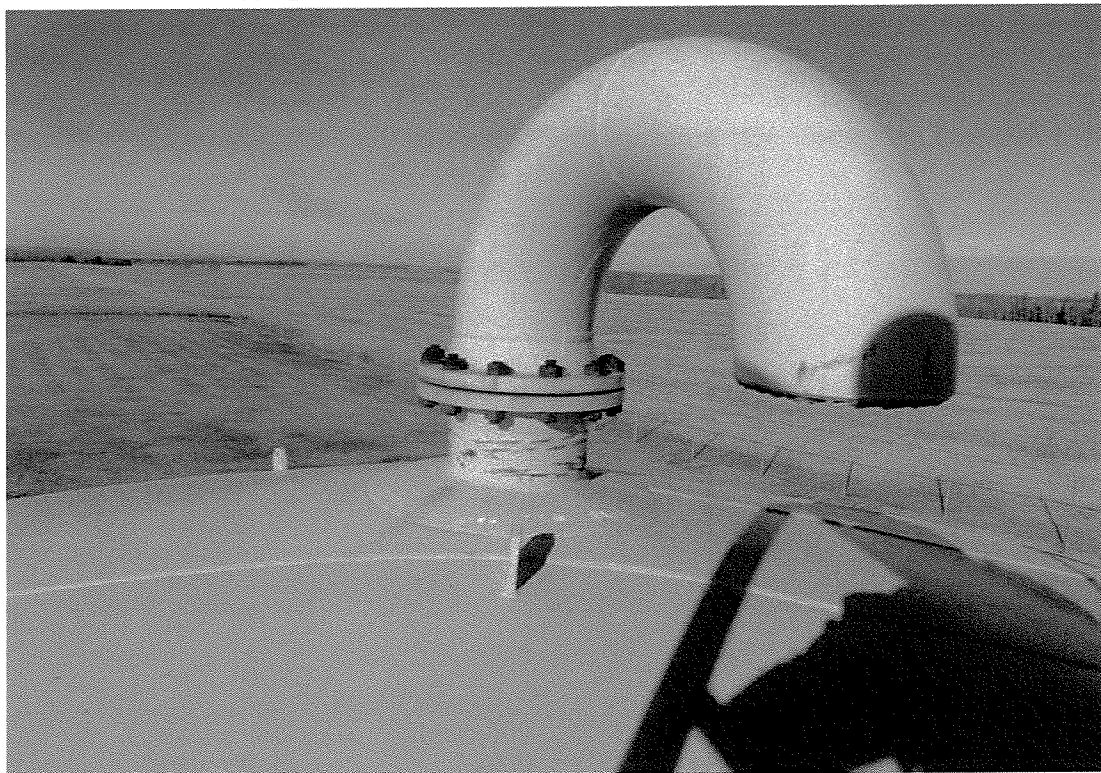
Photo #15: Open atmosphere vent screen covered and clean

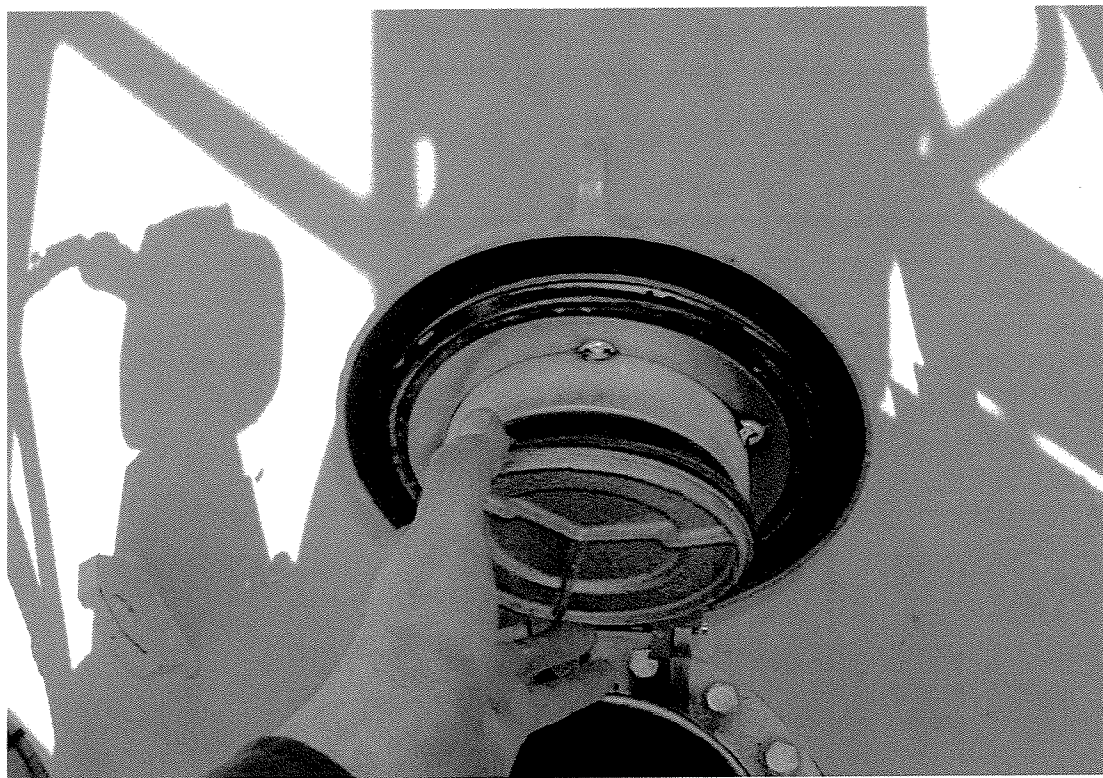
Photo #16: Fully functional vacuum breaker

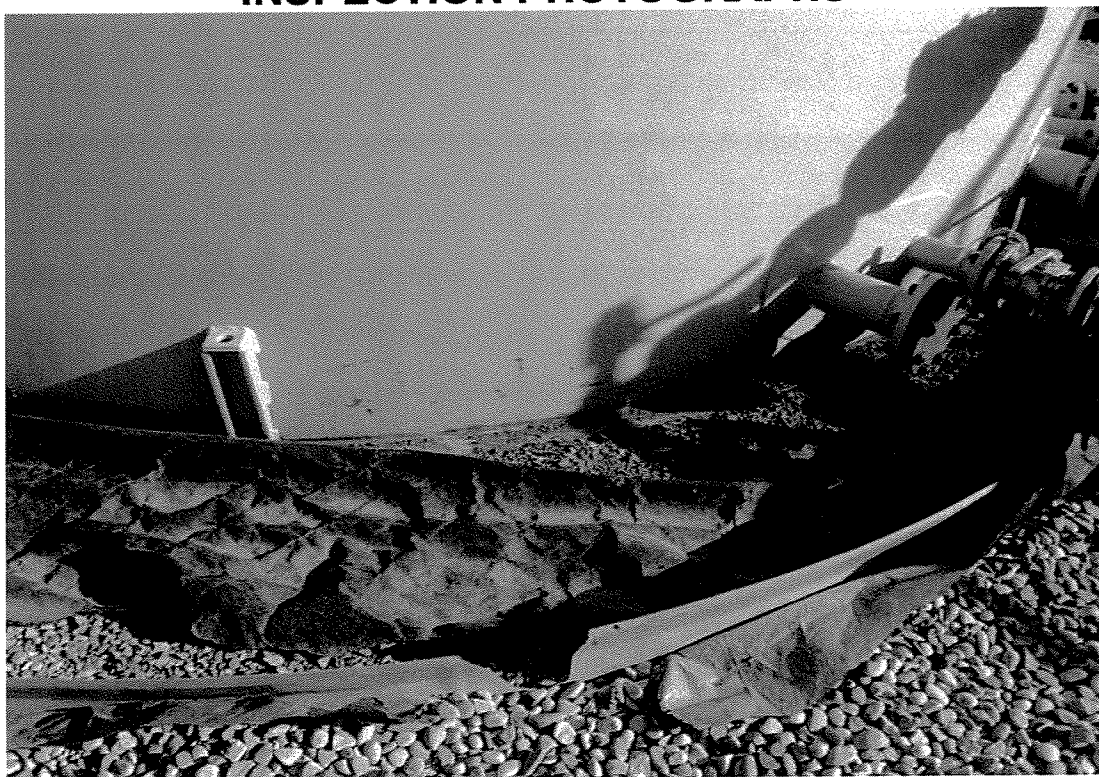
Photo #17: Soil piled up around shell bottom, anchor points not utilized

Recommendations
<p>Remove buildup of soil from around the bottom of the tank.</p>

- 1.) It is recommended that small areas of external damaged coating be sanded and spot repaired (Photo 17).
- 2.) It is recommended that the accumulated soil (Photo 17) from around the base of the tank be removed, as this could lead to moss and vegetation growth which may promote corrosion over time.
