Plant	Sylvan Lake Gas Plant	Op Unit	Flare	System	Flare
Prov Insp. #		CRN		Equip Tag # (Barcode)	43357
Equipment Description	Flare Knockout Drum			Serial #	
Manufacturer	Unknown			Vessel Class	Non-code Vessel
Internal Access	YES	Description:	Manway	Year Built	
MAWP	14.9	psi	@	MDMT	0
Code	None	RT:	4	PWHT	NO
Diameter	84"	Length	(T/T) 132"	OAL	
Shell	Mat'l	Thickness		Horizontal	
Head	Mat'l	Thickness		Corr. Allowance	
Nozzle	Mat'l	Thickness		Corr. Allowance	
Internal Coating	NO	Internal Clad:	NO	Capacity	m ³
Manway:	YES	Inspection Port	NO	Saddle	
Nozzle Rating	150	lb ANSI	Painted:	YES	Insulated NO

PRESSURE VESSEL & COLUMN INSPECTION REPORT

Cover Page – Static Equipment Inspection Report			
Client:	Husky Oil	Inspection Date:	September 25, 2014
Facility:	Sylvan Lake Gas Plant	LSD:	01-21-038-03 W5M
Requested By:	Bob Marchak	Equipment#:	
Equipment:	Flare Knockout Drum

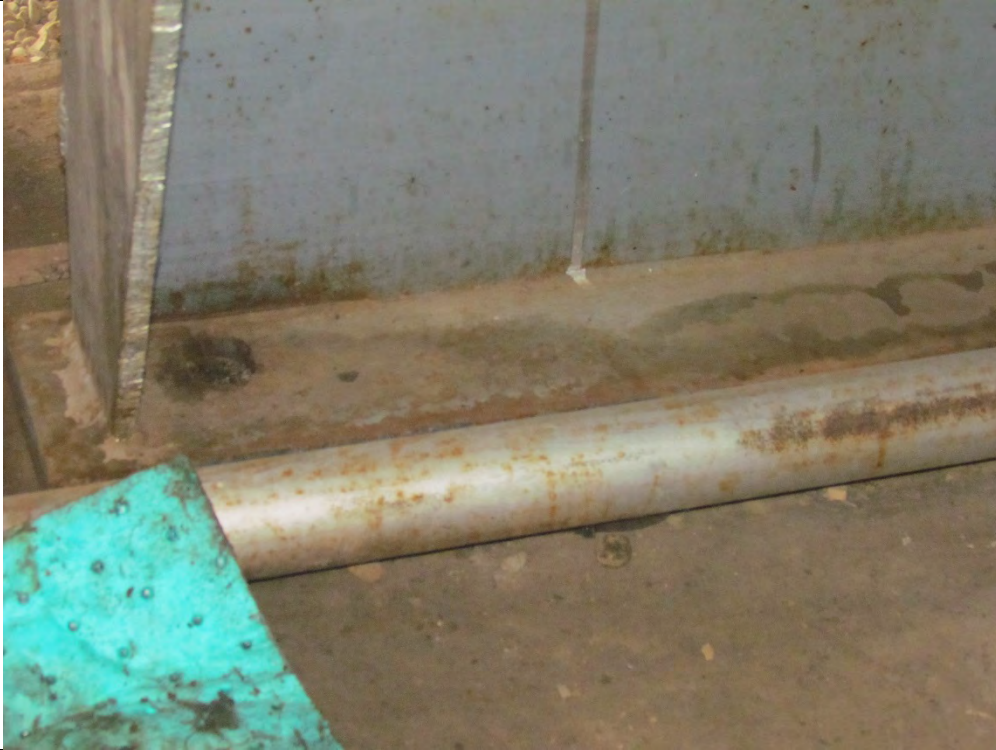
Anchor bolts were missing.

Vessel not anchored.

V13	Gauge/Site Glass	<input type="checkbox"/> Good <input type="checkbox"/> Fair <input type="checkbox"/> Poor <input checked="" type="checkbox"/> N/A
V14	Shell	<input checked="" type="checkbox"/> Good <input type="checkbox"/> Fair <input type="checkbox"/> Poor <input type="checkbox"/> N/A
V15	Jacket	<input type="checkbox"/> Good <input type="checkbox"/> Fair <input type="checkbox"/> Poor <input checked="" type="checkbox"/> N/A
	Supports	Condition
V21	Other (please explain)	<input type="checkbox"/> Good <input type="checkbox"/> Fair <input type="checkbox"/> Poor <input type="checkbox"/> N/A
V22	Foundation	<input checked="" type="checkbox"/> Good <input type="checkbox"/> Fair <input type="checkbox"/> Poor <input type="checkbox"/> N/A
V23	Anchor Bolts	<input type="checkbox"/> Good <input type="checkbox"/> Fair <input checked="" type="checkbox"/> Poor <input type="checkbox"/> N/A
Missing anchor bolts.

Missing anchor bolts and cement foundation

Anchor the vessel to the concrete floor.

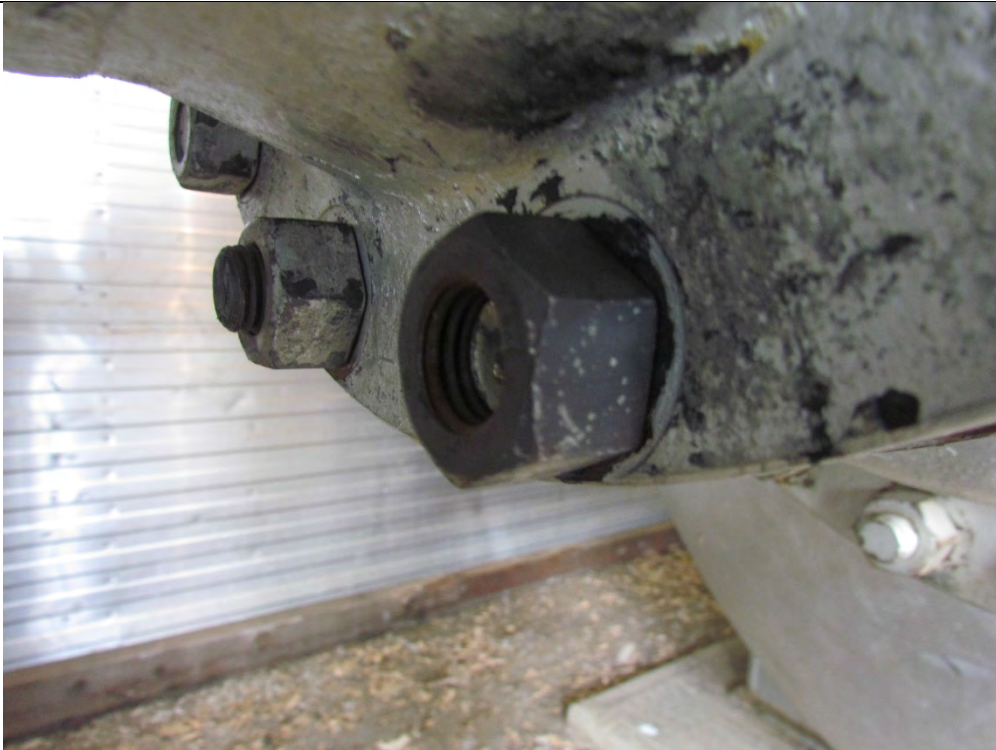
Short bolting on inlet nozzle

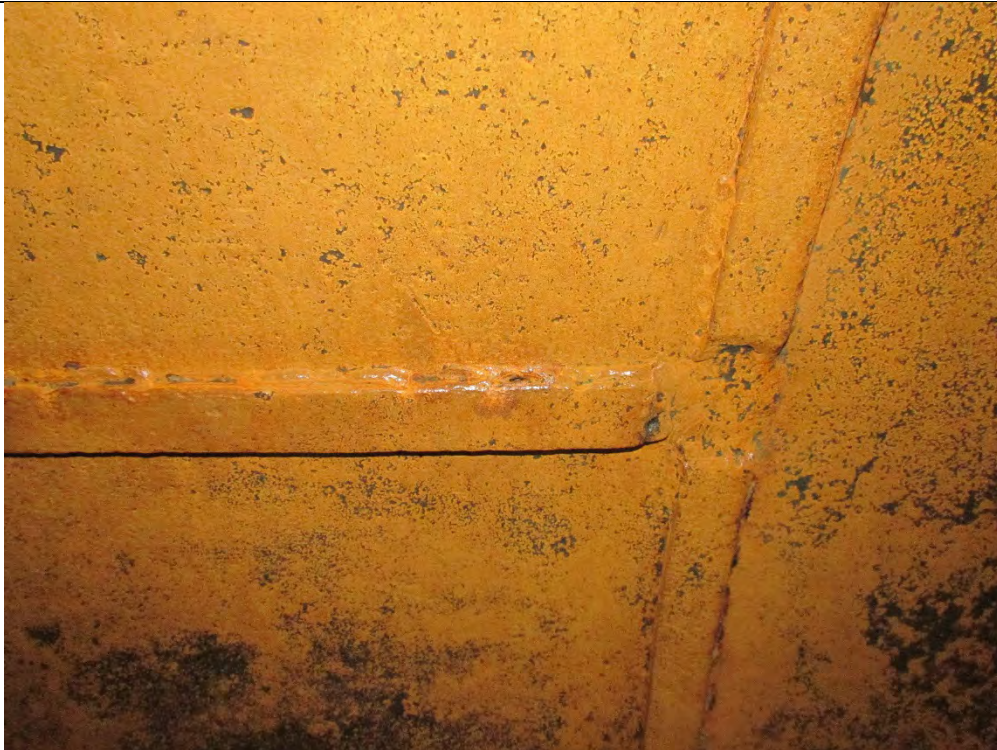
General corrosion was noted throughout the vessel. Backing plates are used for internal vessel welds.

Backing plates for weld seams

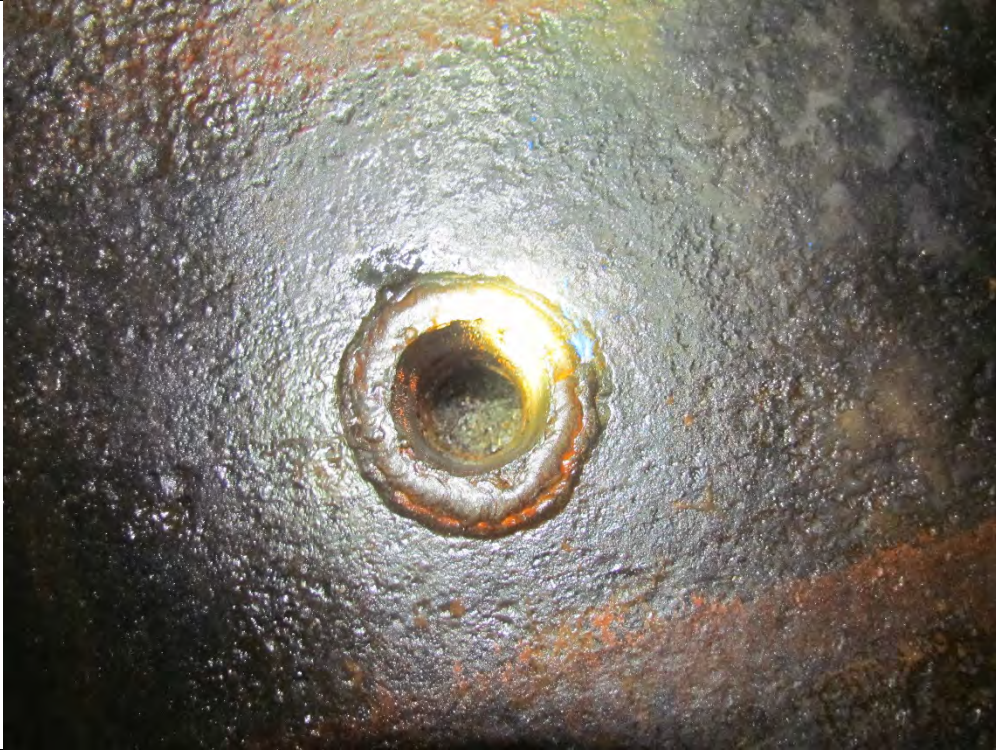
Drain nozzles were obstructed with debris and residue.

Bottom nozzles were obstructed with debris

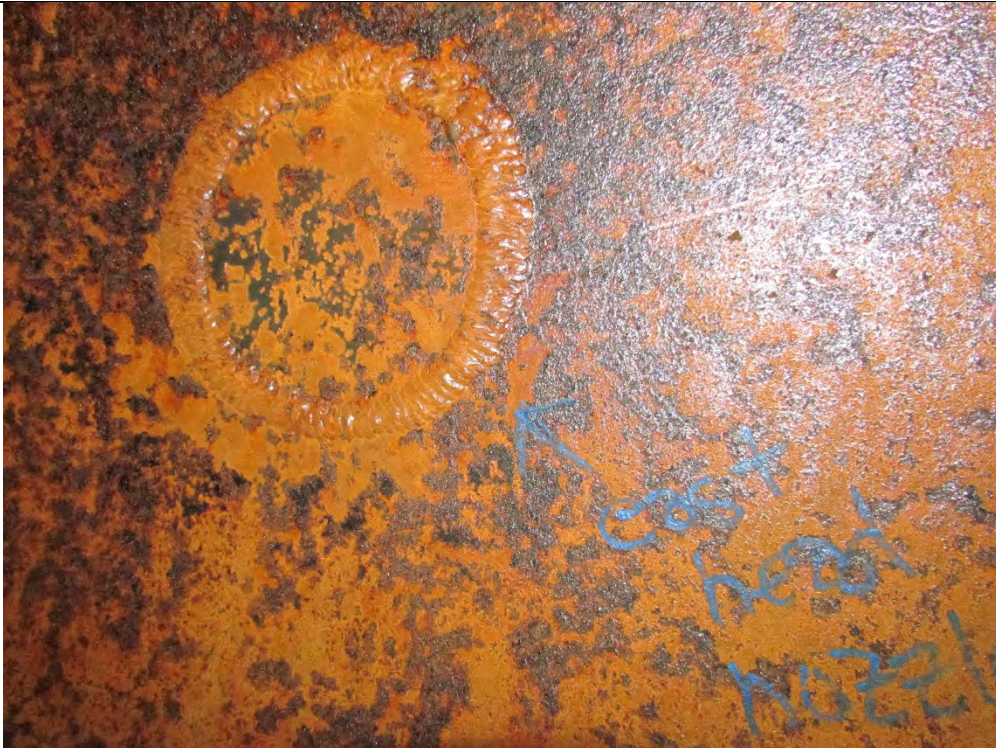
Nozzle has been removed in east head

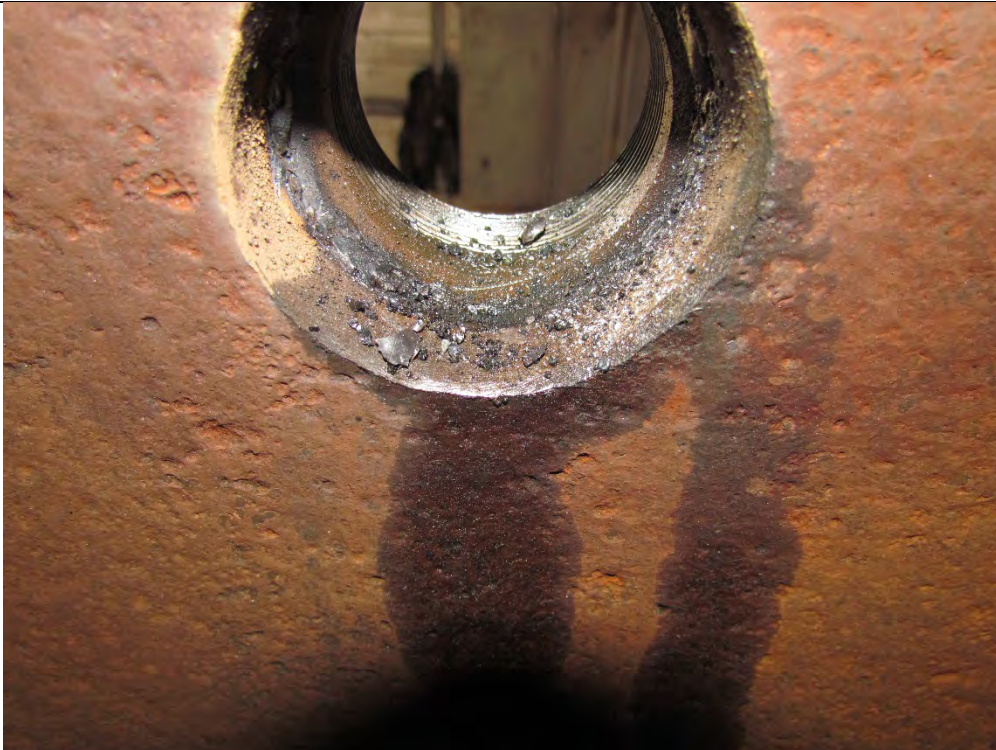
Non full penetration weld for new nozzle

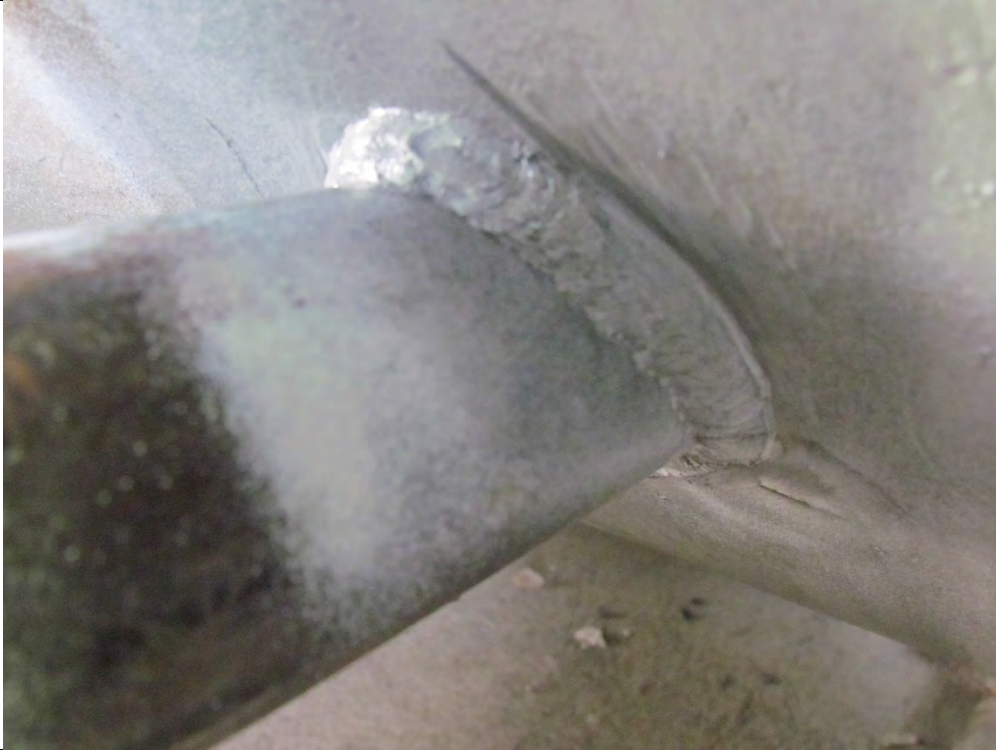
New nozzle weld (1)

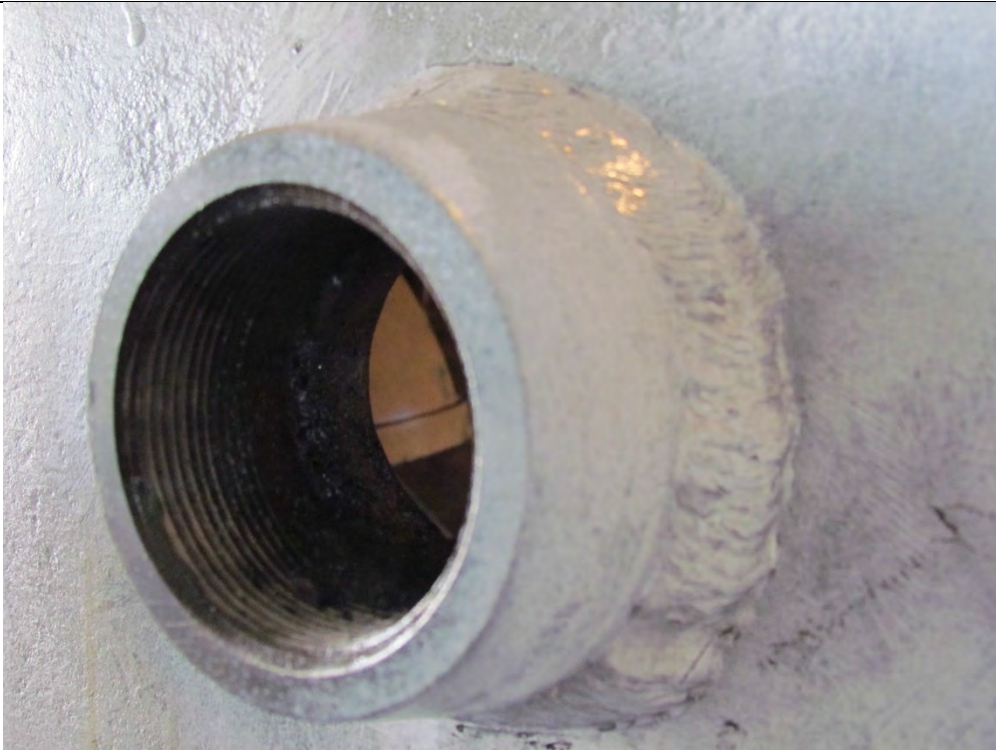
New nozzle weld (2)

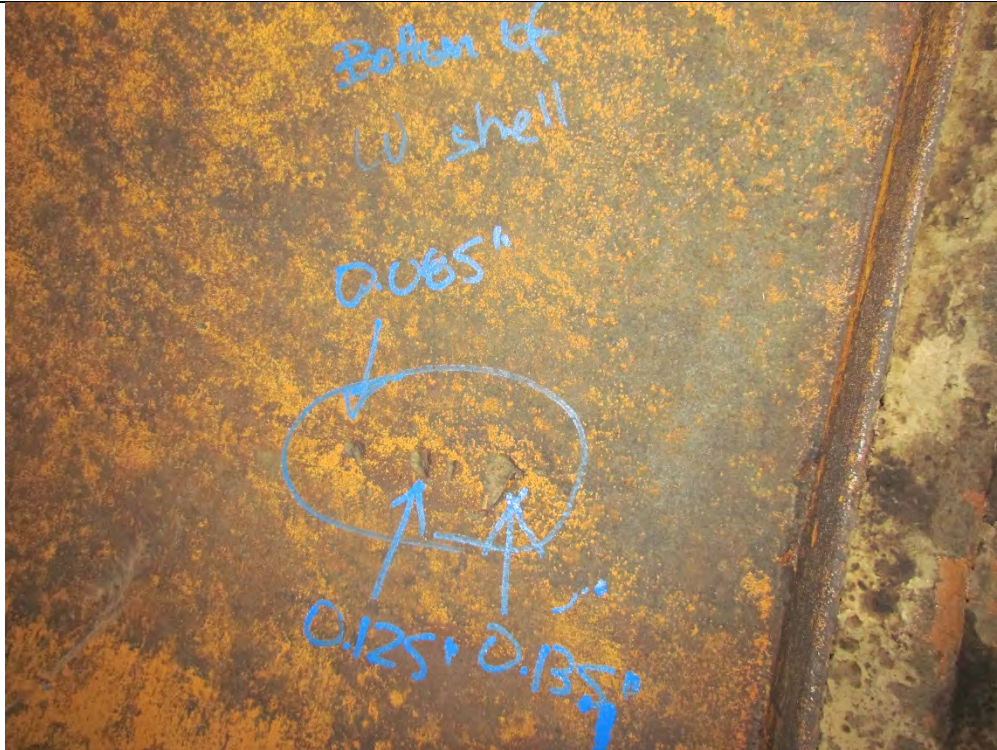
Vessel is non-code and has numerous defects from manufacturing including, gouges and Broken tack welds from the rolling process.

Type of Issue	Depth	Location
Pit	0.060"	Bottom of East Shell
Defect	0.155"	North Side of West End of Shell
Defect	0.065"	Bottom of West End of Shell
Defect	0.125"	Bottom of West End of Shell
Defect	0.135"	Bottom of West End of Shell
Broken Tack Weld	1" Long	Top of West End of Shell
Broken Tack Weld	-	Bottom of West End of Shell
Broken Tack Weld	2" Long - 0.095"	Bottom of West End of Shell
Broken Tack Weld	-	Top of West Head
Gouge	0.110"	East Head (Bottom)
Gouge	3" Long (Shallow)	East Head (Bottom)
Gouge	3" Long - 0.050"	East End of Shell (North)
Gouge	7" Long (Shallow)	Bottom of East End of Shell
Gouge	6" Long (Shallow)	Bottom of East End of Shell
Gouge	2" Long - 0.095"	Bottom of East End of Shell
Gouge	4" Long - 0.090"	Bottom of East End of Shell
Gouge	0.040"	Bottom of West End of Shell

0.065"/0.125"/0.135" defects in bottom of west end of shell

Monitor the depth and length of gouges at next scheduled internal inspection.

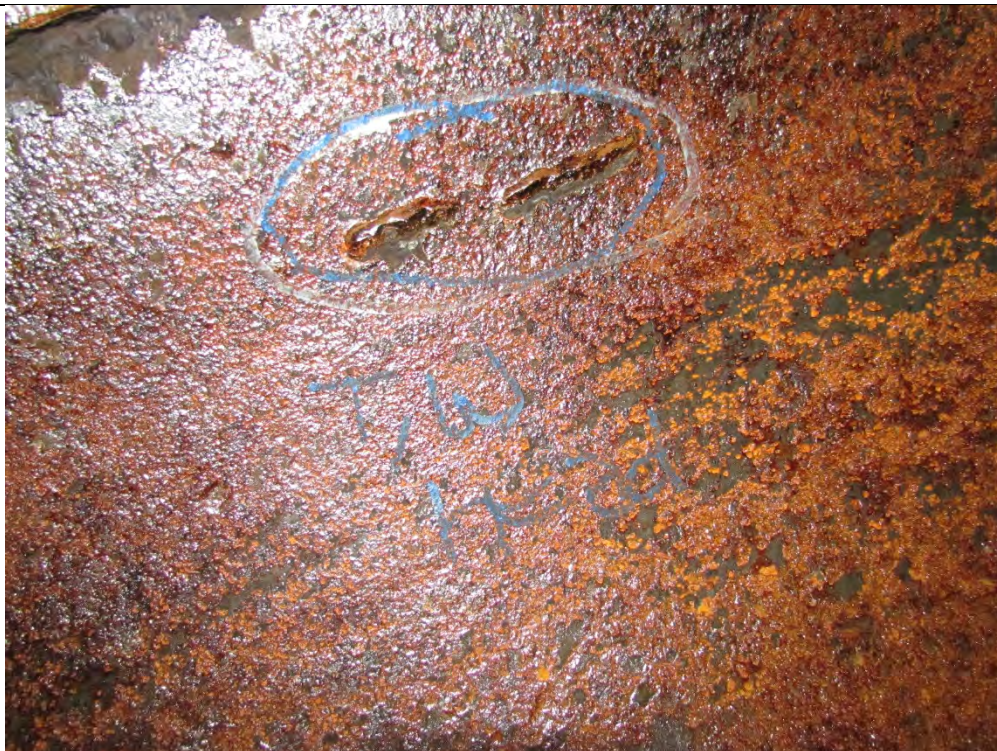
Broken tack weld in top of west head

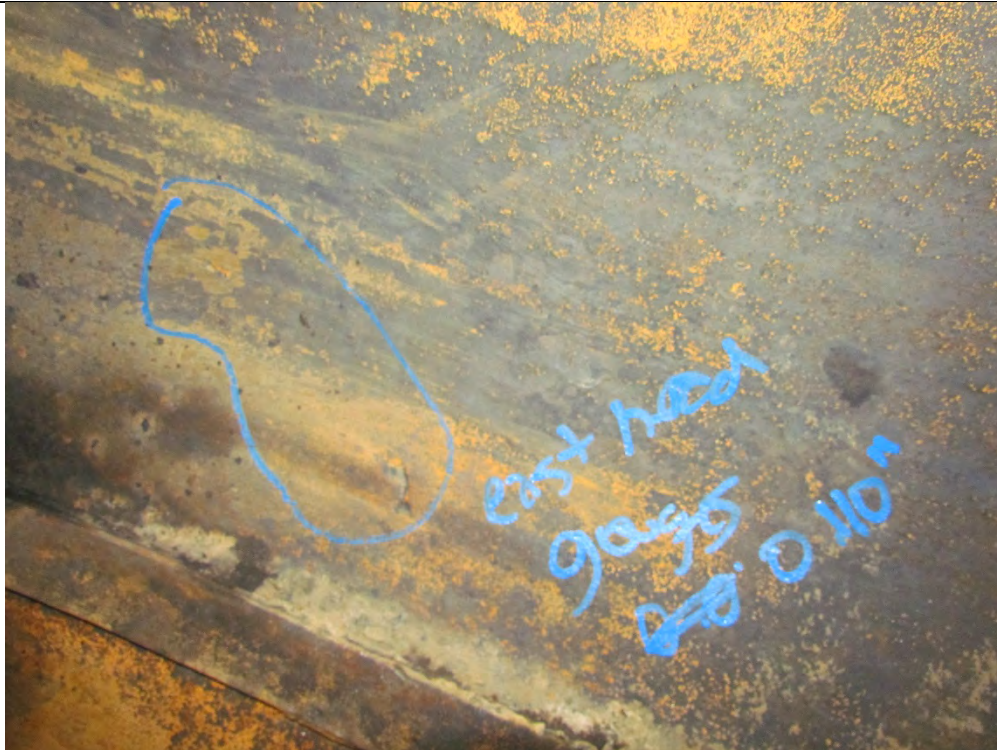
0.110" Depth gouge in east head (bottom)

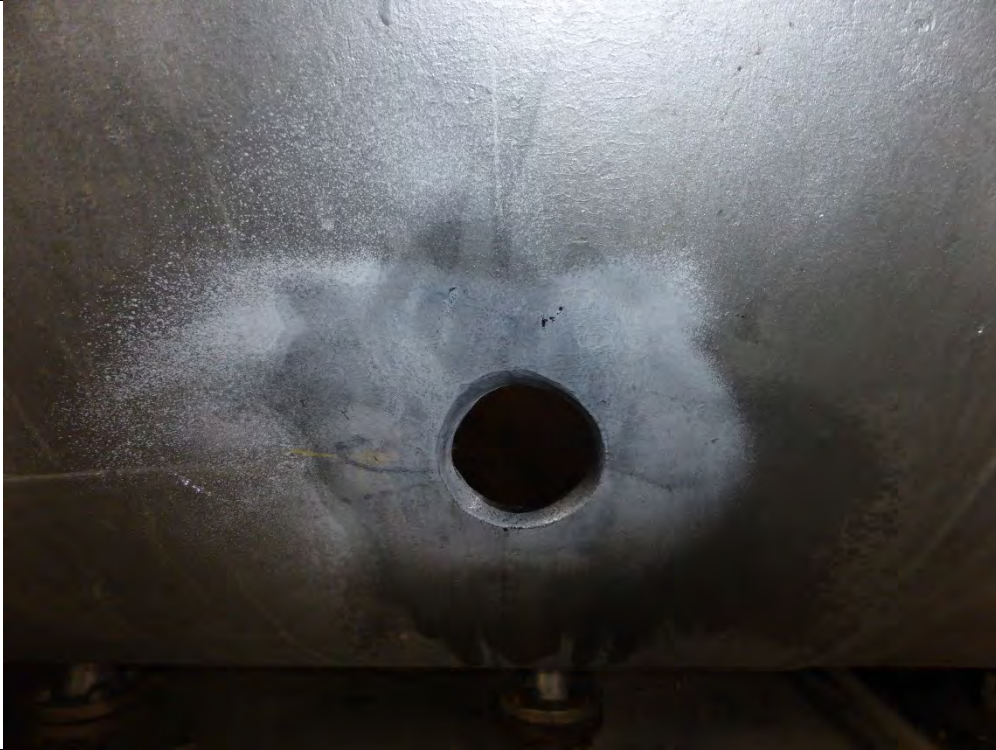
Wet Visible Magnetic Particle Inspection (WVMPI) and Wet Fluorescent Magnetic Particle Inspection (WFMPI) were performed on two, 2" cut outs prior to a new liquid level bridle being installed. No cracks or other indications were found at the time of inspection.

*General view of 2" cut out*

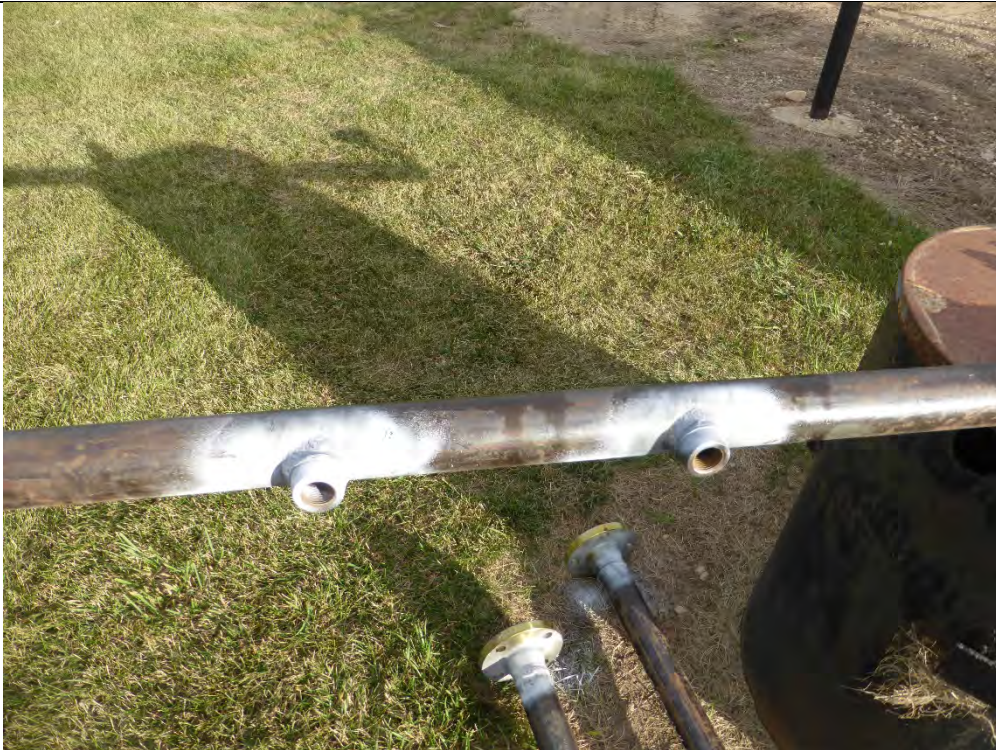
Wet Visible Magnetic Particle Inspection (WVMPI) was also performed on all of the new liquid level bridle attachment welds. No indications were found.

*Liquid level bridle attachment welds*

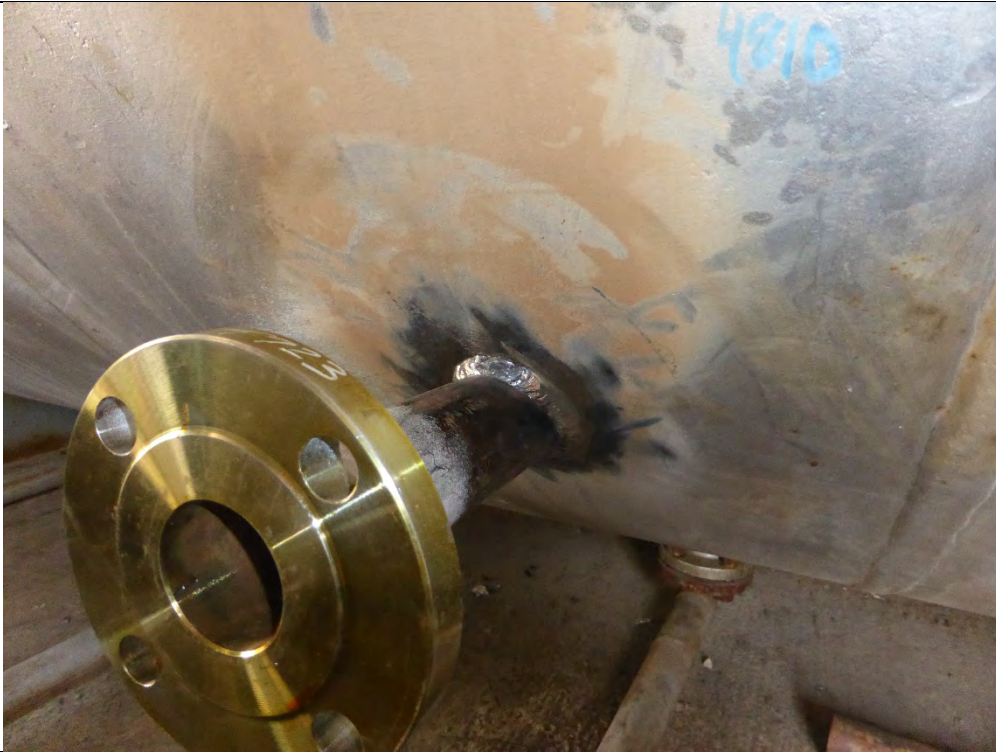
Wet Visible Magnetic Particle Inspection (WVMPI) and Wet Fluorescent Magnetic Particle Inspection (WFMPI) were performed on the completed welds, 24 hours after the completion of the weld, to ensure no cracks or other welding defects were present in the weld and heat affected zones. No rejectable indications were found at the time of inspection.

General view of completed weld (1)

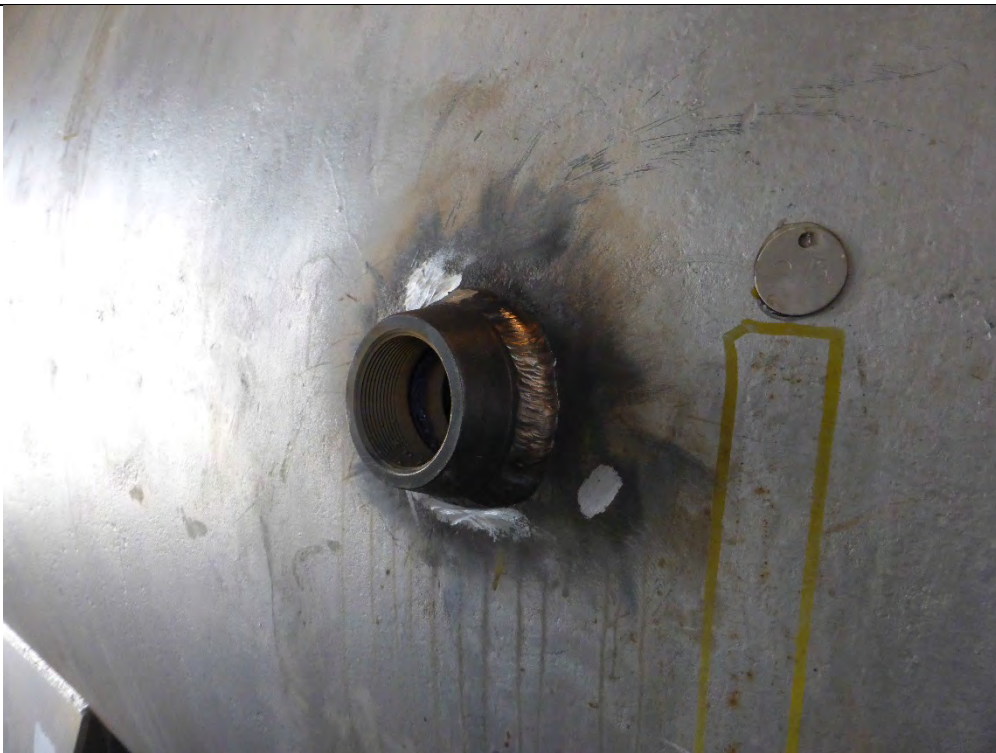
General view of completed weld (2)
