PRESSURE VESSEL & COLUMN INSPECTION REPORT

Date: September 25, 2014

Plant		Sylvan Lake Gas Plant		Op Unit		Sylvan Lake		System		Flare				
Prov Insp. #				CRN				Equip Tag # (Barcode)				43357		
Equipment Description								Flare Knockout Drum				Serial #		
Manufacturer				Unknown				Vessel Class		Non-code Vessel				
Internal Access				YES		Description:		Manway		Year Built				
MAWP		14.9		psi		@		0		MDMT		0		
Code			None		RT:		4		PWHT		NO			
Diameter		84"		Length		(T/T) 132"		OAL		Horizontal				
Shell		Mat'l				Thickness		Corr. Allowance						
Head		Mat'l				Thickness		Corr. Allowance						
Nozzle		Mat'l				Thickness		Corr. Allowance						
Internal Coating			NO			Internal Clad:		NO		Capacity			m³	
Manway:			YES			Inspection Port		NO		Saddle				
Nozzle Rating			150		lb ANSI		Painted:		YES		Insulated		NO

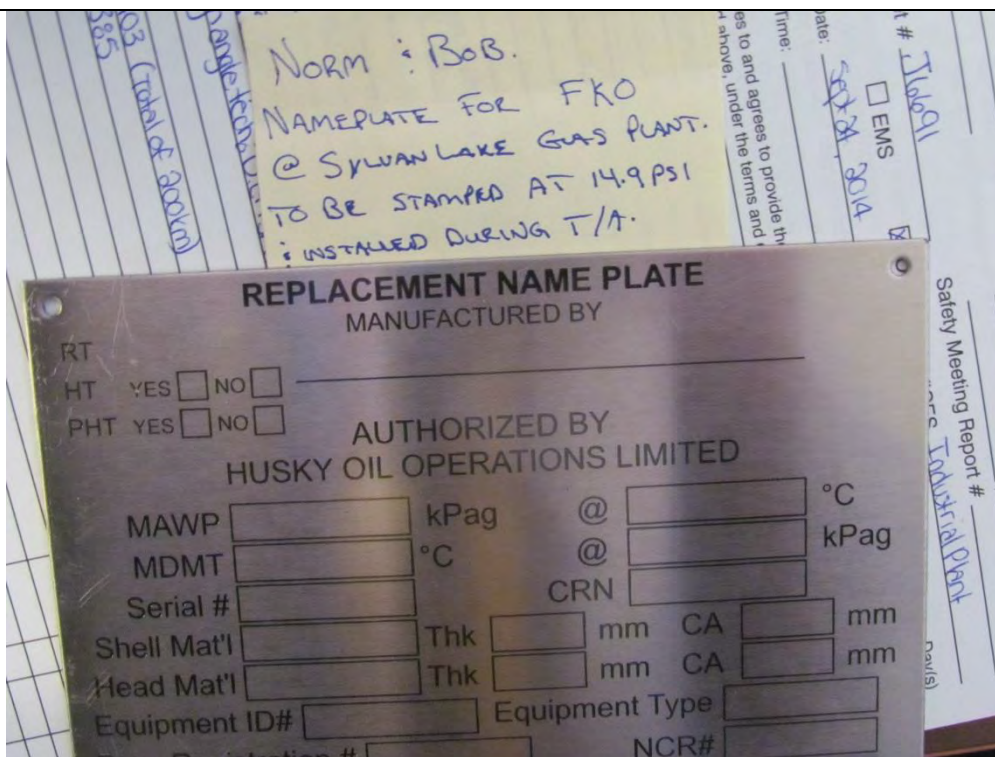
Vessel nameplate to be installed

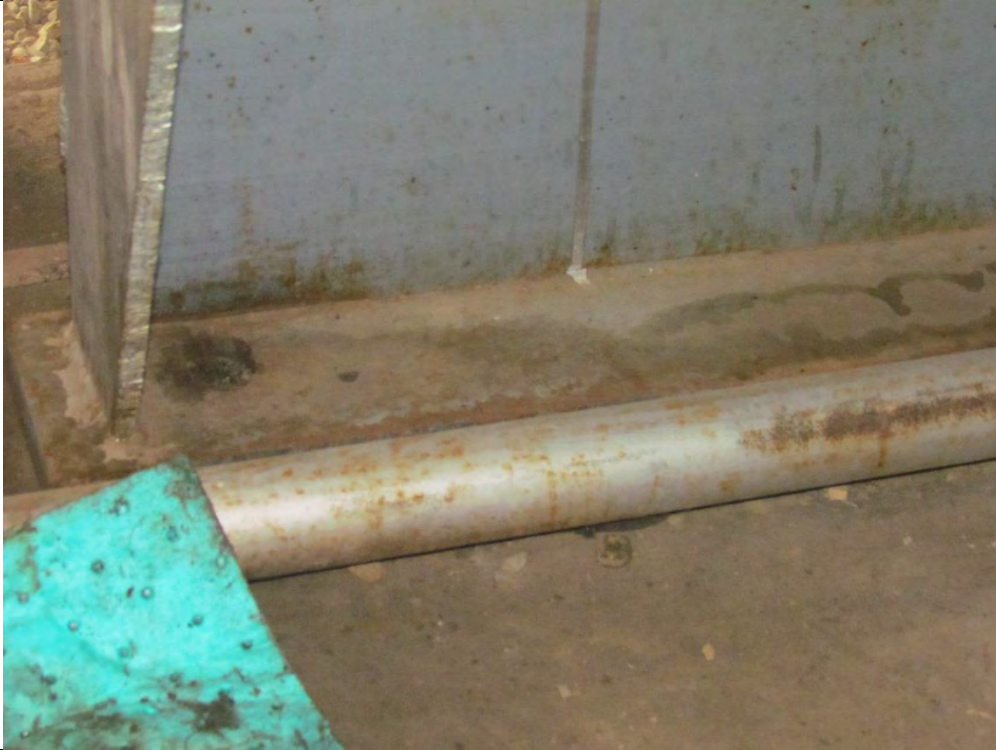
The vessel was not anchored.
The vessel was not grounded.

Missing anchor bolts and concrete foundation

Ensure that the missing anchor bolts are installed and that the vessel is properly grounded. Monitor the depth and length of gouges at next scheduled internal inspection.

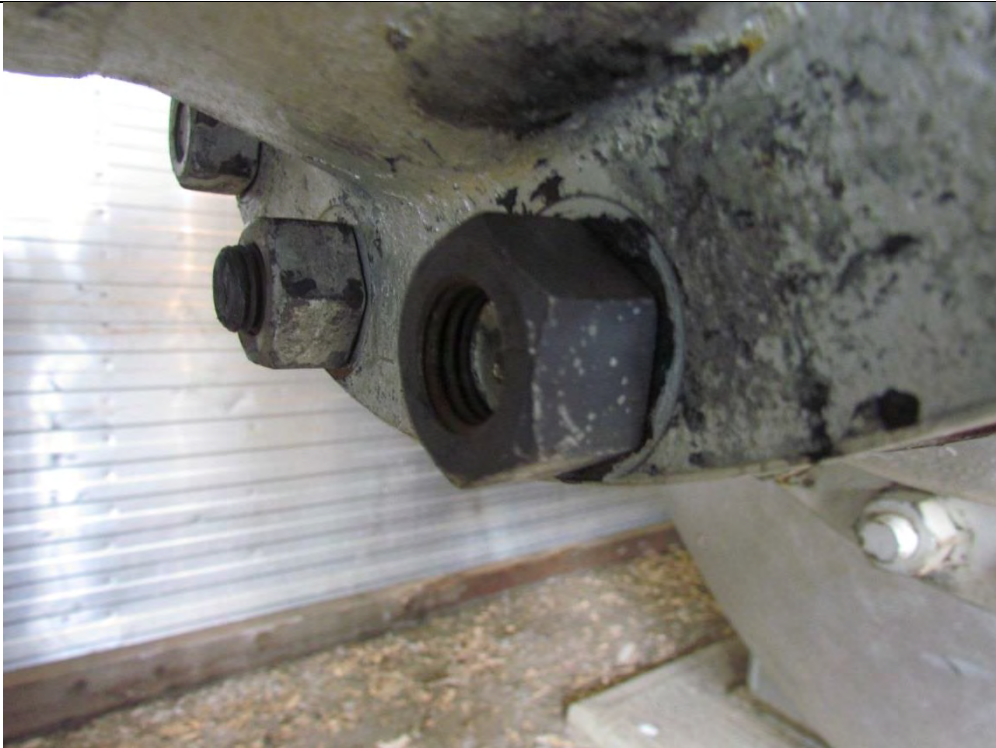
Short bolting on inlet flange

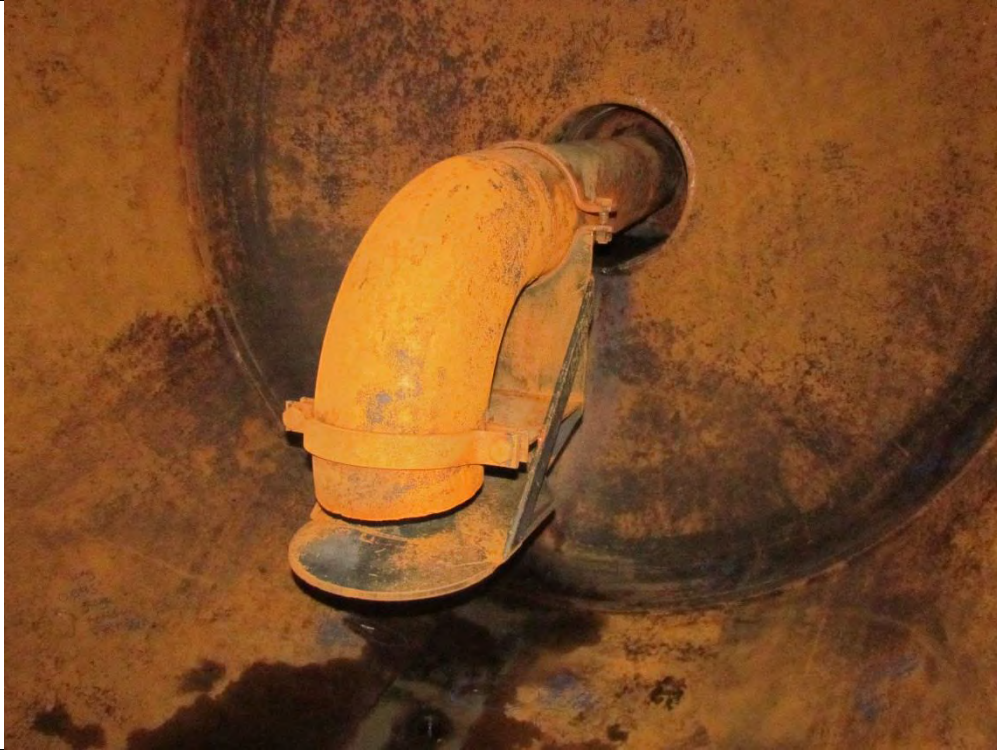
Internals	Condition
V21	Other (please explain)	<input checked="" type="checkbox"/> Good <input type="checkbox"/> Fair <input type="checkbox"/> Poor <input type="checkbox"/> N/A
The internal inlet piping and deflector plate appeared to be secure and in good condition.		
V22	Demister	<input type="checkbox"/> Good <input type="checkbox"/> Fair <input type="checkbox"/> Poor <input checked="" type="checkbox"/> N/A
V23	Baffle / Weir	<input type="checkbox"/> Good <input type="checkbox"/> Fair <input type="checkbox"/> Poor <input checked="" type="checkbox"/> N/A
V24	Sparger	<input type="checkbox"/> Good <input type="checkbox"/> Fair <input type="checkbox"/> Poor <input checked="" type="checkbox"/> N/A
V25	Thermowells	<input type="checkbox"/> Good <input type="checkbox"/> Fair <input type="checkbox"/> Poor <input checked="" type="checkbox"/> N/A
V26	Metallic Linings	<input type="checkbox"/> Good <input type="checkbox"/> Fair <input type="checkbox"/> Poor <input checked="" type="checkbox"/> N/A

Vessel inlet piping and deflector plate assembly

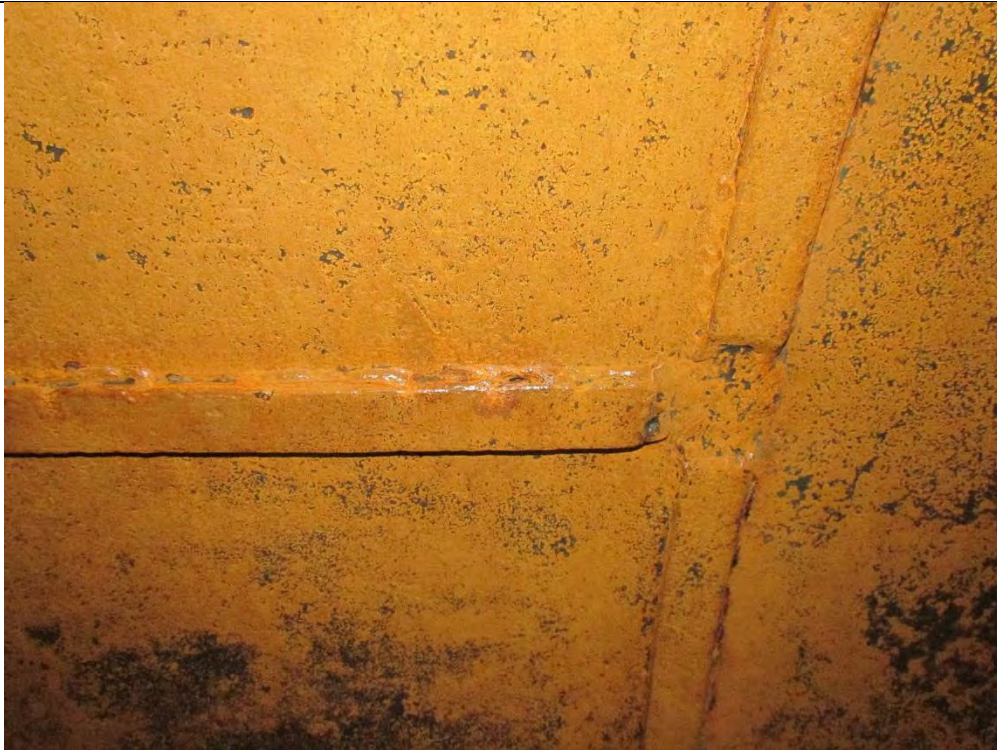
Backing plates for weld seams

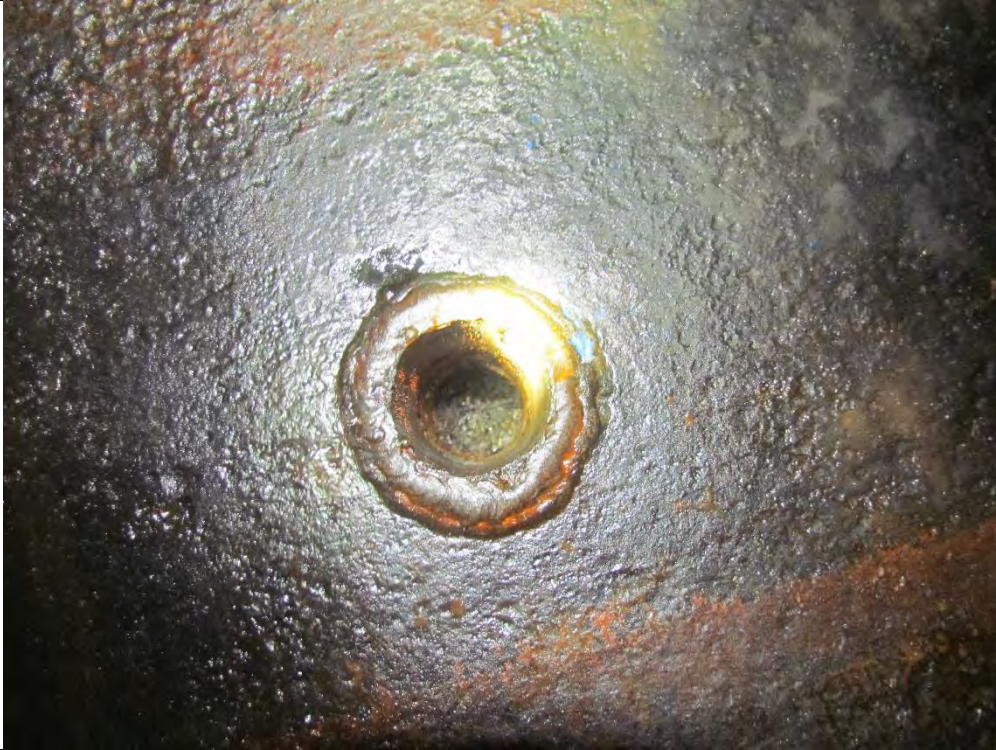
Bottom nozzles were obstructed with debris

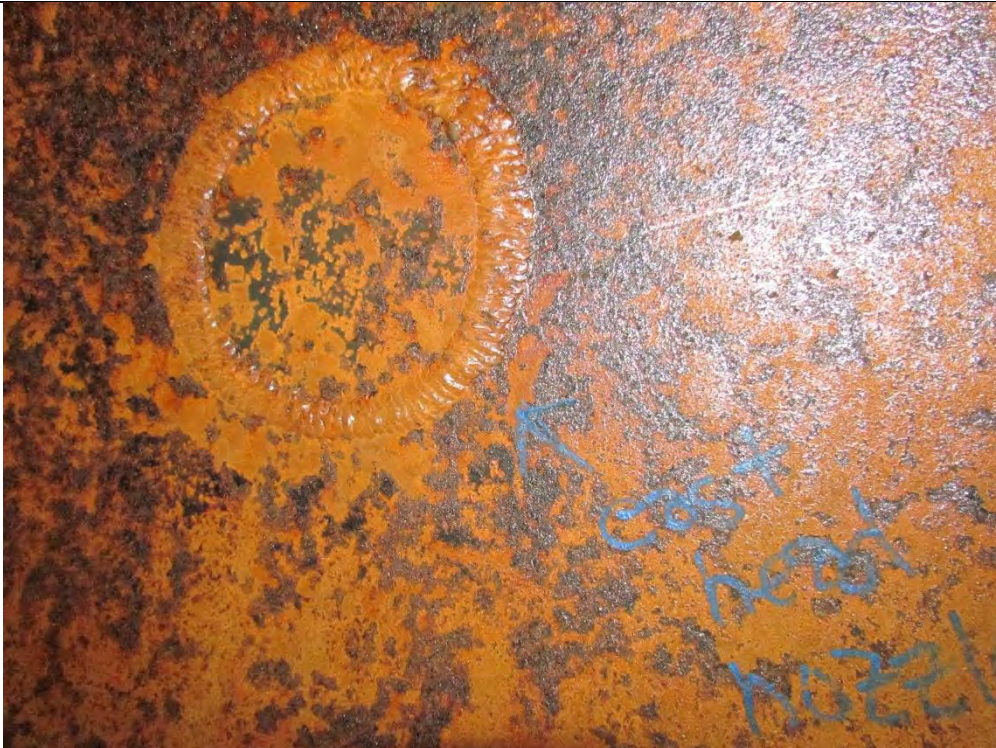
Nozzle has been removed in east head

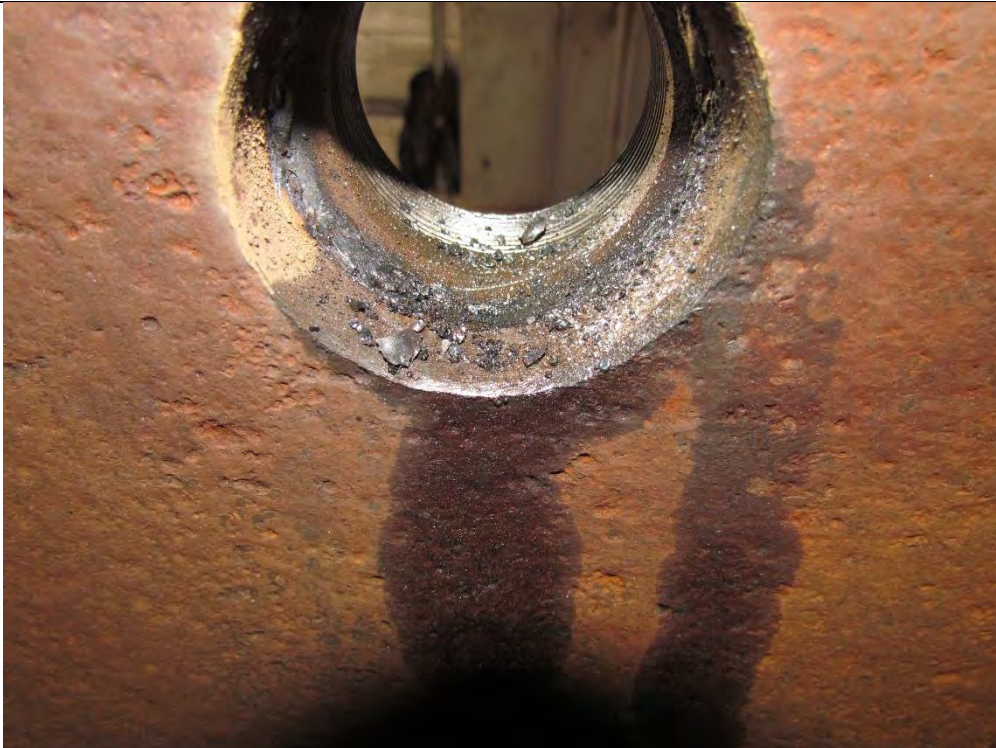
Non full penetration weld for new nozzle

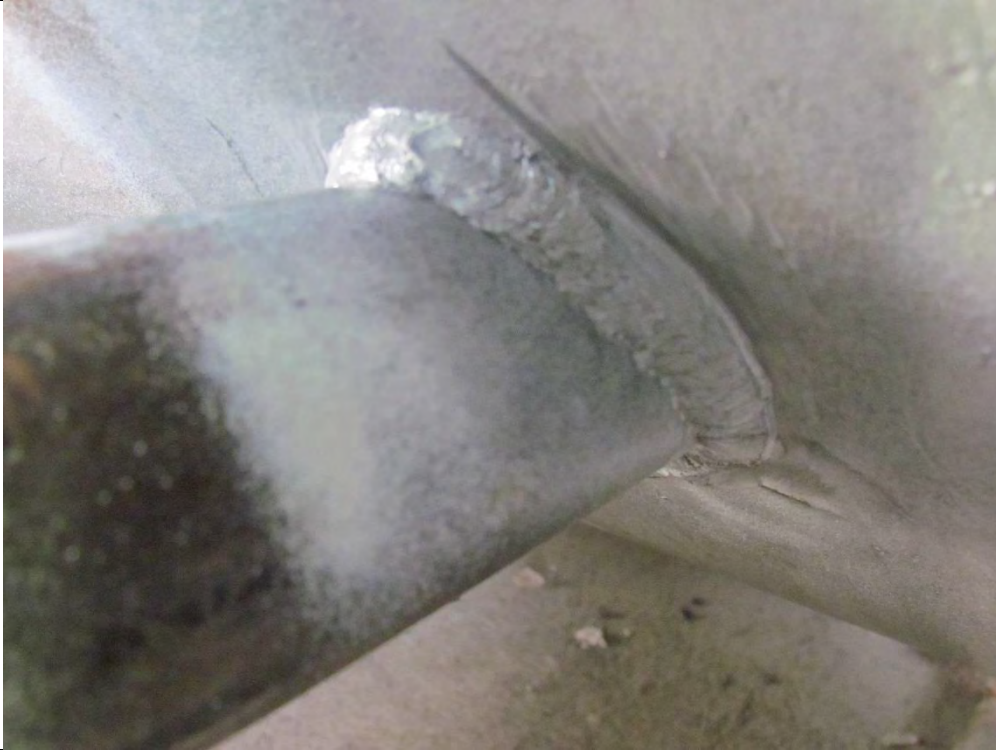
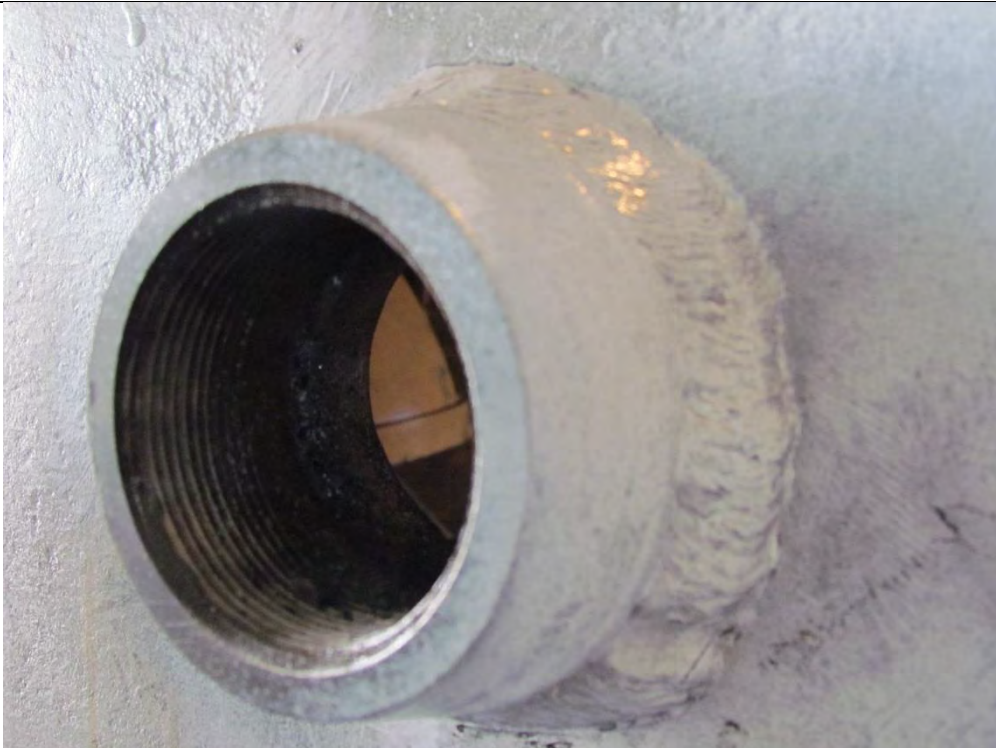
New nozzle weld (1)

New nozzle weld (2)

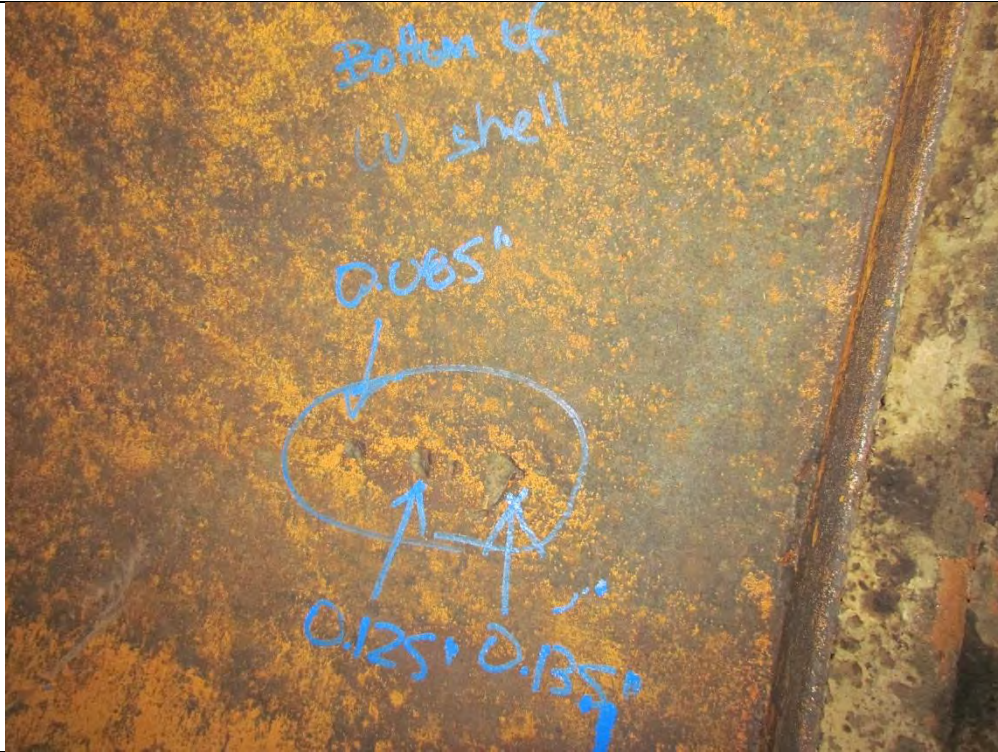
Type of Issue	Depth	Location
Pit	0.060"	Bottom of East Shell
Plate Defect	0.155"	North Side of West End of Shell
Plate Defect	0.065"	Bottom of West End of Shell
Plate Defect	0.125"	Bottom of West End of Shell
Plate Defect	0.135"	Bottom of West End of Shell
Broken Tack Weld	1" Long	Top of West End of Shell
Broken Tack Weld	-	Bottom of West End of Shell
Broken Tack Weld	2" Long - 0.095"	Bottom of West End of Shell
Broken Tack Weld	-	Top of West Head
Gouge	0.110"	East Head (Bottom)
Gouge	3" Long (Shallow)	East Head (Bottom)
Gouge	3" Long - 0.050"	East End of Shell (North)
Gouge	7" Long (Shallow)	Bottom of East End of Shell
Gouge	6" Long (Shallow)	Bottom of East End of Shell
Gouge	2" Long - 0.095"	Bottom of East End of Shell
Gouge	4" Long - 0.090"	Bottom of East End of Shell
Gouge	0.040"	Bottom of West End of Shell

0.065"/0.125"/0.135" plate defects in bottom of west end of shell

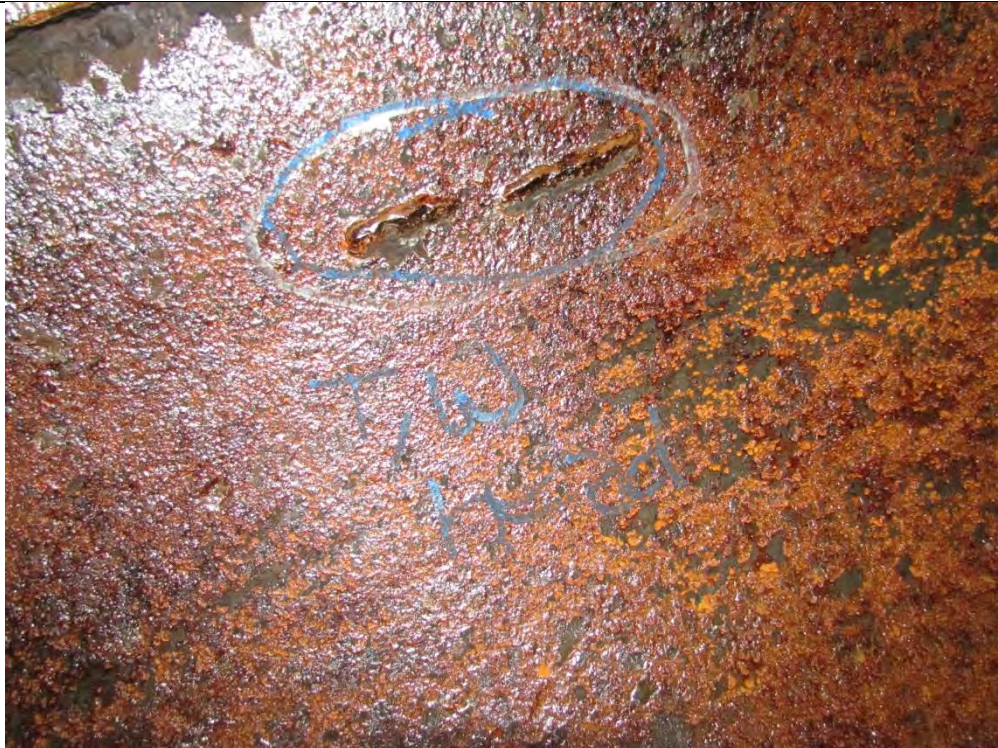
Broken tack weld in top of west head

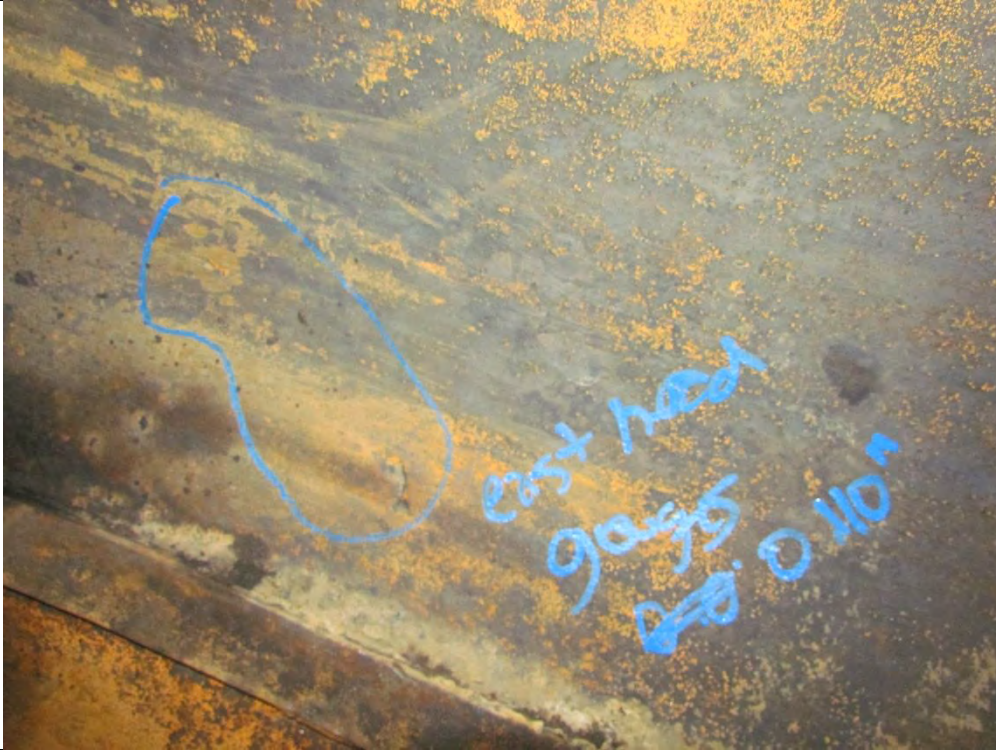
0.110" Depth gouge in east head (bottom)

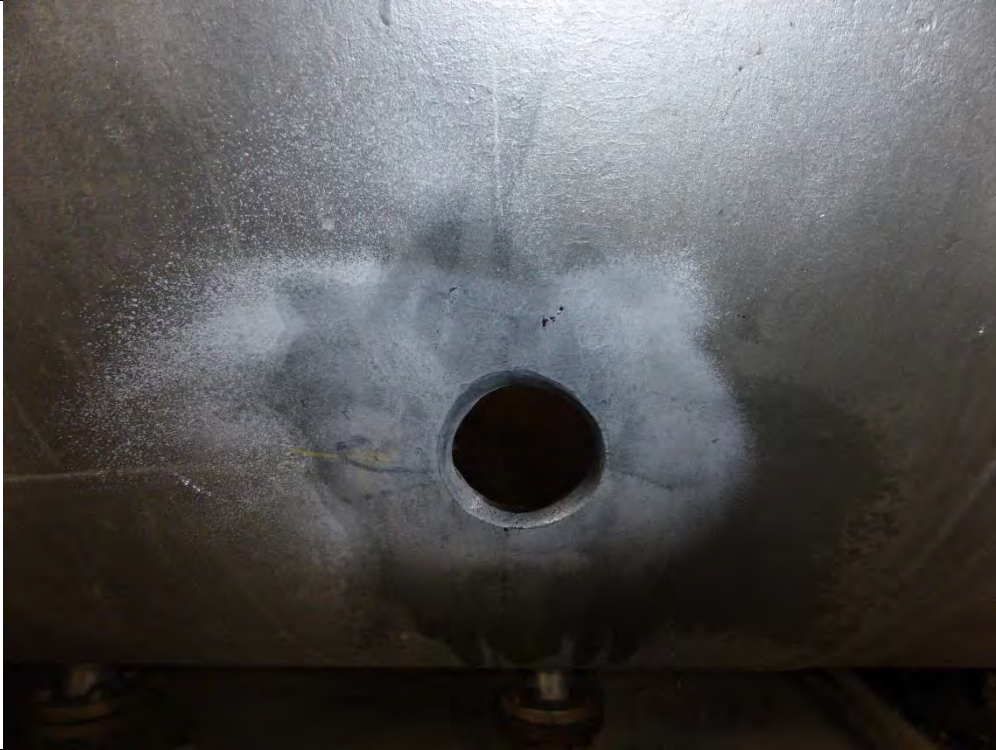
Wet Visible Magnetic Particle Inspection (WVMPI) and Wet Fluorescent Magnetic Particle Inspection (WFMPI) were performed on two, 2" cut outs prior to a new liquid level bridle being installed. No cracks or other indications were found at the time of inspection.

General view of 2" cut out

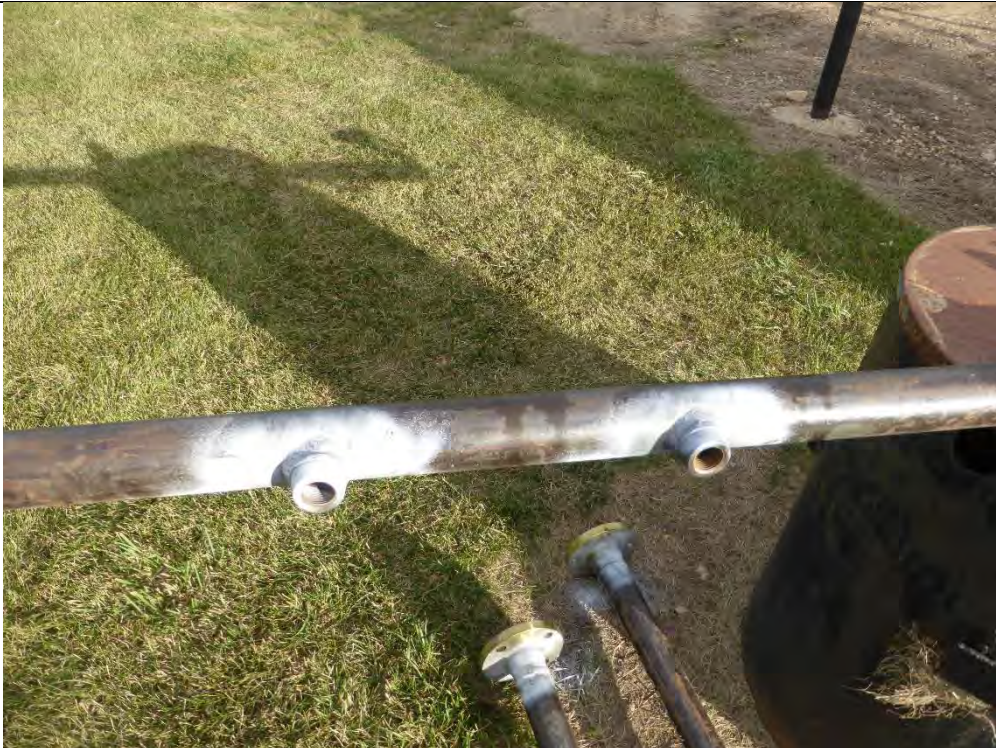
Wet Visible Magnetic Particle Inspection (WVMPI) was also performed on all of the new liquid level bridle attachment welds. No indications were found.

Liquid level bridle attachment welds

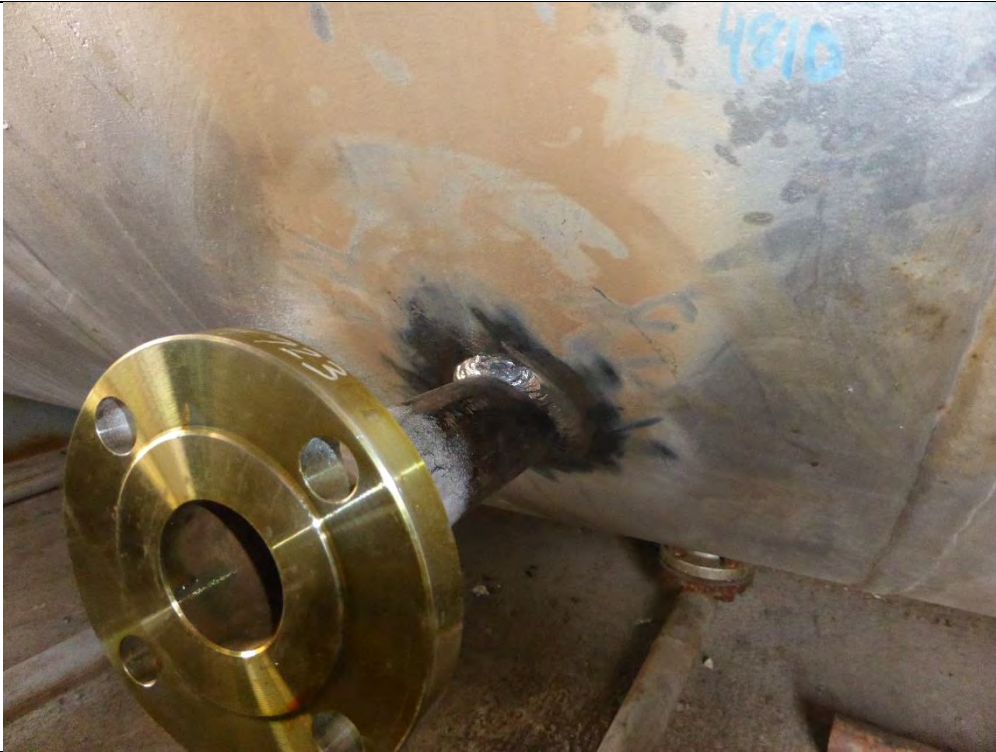
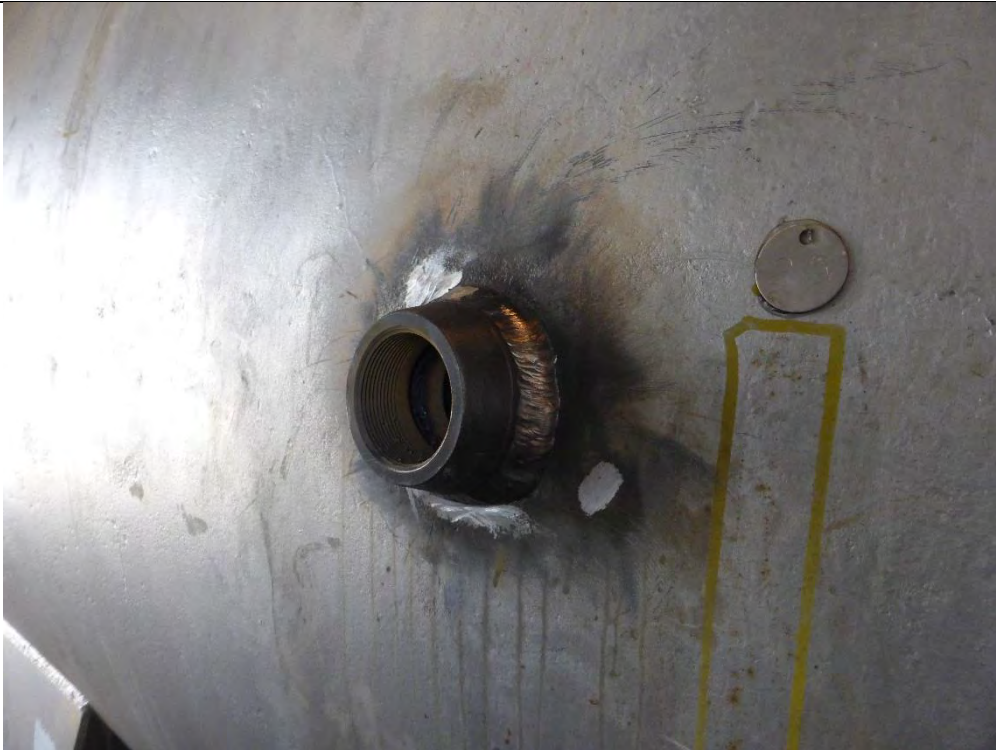
Wet Visible Magnetic Particle Inspection (WVMPI) and Wet Fluorescent Magnetic Particle Inspection (WFMPI) were performed on the completed welds, 24 hours after the completion of the welding, to ensure no cracks or other welding defects were present in the weld and heat affected zones. No rejectable indications were found at the time of inspection.

General view of completed weld (1)

General view of completed weld (2)
