Husky Energy

Tank Inspection Report

NONDESTRUCTIVE INSPECTION REPORT

Item Inspected: Tank #2

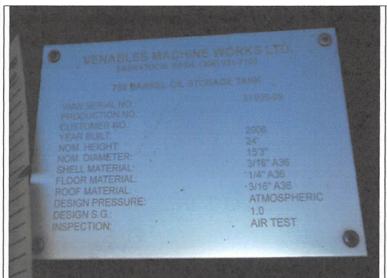
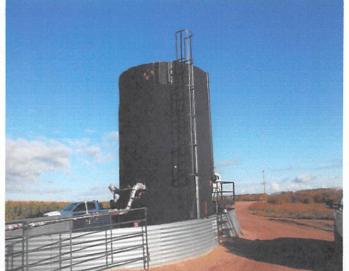
A UT and Visual inspection was carried out on the following 750BBL oil tank for the purpose of continued fitness for service and determination of inspection interval. See the field report for results of inspection, UT recorded values and inspection interval.

Inspection Limitation(s): Only 1st course cleaned for inspection

Recommendations:

-Remove float guide wires
