# Tank Inspection Report

Location: 100/5-27-48-2.W4 Tank Type: Tank 2 Date: Sept 12, 2018  
Mfg: Universal Year blt: 2012 S/N: 023685-7 CAP: 1000 bbl  
Floor Thk: 1/4" Shell Thk: 1/4" 3/16" Roof Thk: 3/16"  
Requisitioned by: Mike Hein Approver: Mike Hein Approver Code: 27-02020569  
WO #: 80041309 PO#: 8401285686 CC: \_\_\_\_\_ SAP #: 66194665

Client: HUSKY OIL OPERATIONS  
IRISNDT #: LYN1801417  
Location: 100/ 5-27-48-2 W4M  
Item Inspected: 1000 bbl tank 2 s/n# 023685-7

a UT and visual inspection was carried out as requested on 1000bbl tank, refer to attached pages for results:

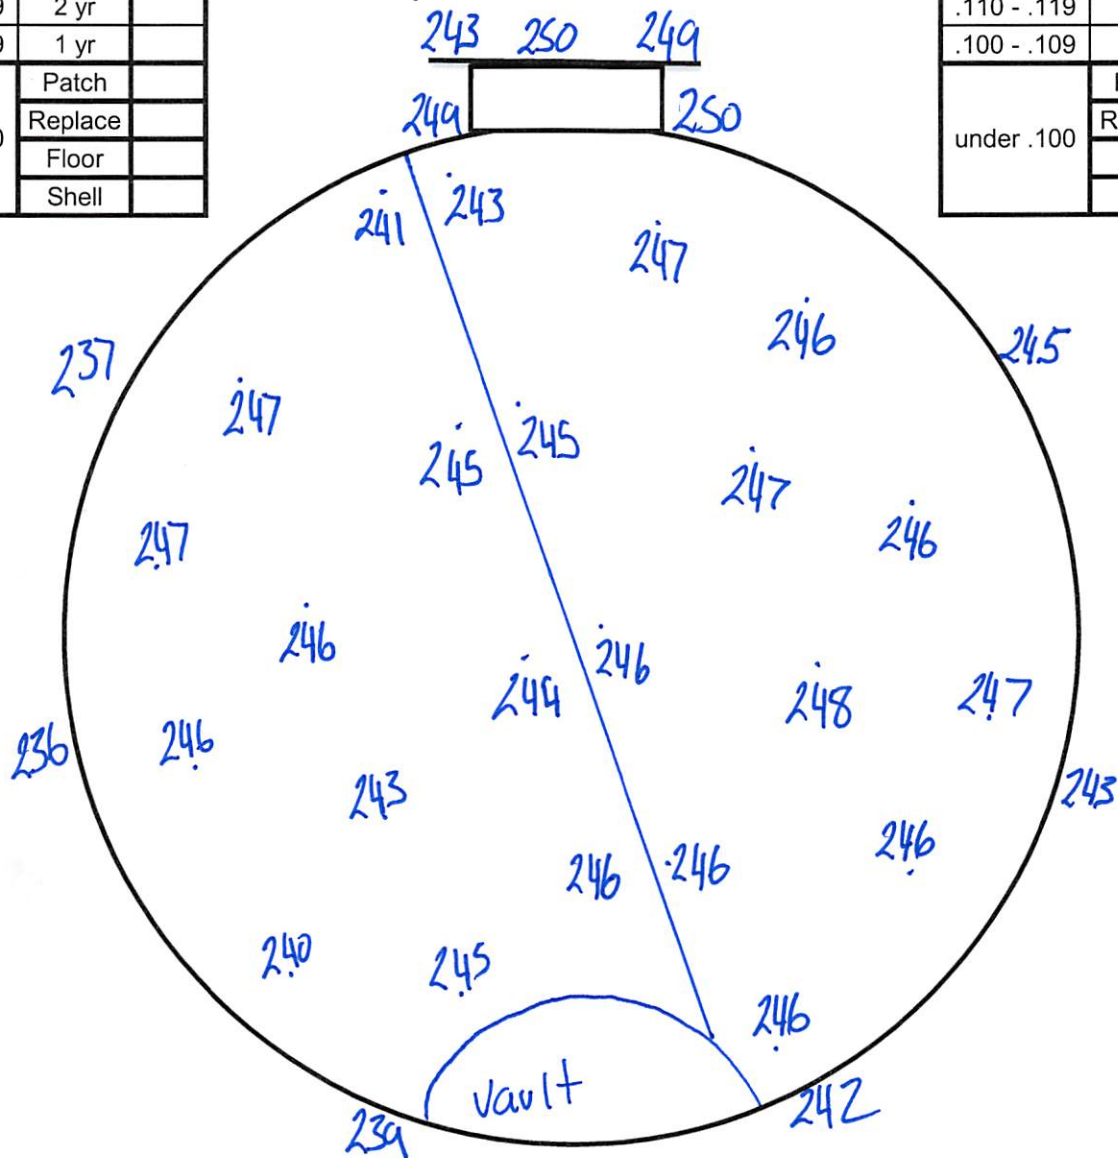
Tank In Good Overall Condition For A 5YR Turnaround.  
 NO Repairs Required
