Equipment #:66164107 Description: Tank Serial# 2374

Location: 07-34-44-28W3

Inspection Date: 2010.08.26

## **NONDESTRUCTIVE INSPECTION REPORT**

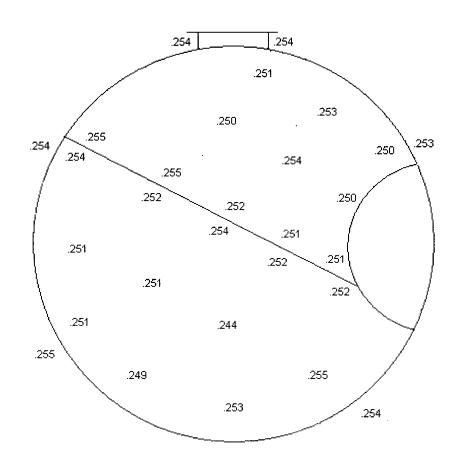
INTERNAL NDE: Random locations of the tank's floor and lower shell were UT thickness tested with some minor metal loss identified. See attached sketch for thicknesses found and approximate locations of tests.

RECOMMENDATION: Continue UT thickness survey at next scheduled inspection.
