Tank Inspection Report

NONDESTRUCTIVE INSPECTION REPORT

Item Inspected: 1000BBL Tank

Tank#2 sn# 027499-6

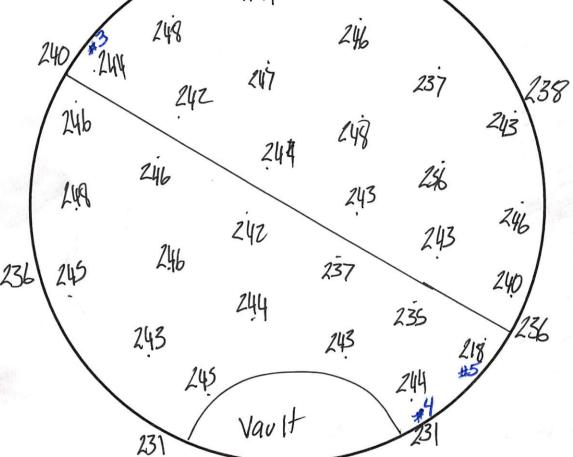
#1=.190	Areas #1 to #5 areas of worst
#2 = .213	Corrosion UT inspected.
#3 = .203	
#4 = .207	
#5 = .213
