Equipment #: 66174963  
 Area: AN-Blackfoot  
 Cost Centre: /LLOYD

**Tank Inspection Report**

ULTRASONIC TESTING REPORT

UT-67-1140

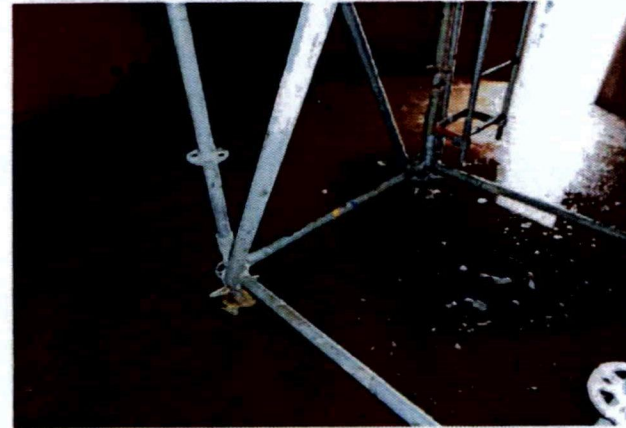
43 FLOOR READINGS & 10 SHELL READINGS TAKEN  
LOW FLOOR READING: 0.234"  
LOW SHELL READING: 0.237"

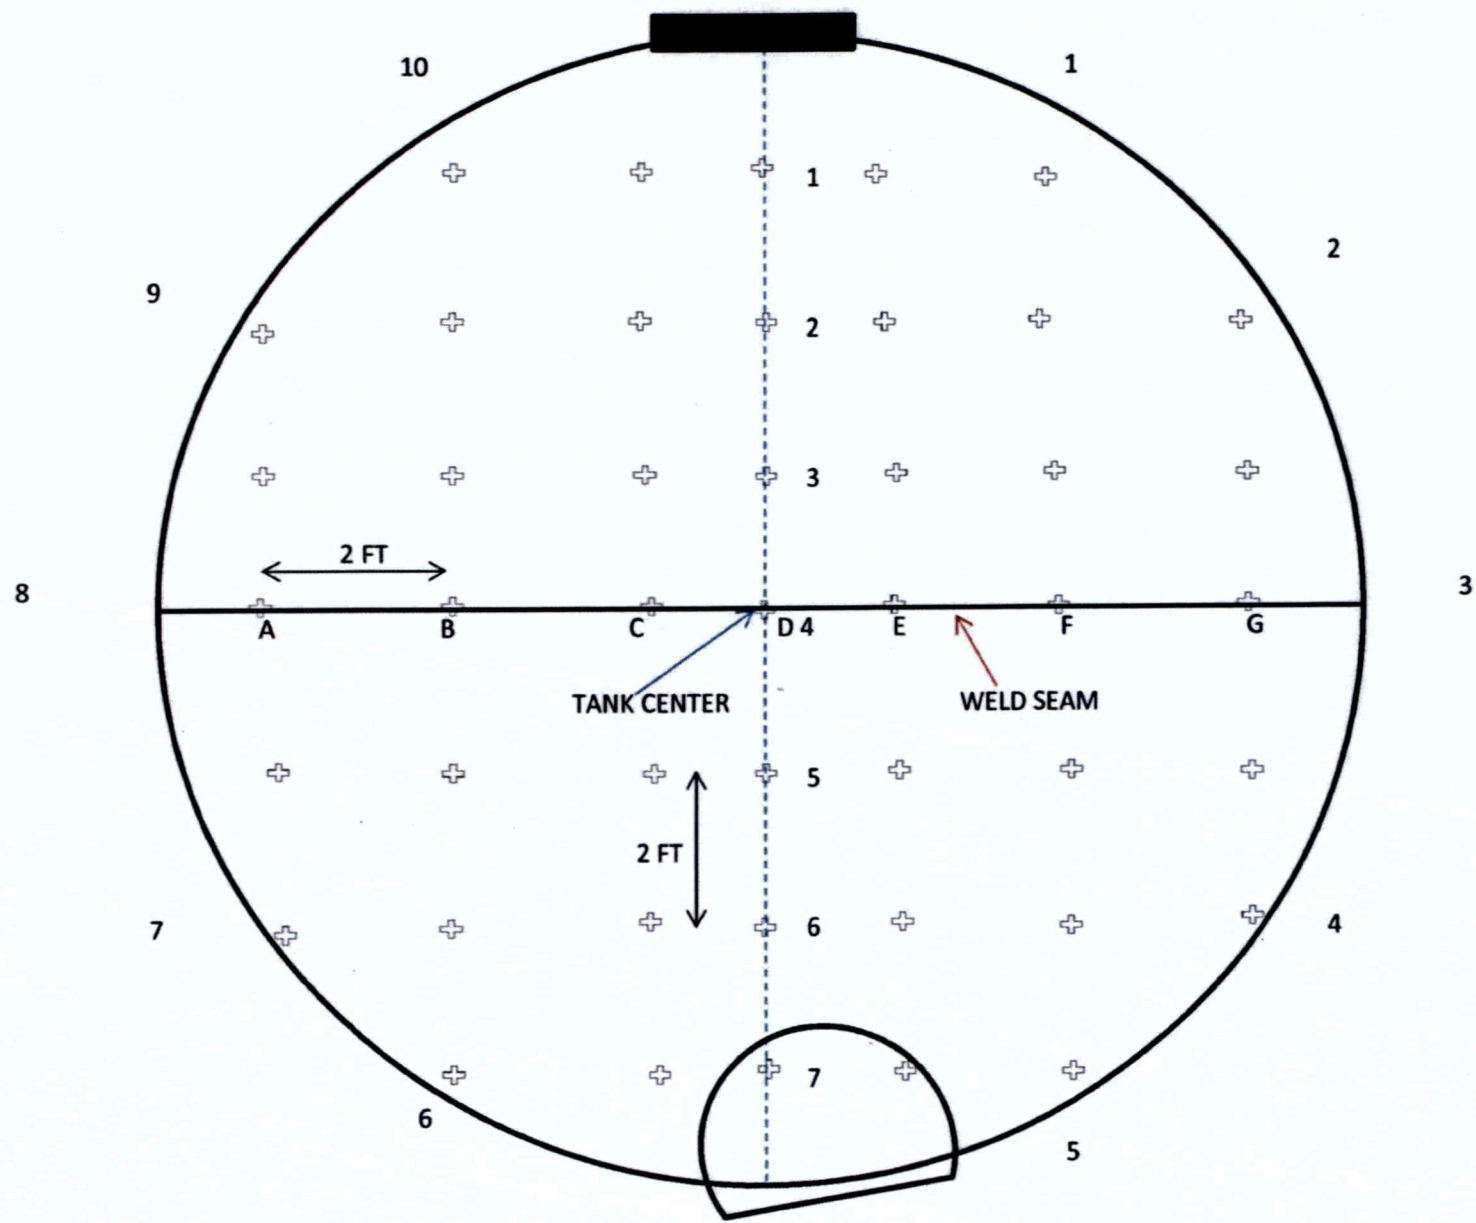
# PRODUCTION TANK LAYOUT

LOW SHELL READING: 0.237"

LOW FLOOR READING: 0.234"
