**INTERNAL INSPECTION:**

S/N: 07-159-4

Location: 8-20-49-2W4

Type of Inspection: VT	Rev: 2.0	Client: HUSKY OIL OPERATIONS	Date: 07-Feb-18
Test Technique: UT thickness( 4.2)		IRISNDT #: LYN1800154	WO #: 50053398
Equipment: DMS2 / FLASHLIGHT GRINDER		Location: 8-20-49-2w4m	PO #: 8401226309
Code / Standard: client information		Item Inspected: 1000bbl tank s/n# 07-159-4

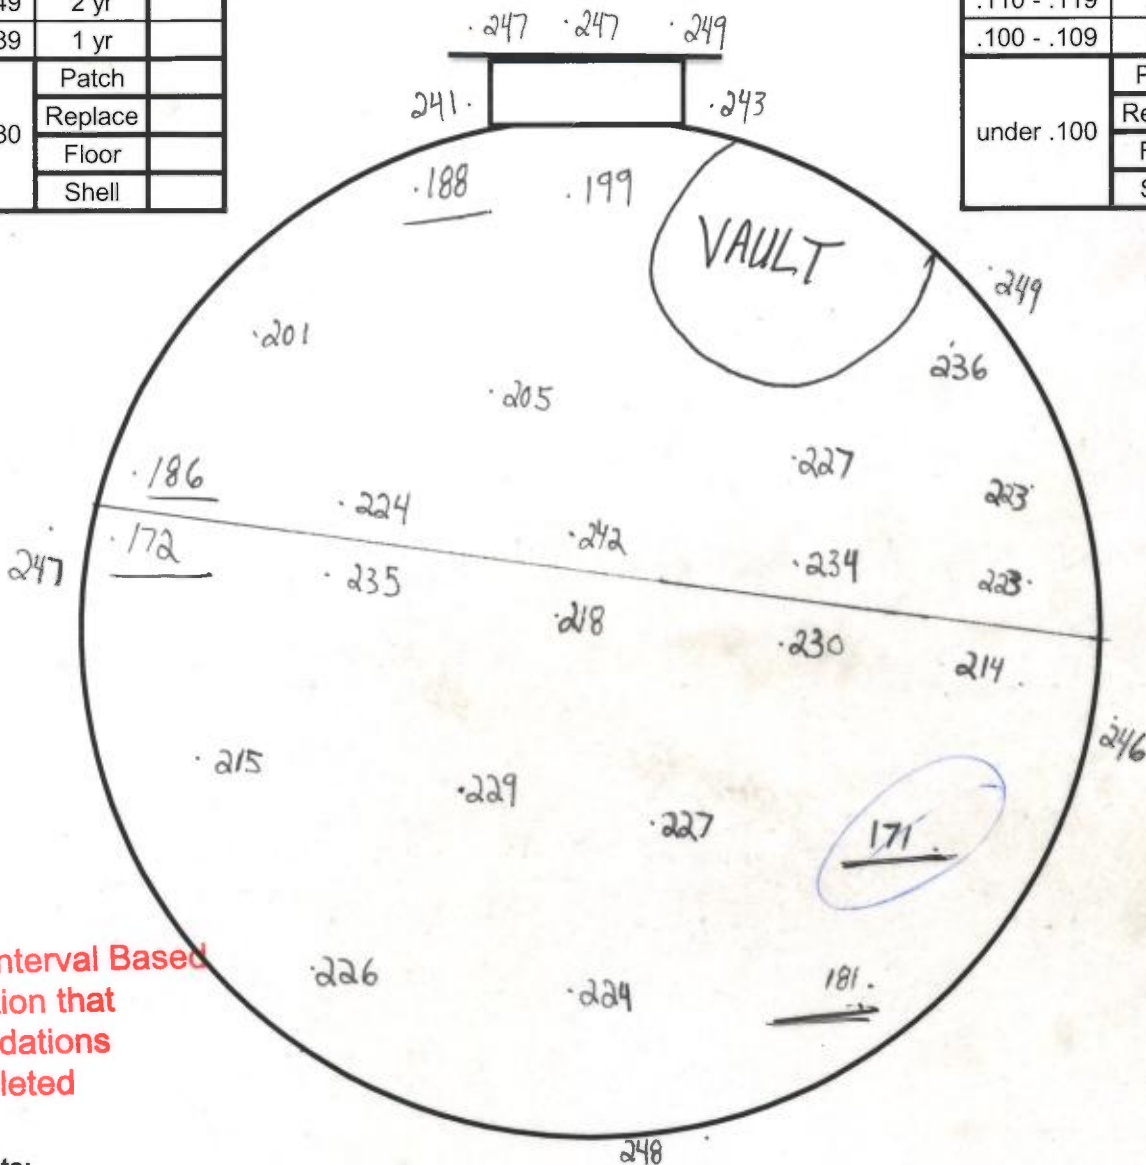
Underside Corrosion on the Floor, no way to Determine the Corrosion Rate. Currently 5YR Turnaround with Low of 0.171" AS PER Husky UT requirements.

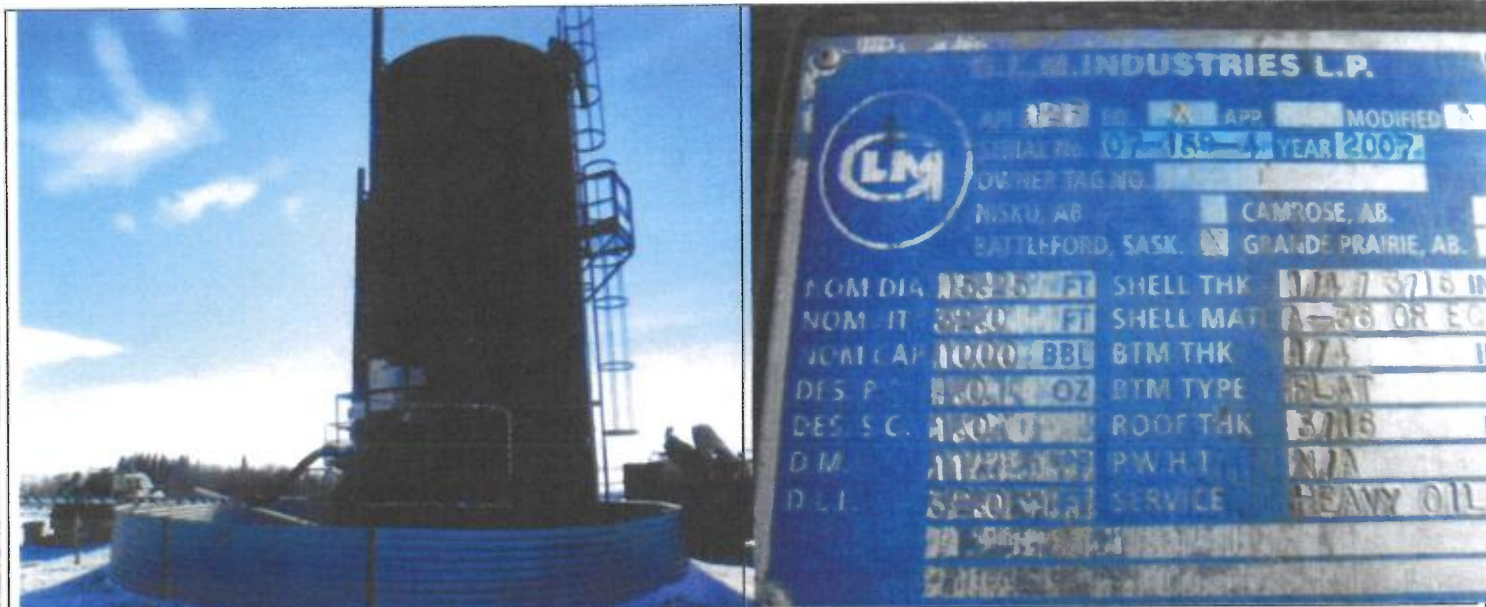
1000bbl tank s/n# 07-159-4: underside corrosion on the floor, no way to determine the rate of corrosion. currently 5yr turnaround with low of 0.171" , as per husky UT requirements.
