Edgerton/Dina

Tank Inspection Report

Location: 14-35-44-4 w4 Tank Type: Dil Storage Date: Nov 16, 2019
 Mfg: GLM Year bilt: 2003 S/N: G03-285-S2 CAP: 1000 bbl
 Floor Thk: 1/4" Shell Thk: 1/4" 3/16" Roof Thk: 3/16"
 Requisitioned by: Randy Churka Approver: Greg Graham Approver Code: 22-00323280
 WO #: 81441270 PO#: 8401358779 CC: _____ SAP #: 62051565

Type of Inspection: VT	Rev: 3.0	Client: HUSKY OIL OPERATIONS	Date: 2019-Nov-16
Test Technique: UT thickness(4.2)		IRISNDT #: LYN1901928	WO #: 81441270
Equipment: DMS 2/ Flashlight/ grinder		Location: 14-35-44-4 W4M	PO #: 8401358779
Code/Standard: client information		Item Inspected: 1000bbl TANK S/N# G03-285-S2

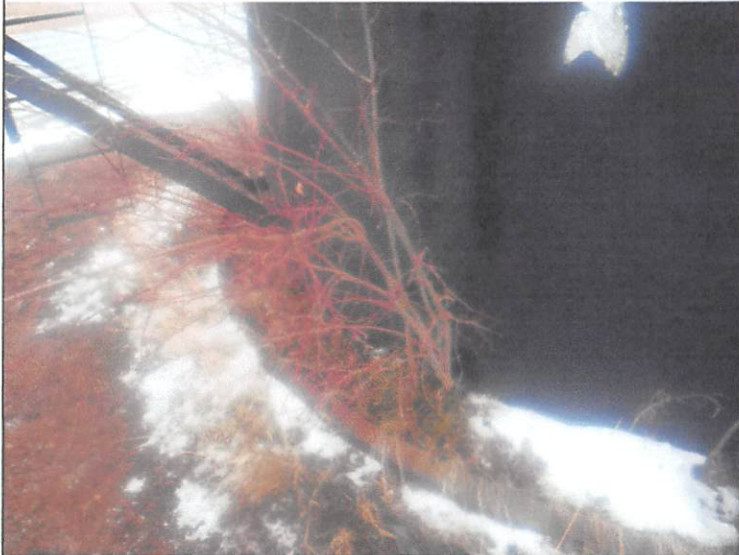
Trees growing from the base, recommend lifting the tank and resetting the base

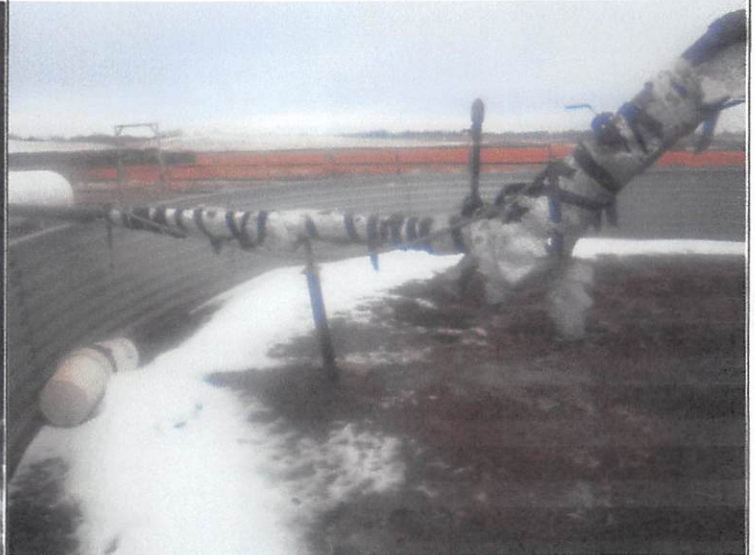
straighten out the flow line stands

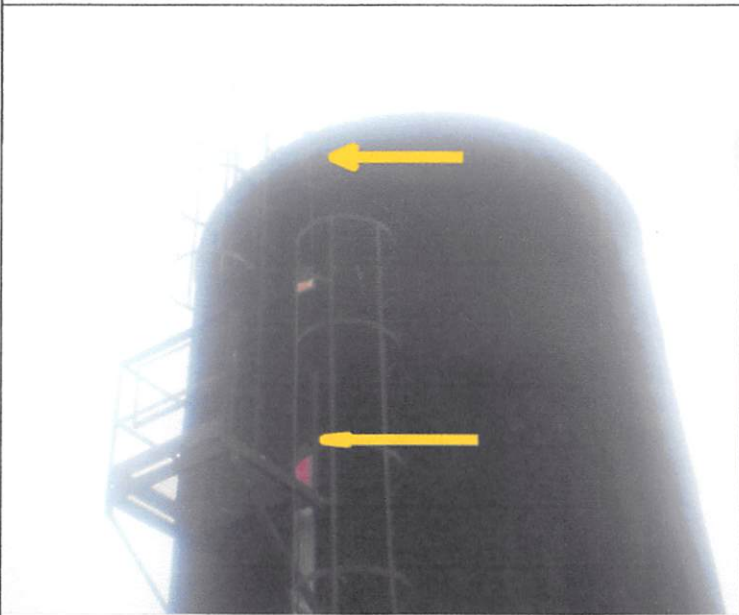
Section of gauge board missing

Replace 2 sch 40 sting nozzles (Vault and cross)
 Recommend lifting the tank and re-setting the base
 Repair the damaged gauge board.
 Blowout the fire tube before putting the tank in service
 5YR Turnaround with repairs.
