Storage Tank External Visual Inspection Report

Equipment ID: 62037250

Description:	TANK, UNIVERSAL 160M3
--------------	-----------------------

Type of Inspection: VT / UT	Job/P.O.#: wo#25000772	IRISNDT #: 149368	Date: 09-May-11
Test Technique:	Client: Husky Operations		
Equipment:	Location: 02/14-12-45-1W4		
Grinder, Generator, DMS 2	Item Inspected: 750 & 1000 BBL Tanks		
	Code: API-650

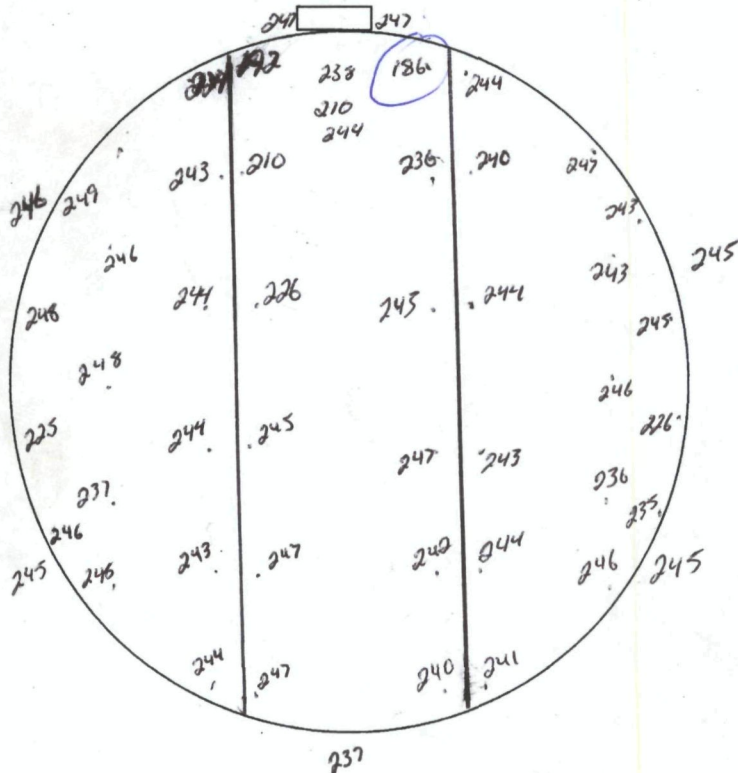
FLOOR CONDITION:	<u>GOOD</u>	<u>FAIR</u>	POOR	<u>U.S corrosion evident</u>
SHELL CONDITION:	<u>GOOD</u>	FAIR	POOR	
ROOF CONDITION:	<u>GOOD</u>	FAIR	POOR	
FIRETUBE:	<u>GOOD</u>	FAIR	POOR	
PIPING/NOZZLE CONDITION:	<u>GOOD</u>	FAIR	POOR	<u>Brace 8" Riser/replace 2.4" string</u>
BACKWELDING REQ:	<u>YES</u>	NO	WHERE	
ANODES: Yes <u>NO</u>	Total	BLOCK	CYLINDRICAL	CONSUMED %
COATING: Yes <u>NO</u>	GOOD	FAIR	POOR	TYPE:

- * Monitor U.S corrosion
- * Brace 8" riser
- * Replace 2.4" String Nozzles
- * Tighten Ladder bolts
- * Replace Tank base
- * Clean inside firetube and re-inspect
