Tank Inspection Report

S/N: 29085-1 (TANK 2)

Client: HUSKY OIL OPERATIONS
IRISNDT #: LYN1900860
Location: 102/ 9-11-47-5 W4M
Item Inspected: 1000 bbl tank 2 S/N# 29085-1

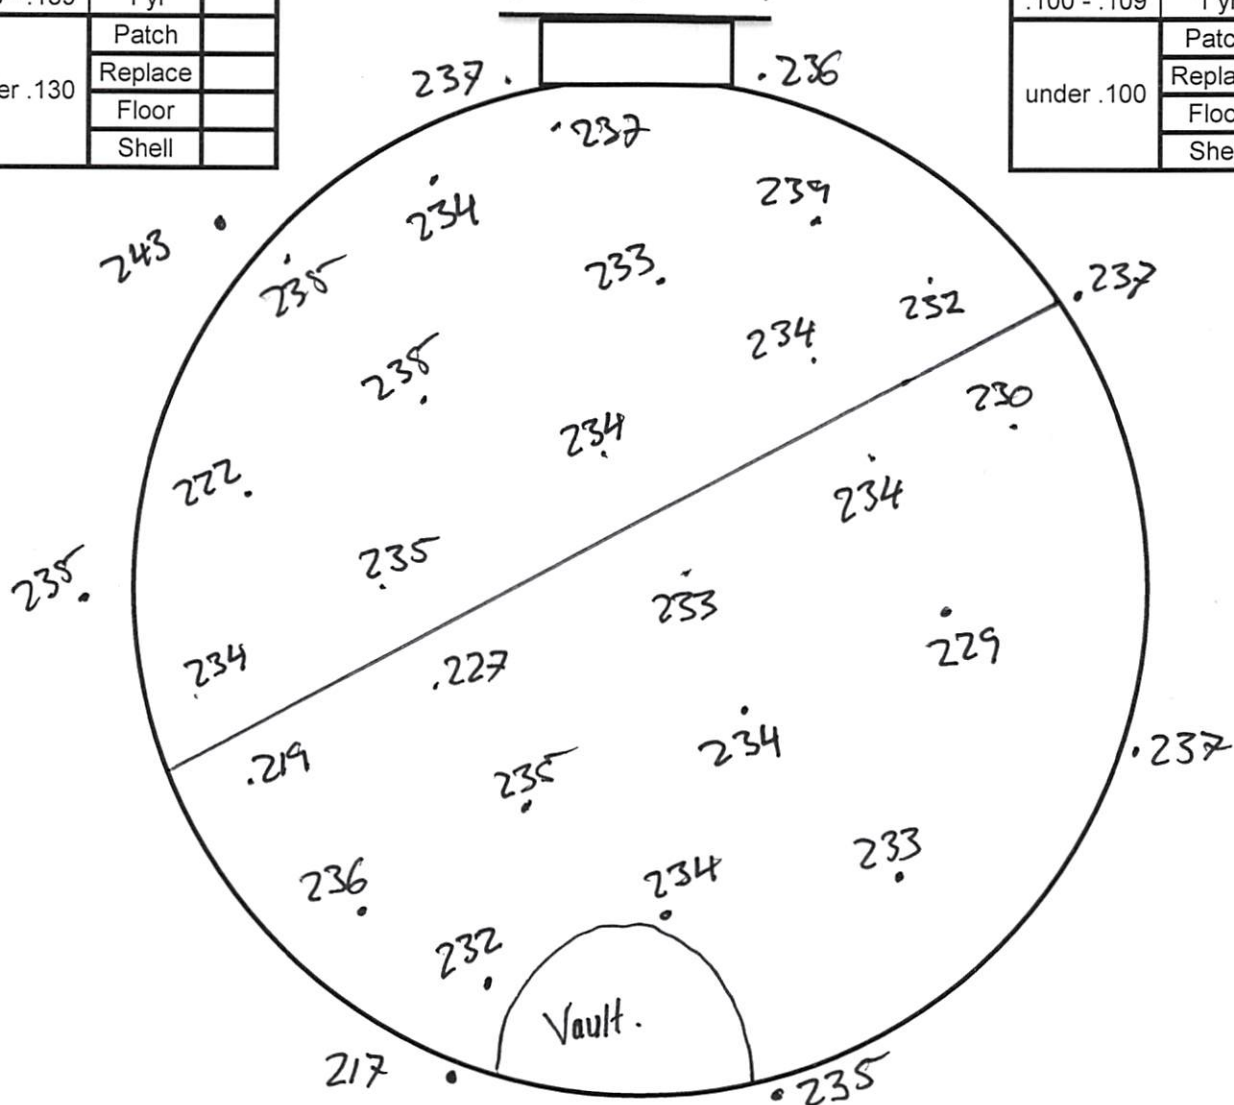
Without MFE		
.170 - up	5 yr	✓
.160 - .169	4 yr	
.150 - .159	3 yr	
.140 - .149	2 yr	
.130 - .139	1 yr	
under .130	Patch	
	Replace	
	Floor	
	Shell

Location: 102/9-11-47-5W4
234 222 238

With MFE		
.140 - .150	5 yr	
.130 - .139	4 yr	
.120 - .129	3 yr	
.110 - .119	2 yr	
.100 - .109	1 yr	
under .100	Patch	
	Replace	
	Floor	
	Shell

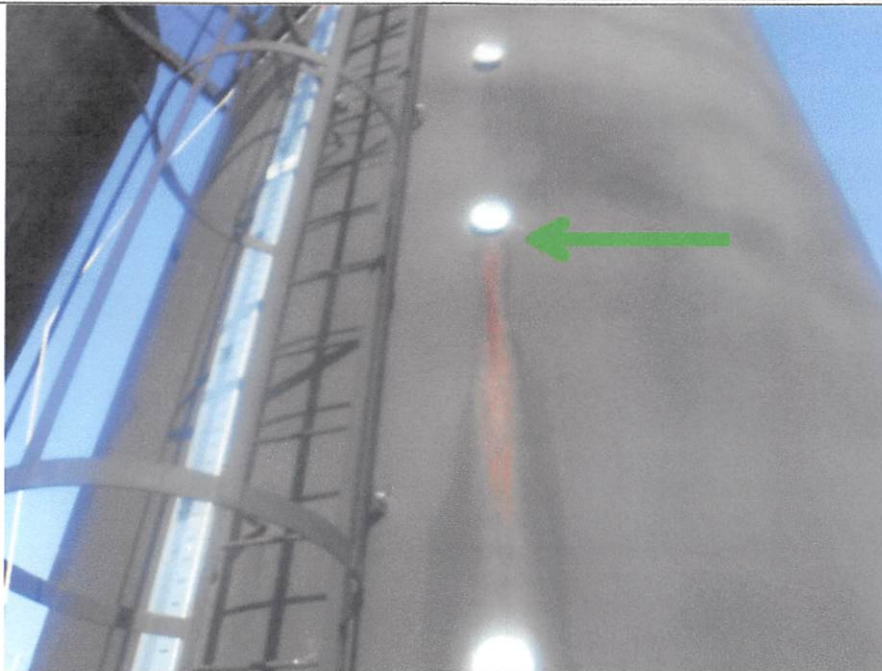
*Temp COLLAR Appears to be Leaking, Remove Insulation to evaluate.

stained insulation, leak at the temp collar.

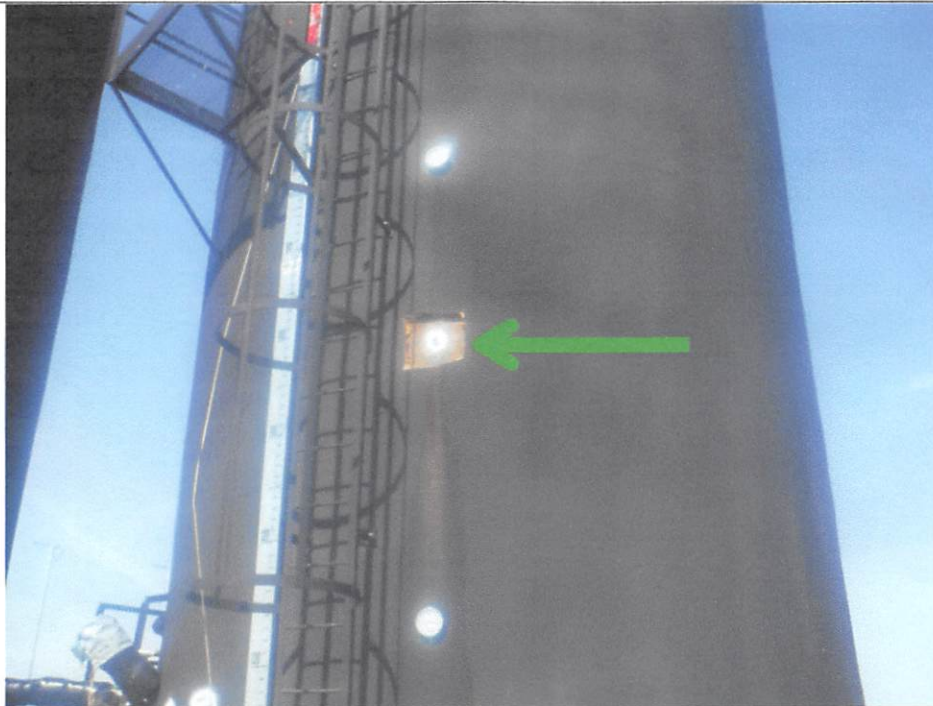
1000bbl tank 2 S/N# 29085-1: Temp collar was leaking, insulation stained. the insulation was removed and appeared to be leaking from the fitting the fitting. L&L removed the fitting and repaired the threads, monitor to ensure leak has stopped. no additional repairs required. the tank is in good overall condition for a 5yr turnaround.

Insulation removed and repaired threads on fitting. monitor to ensure leak has stopped
