FIRED HEATER INSPECTION REPORT

LSD: 12-05-054-20W5M

Date: May 11, 2016

SAP Equipment ID: 66068448 & 66068278

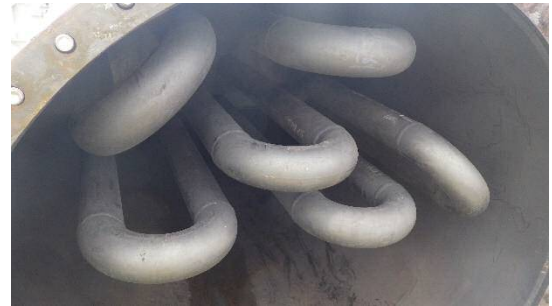
Internal coils: No external pitting/corrosion located. There was no fretting found at the coil to baffle plate intersects. No warping or mechanical damage was located. Coils are in good condition. Random UT was done by Streamline Inspection on the U-bends and straight sections. No internal pitting was reported. See Streamline report# UCG-160511-2 for details of results

Internal coils

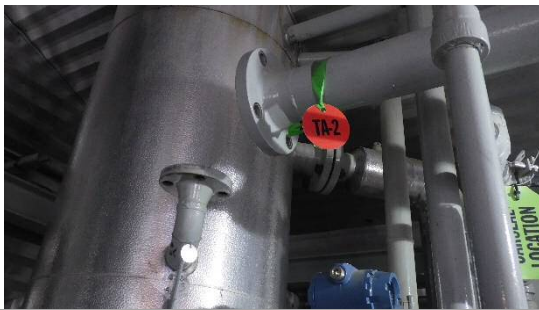
Coil Prov.# A0465810. See coil#1, radiant data for data plate info. Coil PSV vents to flare. The coil psv is located off of Separator A0465811 west shell. PSV was removed at time of inspection for servicing.

PSV Removed for service

Ensure coil PSV is set at or below mawp after servicing is completed.

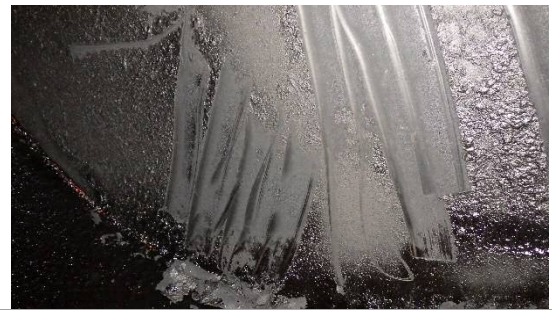
East Head: Good condition, no internal pitting/corrosion or mechanical damage located. No deterioration of the shell to head weld found.

East Head (Internal)

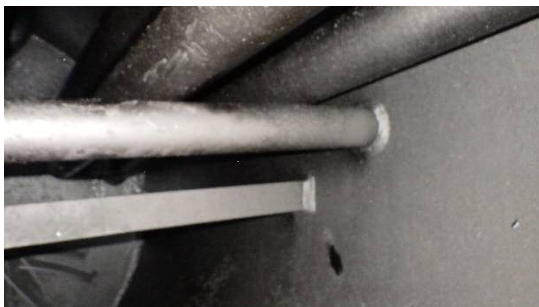
Coil support bracket

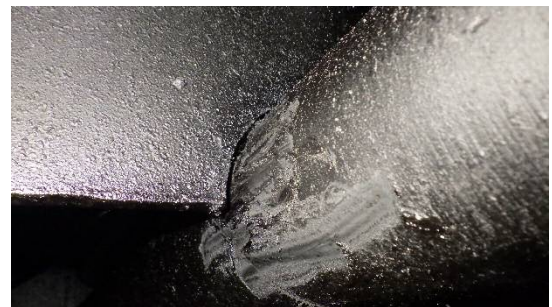
Coil to baffle plate intersect

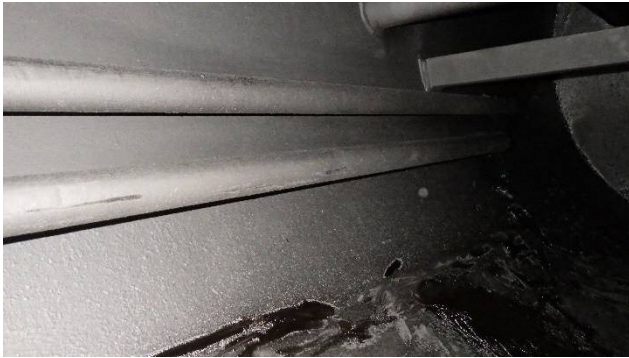
Fuel Gas Line

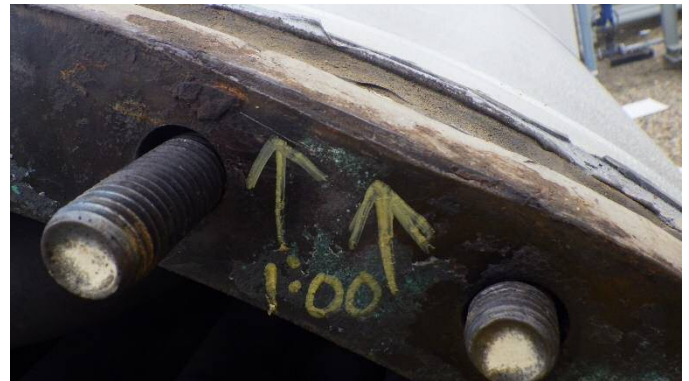
West flange gasket face: Good condition with no pitting/corrosion noted. A minor mechanical damage was noted @ approx. 1:00 position. No warping noted.

Mechanical damage on west flange Reboiler)

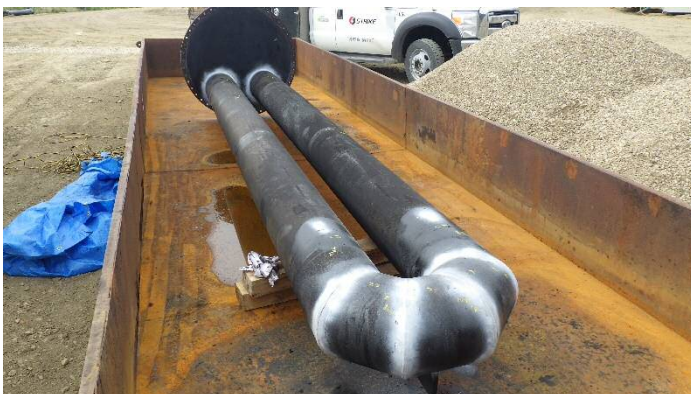
Reboiler Firetube

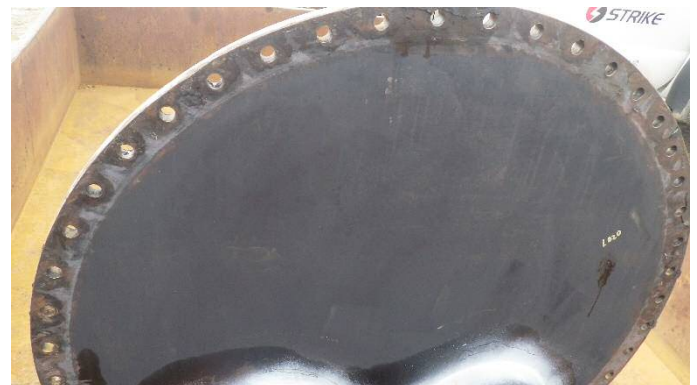
Tube Sheet: The tube sheet is in good condition. No warping or mechanical damage noted. The gasket face is in good condition. No pitting/corrosion noted at the time of this inspection.

Firetube tube sheet (Process side)

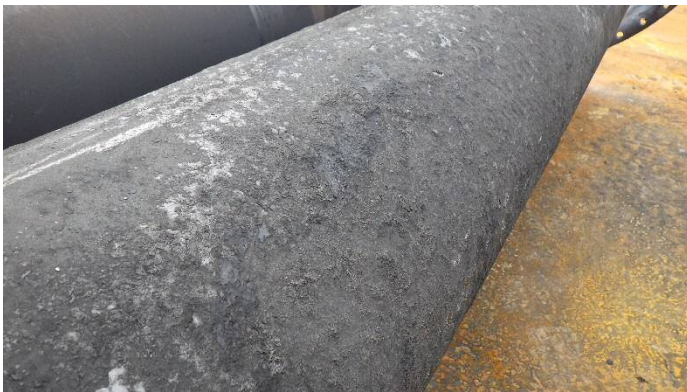
Exhaust Tube: The exhaust tube is in good condition. No warping or mechanical damage noted. There was no external pitting/corrosion located at the time of this inspection. The tube slip on flange is in good condition, no warping or mechanical damage noted. Product was baked on to the external shell tube section approximately 1/4 way down from the tube sheet. This section was buffed clean and no pitting was found. UT was done on this section by Streamline Inspection Ltd. and no pitting/corrosion was reported.

Product Baked on Exhaust Tube

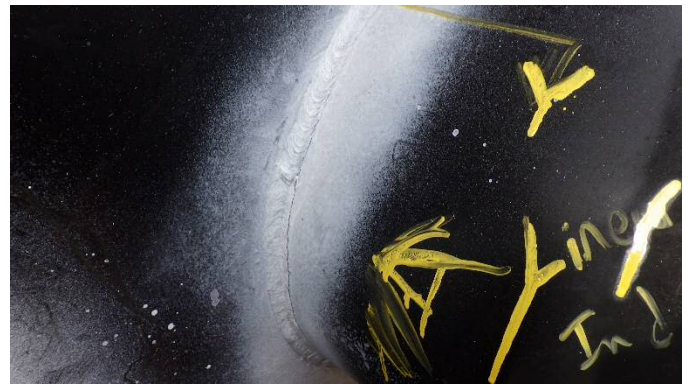
MT was performed by Streamline Inspection on the fillet and miter welds. Linear indications were located in the HAZ of the tube to tube sheet fillet welds. See Streamline report MCG-160511-1 for details of results.

Linear Indication, Exhaust Tube Side

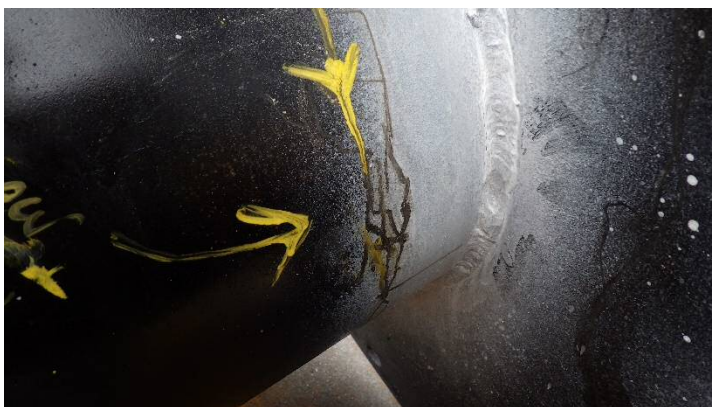
Linear Indication, Burner Tube Side
