FIRED HEATER INSPECTION REPORT

LSD 12-05-54-20W5

Report #20170103GGa

Fire tube failure December 30, 2016

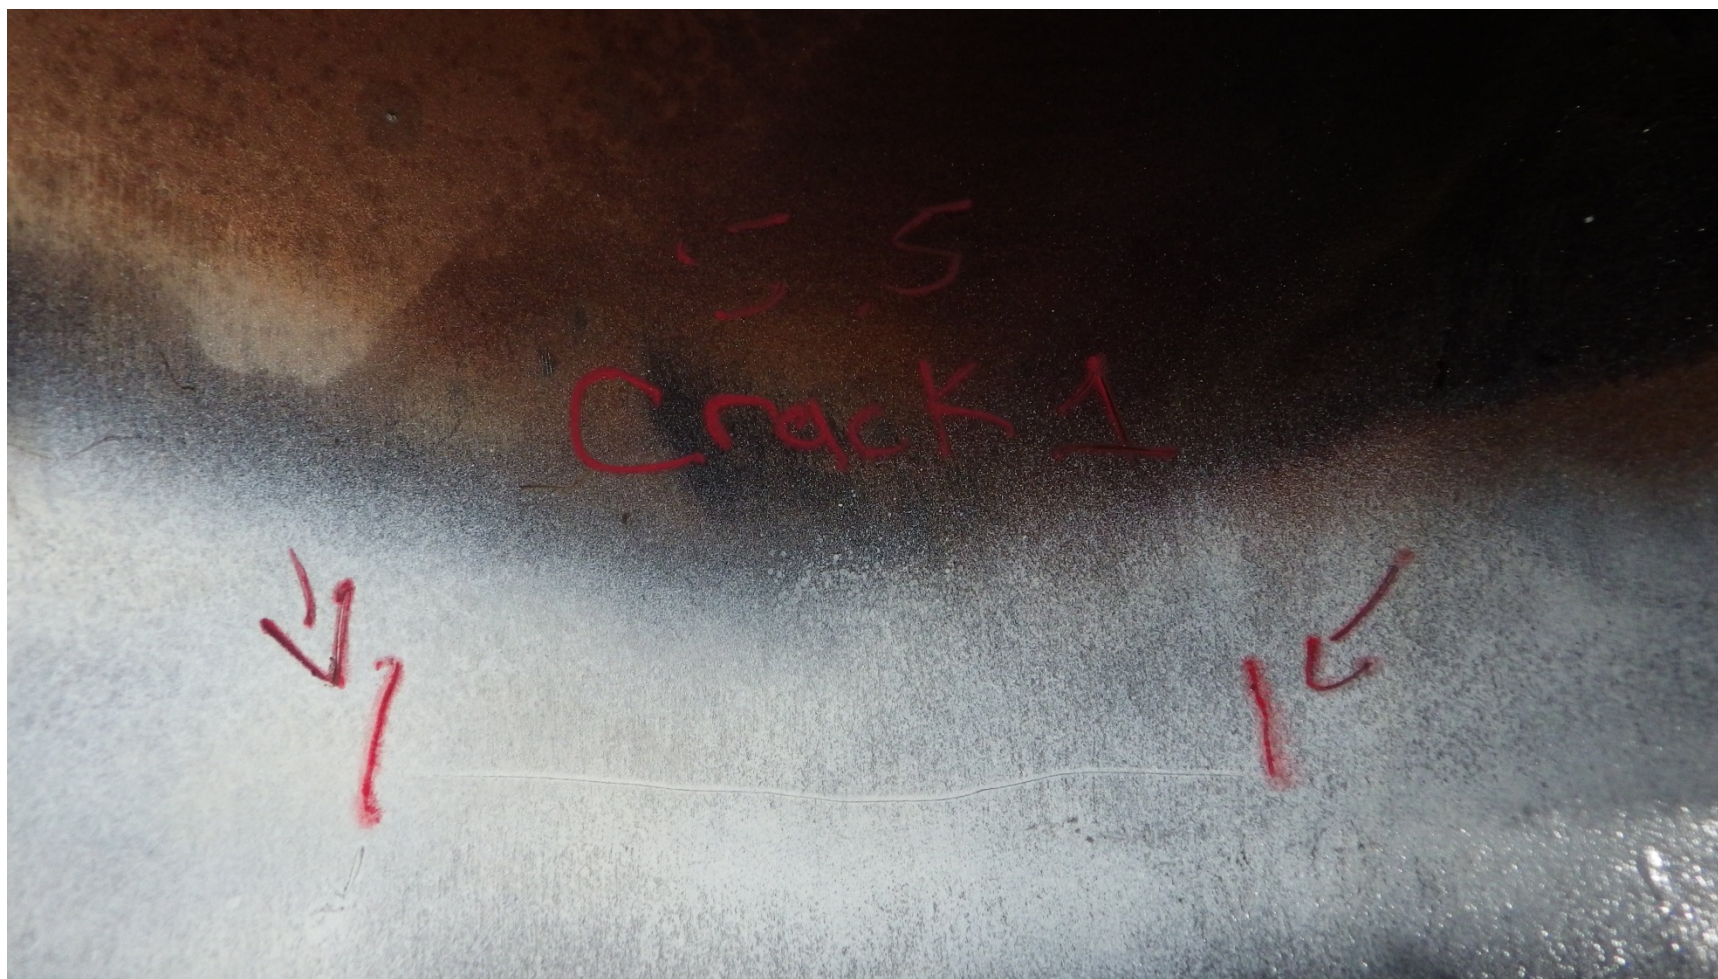
There was a visible linear indication on the inside of the fire tube on the exhaust side at the fire tube to flange weld. Wet magnetic particle testing (WMPT) was completed on this linear indication and found that the it runs from 7:30 to 9:45 o clock (looking into the fire tube) that measured 5.5 inches long (See picture INSIDE INDICATION 5.5 INCHES LONG), there were no other indications found on the inside of the exhaust side at the fire tube to flange weld.

Inside Indication – 5.5 Inches Long

The linear indication on the inside of the fire tube was ground out 3/8 of an inch for the length of indication (5.5 inches), dry magnetic particle testing (DMPT) was completed on the ground out linear indication. There was 2

linear indications at either end of the ground out indication. Linear indications were then ground out 3/4 of an inch more on either side and DMPT was completed again and no indication were found throughout the entire ground out liner indication. Total length of linear indication was 6.5 inches.

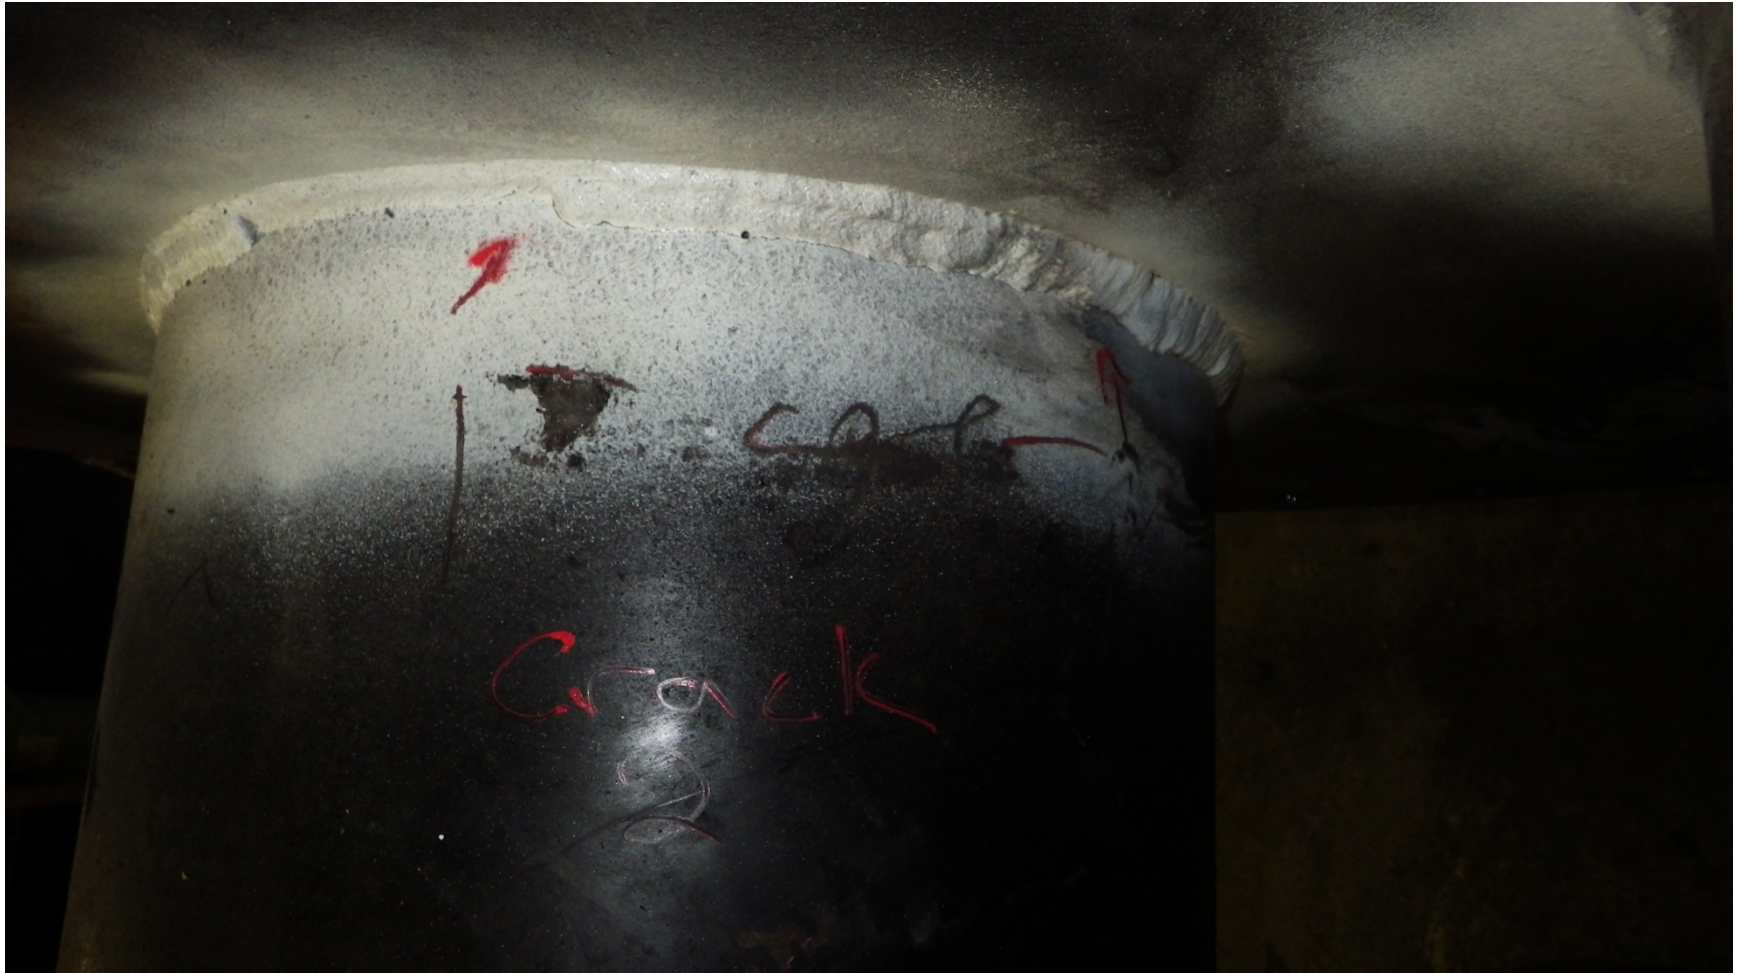
Wet magnetic particle testing (WMPT) was completed on the fire tube to flange fillet weld. WMPT show a linear indication that runs from 1 to 3:30 o clock (looking at the fire tube to flange fillet weld) that measured 7 inches long (see picture OUTSIDE INDICATION 7 INCH LONG), there were no other indications found on the fire tube to flange fillet weld. History: This weld was repair in the spring of 2016 during the 2016 Galloway T/A in the same location. At the time of the repair the linear indication was completed removed. It is my thought that when the repair was completed not all indications were found, leaving linear indications (cracks) that have propagated out causing this failure. Recommend that the firing rates of the heater be looked at to maybe help reduce vibrations and/or replacing the fire tube with a new that has bellows to absorb the stresses and vibrations caused by the burner.

Outside Indication – 7 Inches Long

The linear indication on the fire tube to flange fillet weld was ground out for the length of indication (7 inches). The indication started at the toe of the fillet weld on the fire tube side and moved to the center of the fillet weld towards the flange, this was found using dry magnetic particle testing (DMPT). DMPT was completed again completed again a new indication was found, the fillet weld was then completely ground out. DMPT was completed again completed again and 2 indications were found on either side of the ground out indication. These indications were ground out 1/2 inch and DMPT was completed again completed again and no indications were found. Total length of linear indication was 8 inches.

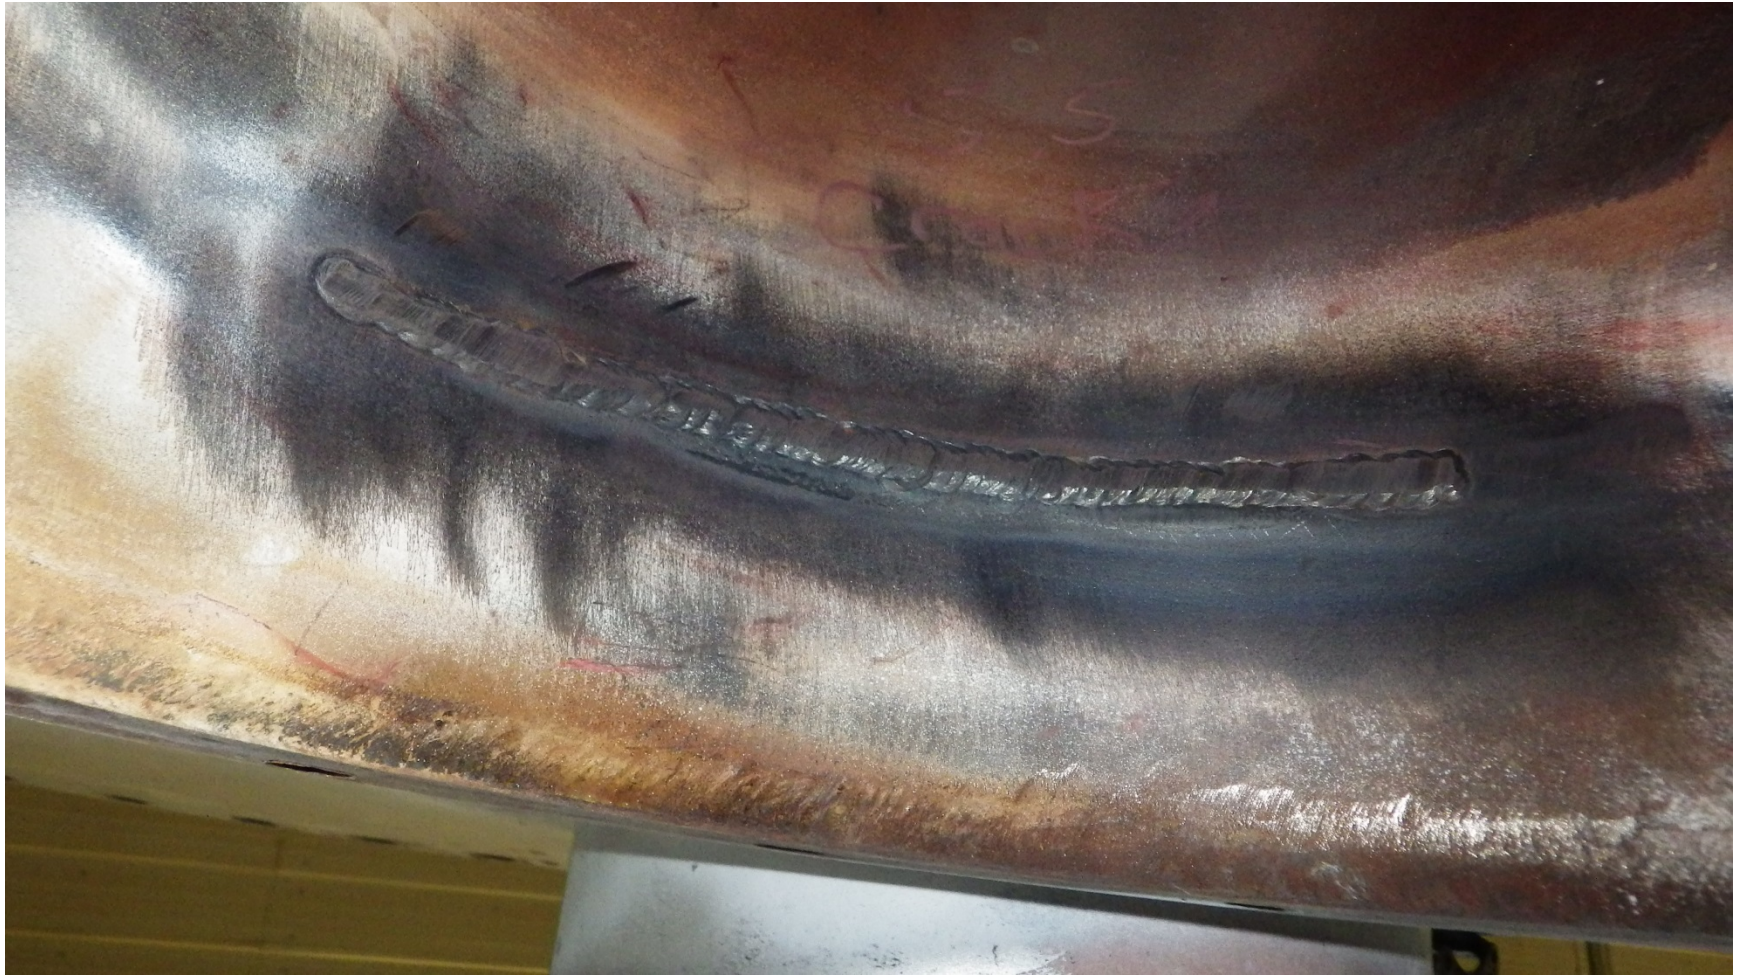
Inside Indication – Butt Weld

Linear indication was filled using a butt weld. See picture INSIDE INDICATION BUTT WELD.

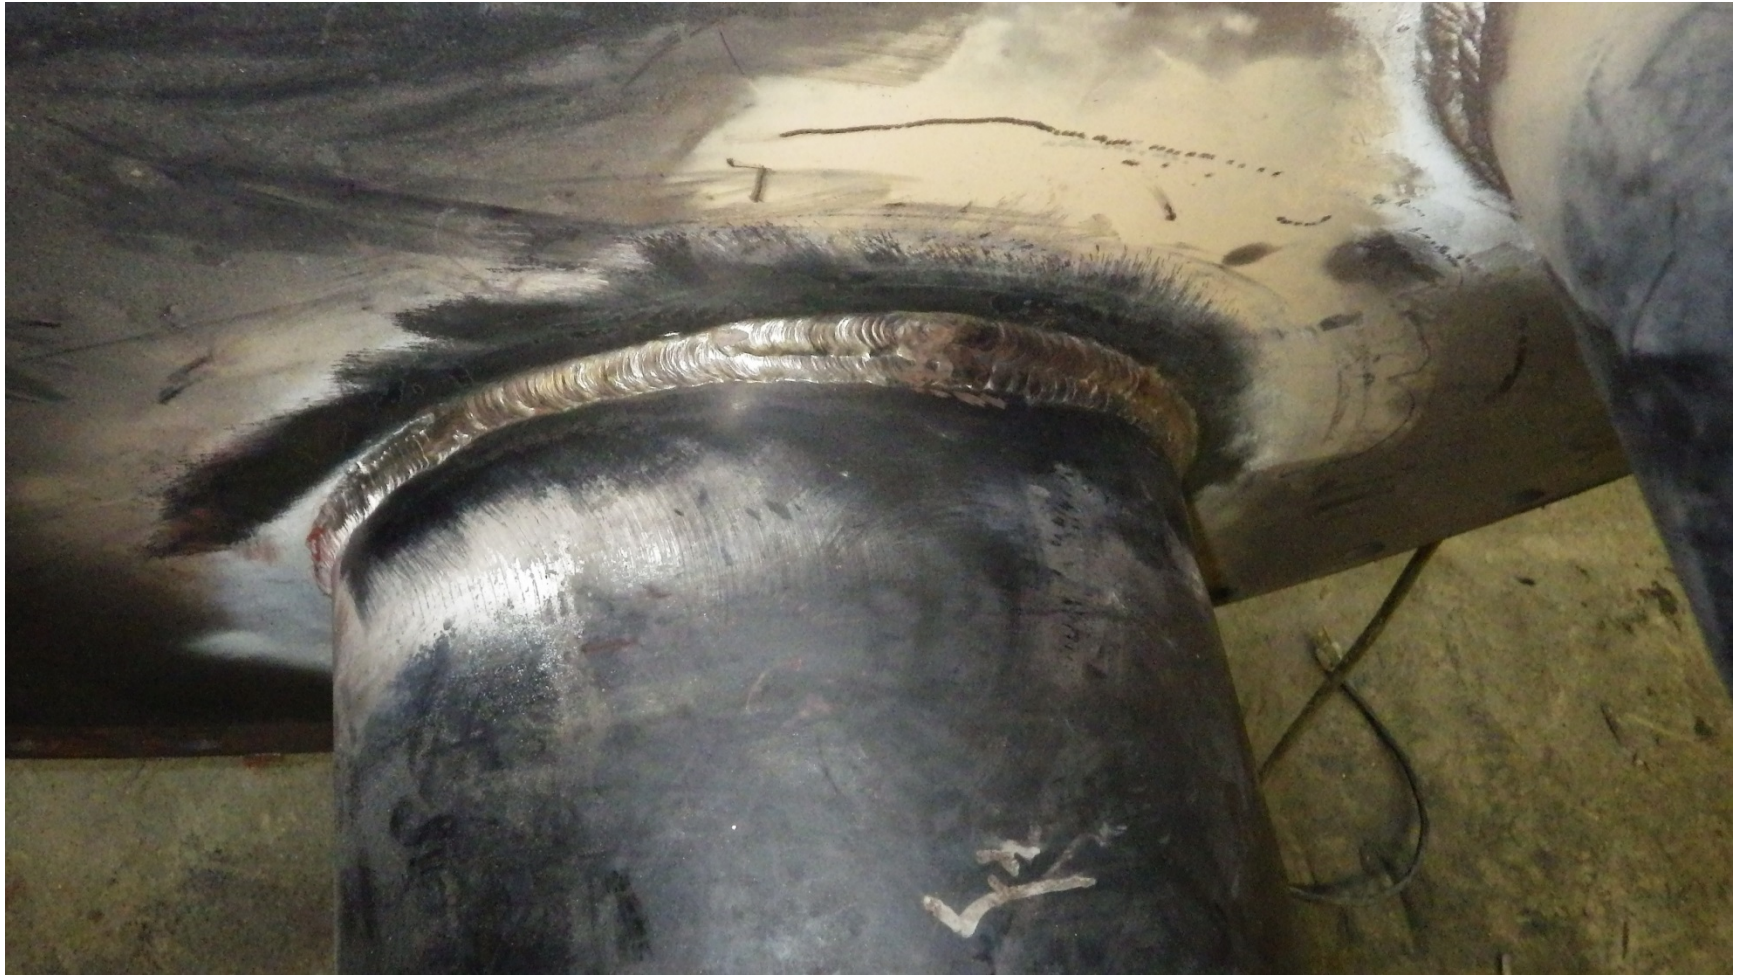
Outside Fillet Weld – 8 Inches Long

Linear indication was filled using a fillet weld. See picture OUTSIDE FILLET WELD 8 INCH LONG.
