STORAGE TANK INSPECTION REPORT

LSD: 04-16-060-22W5

SAP Equipment ID: 66172118

| STORAGE TANK STATIC DATA | | | | | | | | | |
|---|---|---|---|---|---|---|---|---|---|
| Equipment Description: | | | Produced water tank | | | | Equip Tag #: | | |

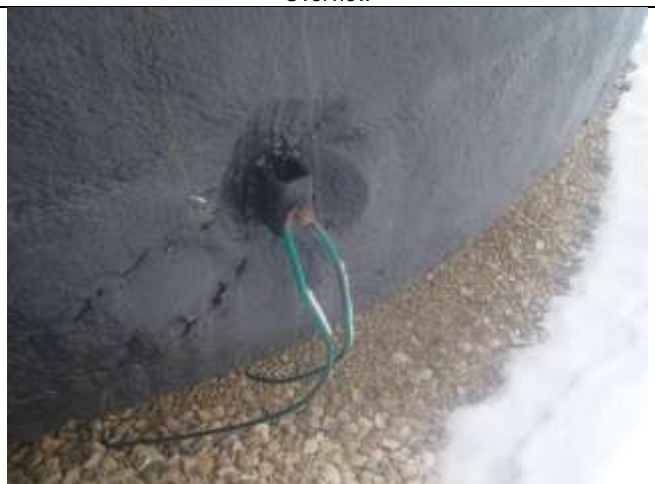
Grounding

| ID | Description | Condition | Location | NCR | Comments |
|---|---|---|---|---|---|
| T8 | Electrical Ground | Good | | | |

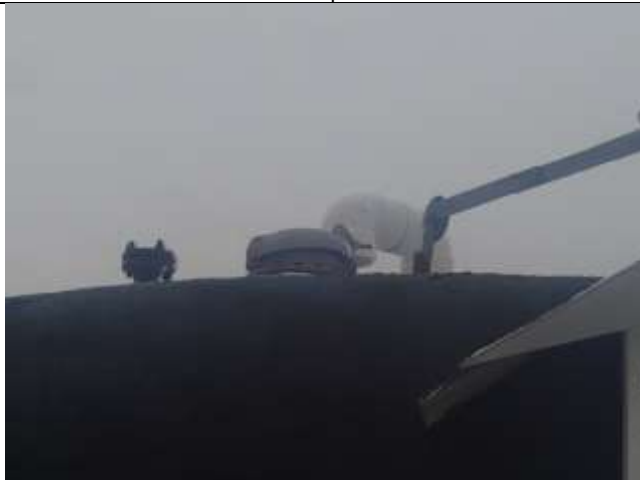
| ID | Description | Condition | Location | NCR | Comments |
|---|---|---|---|---|---|
| T71 | Relief Devices Other (Please explain) | Good | | | Thief hatch and open 4 inch diameter PVC vent |

Thief hatch and vent

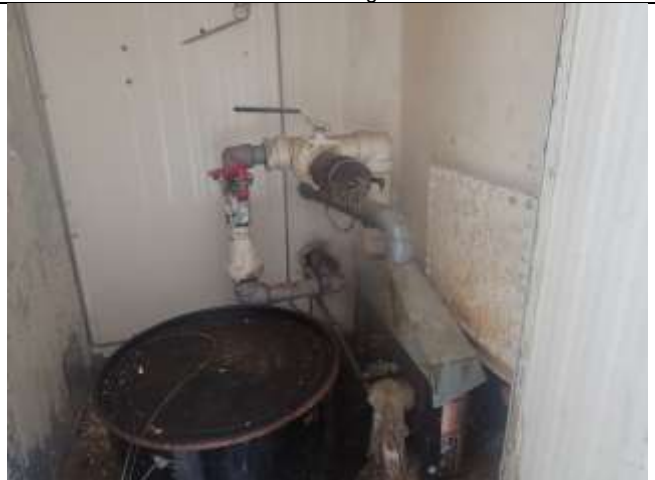
Inlet piping and truck out connection

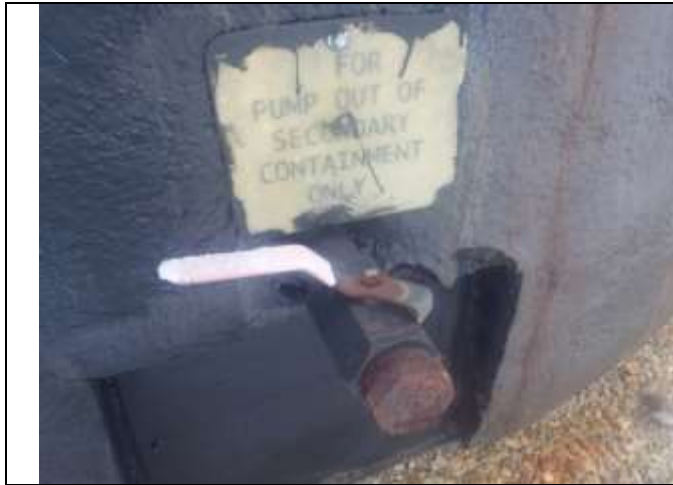
| ID | Description | Condition | Location | NCR | Comments |
|---|---|---|---|---|---|
| T14 | Secondary Containment | Good | | | Double walled |

Secondary containment drain

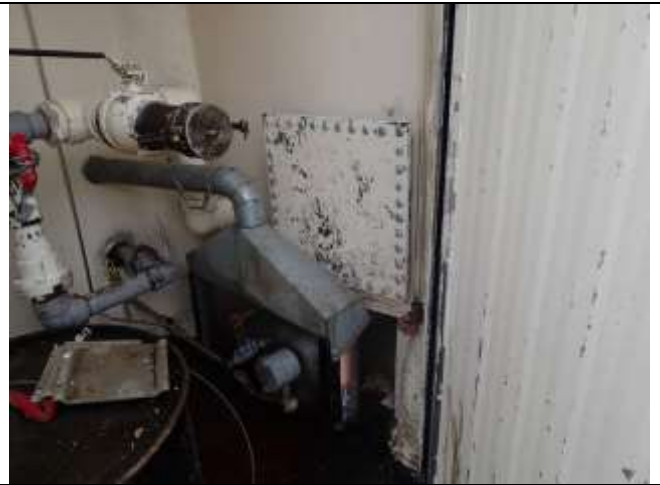
Interior of attached shack. Interstitial space leak indicator to right of manway.

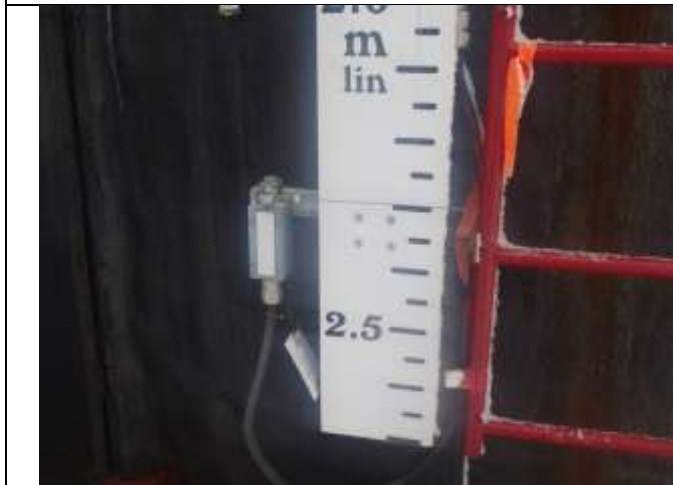
High level indication

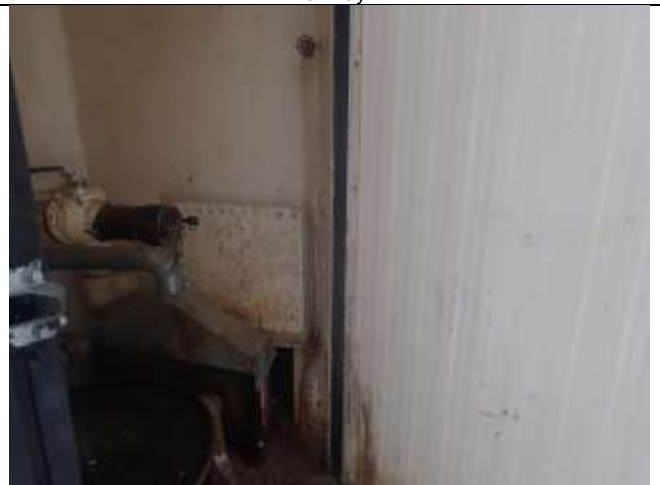
Manway

| ID | Description | Condition | Location | NCR | Comments |
|---|---|---|---|---|---|
| T45 | Manways/Hatches | Good | | | |
| T48 | Bolting | Good | | | Only on small manway |
