PRESSURE VESSEL & COLUMN INSPECTION REPORT

LSD: 06-22-057-20W5

SAP Equipment ID: 66172348

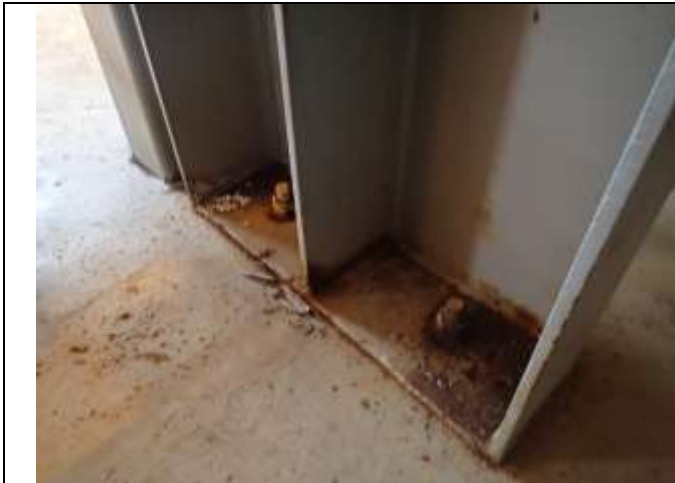
Support connection to skid. Rust flakes from paint failure/ minor external corrosion above.

- Recommend to remove external corrosion product/prep and re-paint areas of paint failure on shell/heads.
- Recommend UT on Blowcase charge gas equalization line which showed signs of external corrosion. (this will be planned for February 2016)

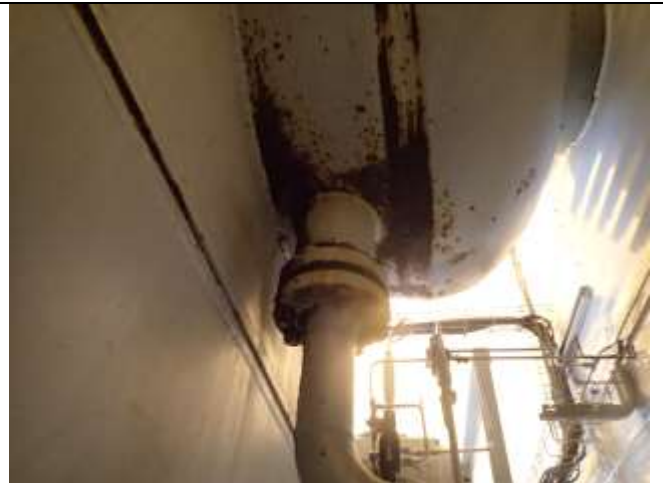
ID	Description	Condition	Location	NCR	Comments
V1	General Other (Please Explain)	Acceptable			Minor external corrosion noted less than .005 in deep as noted in areas of coating failure in item V11 below. Corrosion product was scraped away and wire brushed to allow for inspection.
V2	General Corrosion	Acceptable			See V1
V3	General Leaks	None			
V4	Vibration	None			
V5	Dissimilar Flange Rating	None			
V6	Ladder/Stairway	Acceptable			
V7	Heads	Acceptable			
V8	Guy Wires				
V9	Electrical Ground	Acceptable			
V10	Painted Inactive Corrosion	None			
V11	Coating/Painting	Fair			Paint failure noted at east end below manway on shell – approximately 2 square foot area. Several other small locations scattered around external.
V12	Expansion Joint or Bellows	NA			
V13	Gauge/Site Glass	Acceptable			
V14	Shell	Acceptable			
V15	Jacket	NA			
V21	Support Other (Please explain)	NA			
V22	Foundation	Acceptable			Steel skid

Paint failure area with minor external surface corrosion less than .005 in deep on east end. Not an integrity issue at the time of inspection.

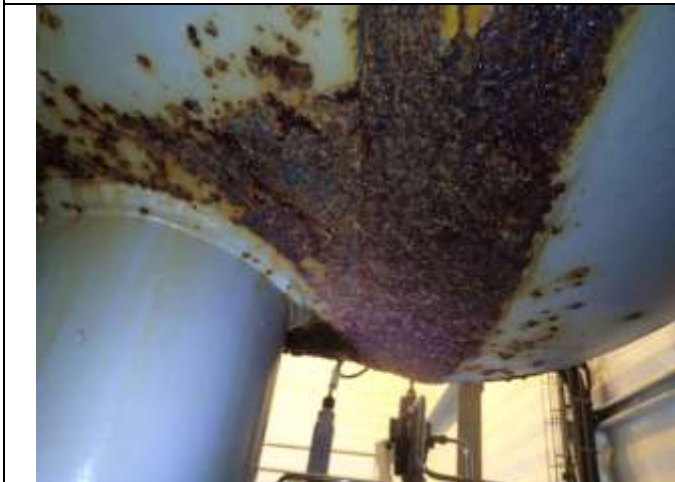
Close up of paint failure/external corrosion area.

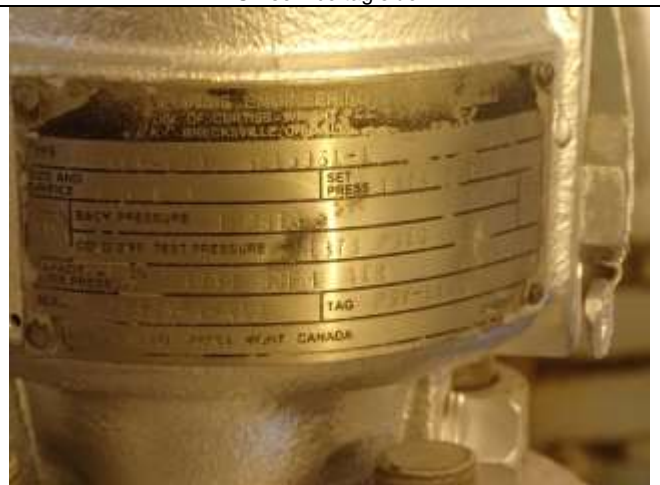
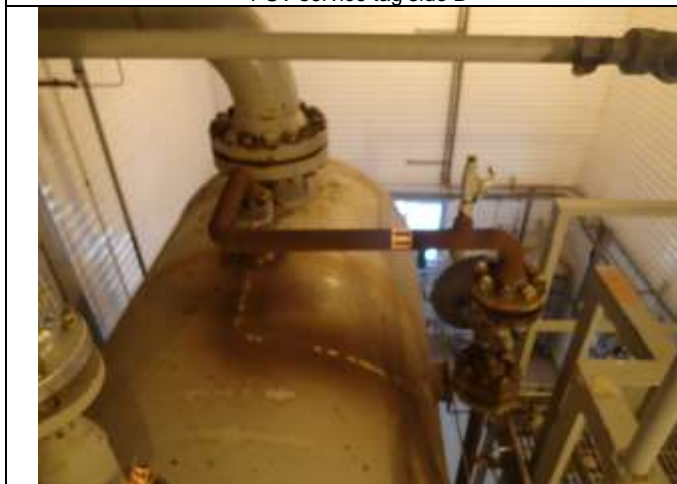
Blowcase charge gas equalization line. Paint failure and external corrosion due to ice buildup/thaws from operational cycles. The discoloration on the vessel below the piping is the corrosion product (dust) from the equalization line.
