PRESSURE VESSEL & COLUMN INSPECTION REPORT

LSD: 06-22-057-20W5

Date: 29-May-2017

SAP Equipment ID: 66172348

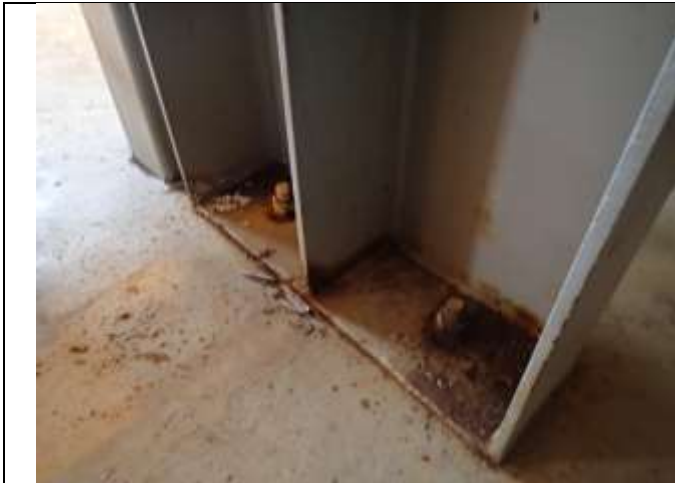
Support connection to skid. Rust flakes from paint failure/ minor external corrosion above.

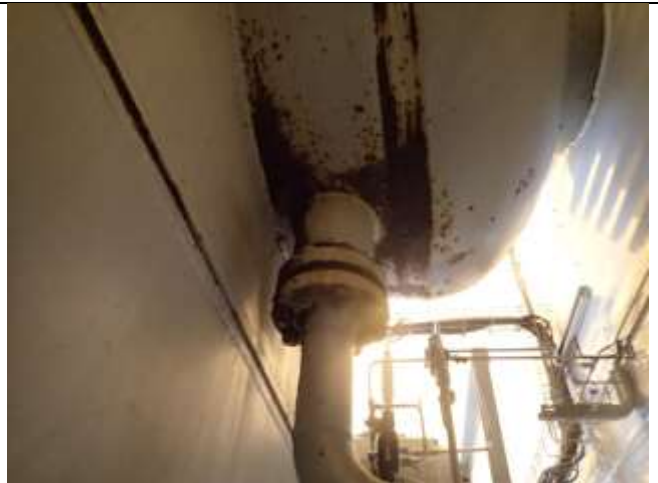
ID	Description	Condition	Location	NCR	Comments
V1	General Other (Please Explain)	Good			Minor external corrosion noted less than .005 in deep as noted in areas of coating failure in item V11 below. Corrosion product was scraped away and wire brushed to allow for inspection.
V2	General Corrosion	Good			See V1
V3	General Leaks	None			
V4	Vibration	None			
V5	Dissimilar Flange Rating	None			
V6	Ladder/Stairway	Good			
V7	Heads	Good			
V8	Guy Wires				
V9	Electrical Ground	Good			
V10	Painted Inactive Corrosion	None			
V11	Coating/Painting	Fair			Paint failure noted at east end below manway on shell – approximately 2 square foot area. Several other small locations scattered around external.
V12	Expansion Joint or Bellows	NA			
V13	Gauge/Site Glass	Good			
V14	Shell	Good			
V15	Jacket	NA			
V21	Support Other (Please explain)	NA			
V22	Foundation	Good			Steel skid
V23	Anchor Bolts	Good			
V24	Saddle/Skirt	Good

Paint failure area with minor external surface corrosion less than .005 in deep on east end. Not an integrity issue at the time of inspection.

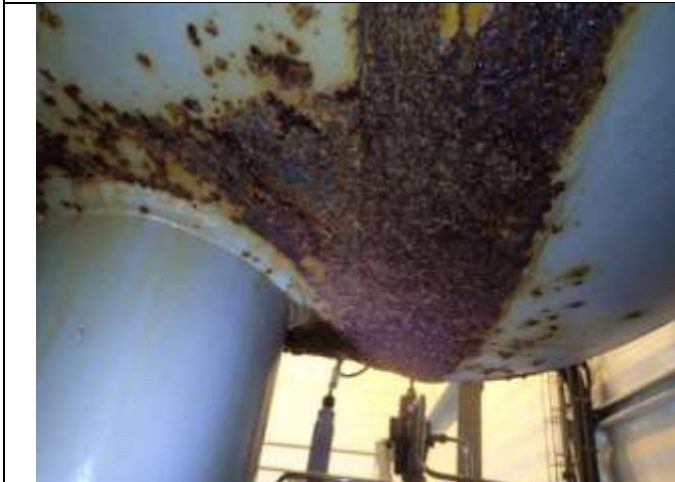
Close up of paint failure/external corrosion area.

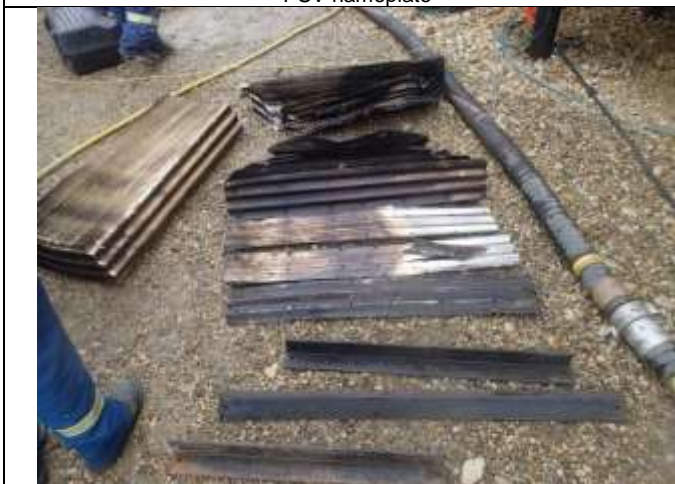
- No relevant indications of in-service corrosion/erosion. The internal chevron vein pack (non-pressure part) was mechanically damaged and had to be replaced in kind during the outage.
- No non-conformances
- No inspection deficiencies
- No requirements for inspection interval change

May 2017 Internal – Remainder of the vein pack removed from the vessel. No damage to the vessel shell or internal components

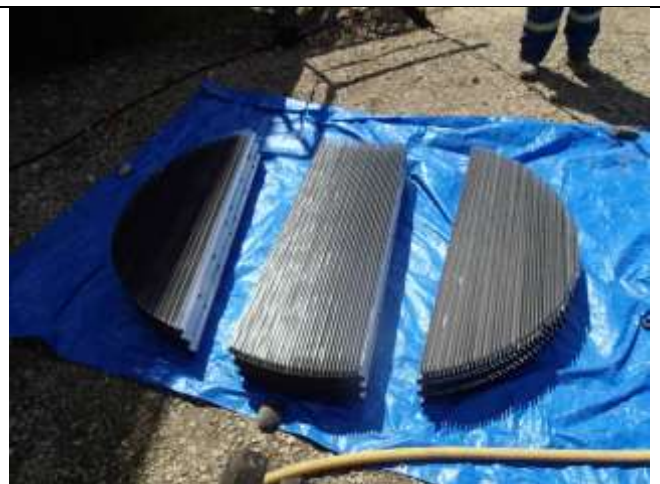
May 2017 Internal – New replacement vein pack prior to installation

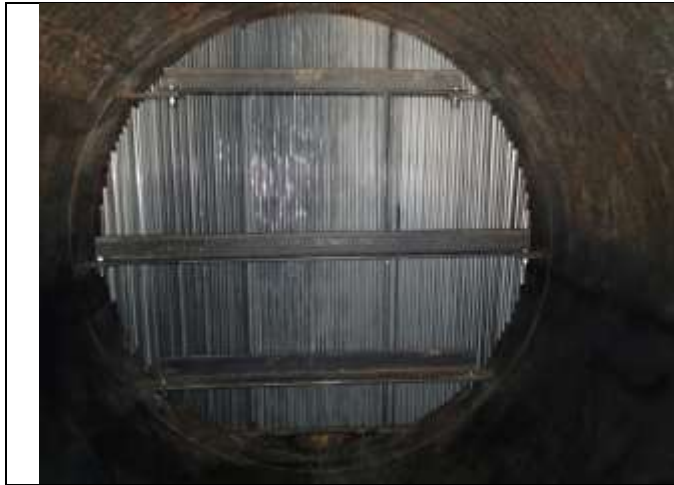
May 2017 Internal – Replacement vein pack installed

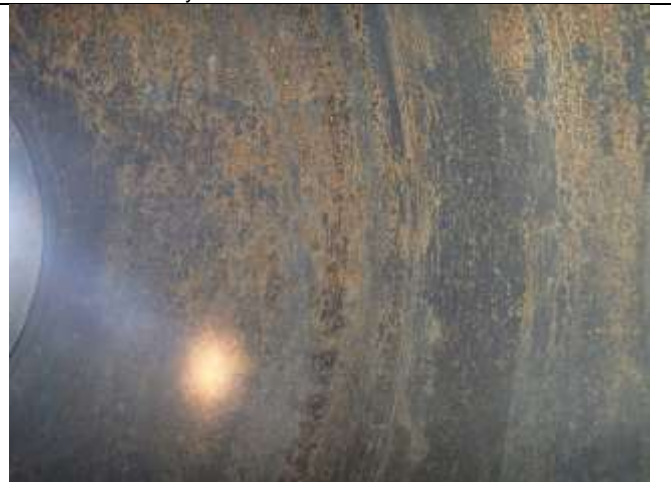
May 2017 Internal – Outlet end of shell. Typical all around with no relevant indications of corrosion/erosion or mechanical damage.
