PRESSURE VESSEL & COLUMN INSPECTION REPORT

LSD: 06-22-057-20W5

SAP Equipment ID: 66172228

VESSEL STATIC DATA									
Plant: Foothills & BC			Op Unit Kaybob			System			
Prov. Insp. # 457111			CRN L9454.213			Equip Tag #			
Equipment Description			SEPARATOR, COMPRESSOR BLOWCASE			Serial # 00-742			
Manufacturer			INTERNATIONAL VESSEL FAB.			Vessel Class Pressure Vessel			
Internal Access: No			Description:			Year Built 2000			
MAWP 1445			Psi @ 300			MDMT -20 °F			
CODE : U			RT : 1			PWHT : Yes			
Diameter		Length		OAL		mm / in			
						Horizontal			
Shell	Mat'l	106-B		Thickness	.844	In		Corr Allowance	.125 in
Head	Mat'l	516-70N		Thickness	.750	In		Corr Allowance	.125 in
Nozzle	Mat'l	106-B/105N		Thickness	Various		mm / in		Corr Allowance NS mm / in
Internal Coating: NO			Internal Clad : NO			Capacity 2.86 Ft3			
Manway : No			Inspection Port : YES			Support: Custom Clamp			
Nozzle Rating		900 lb. ANSI		Painted : YES		Insulated No

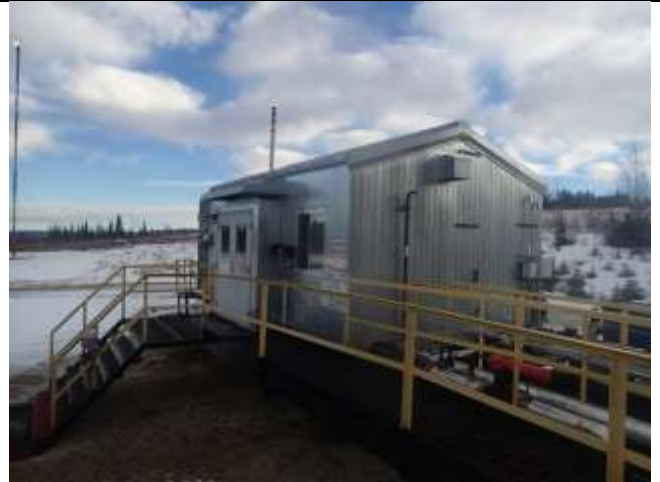
Building overview

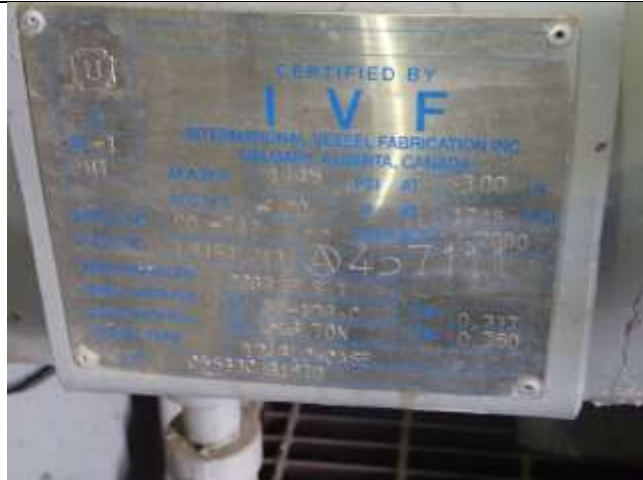
Nameplate

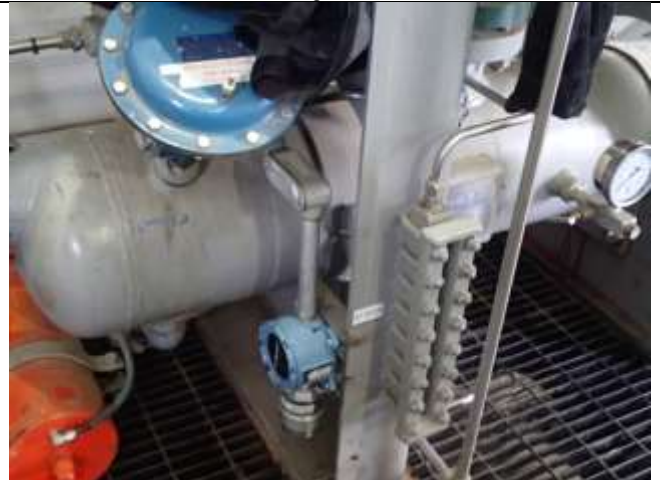
Overview

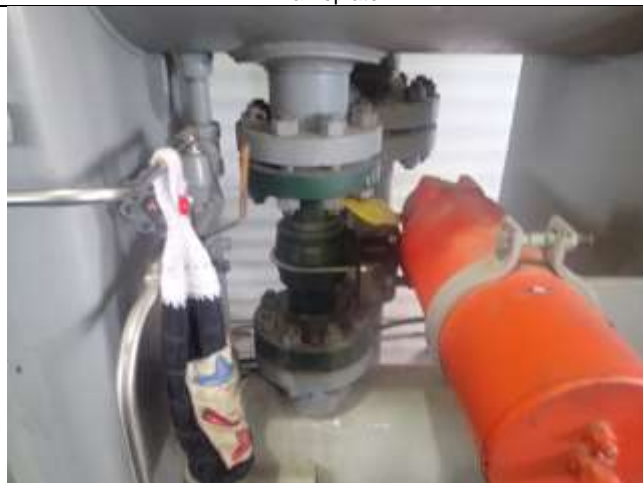
Inlet piping

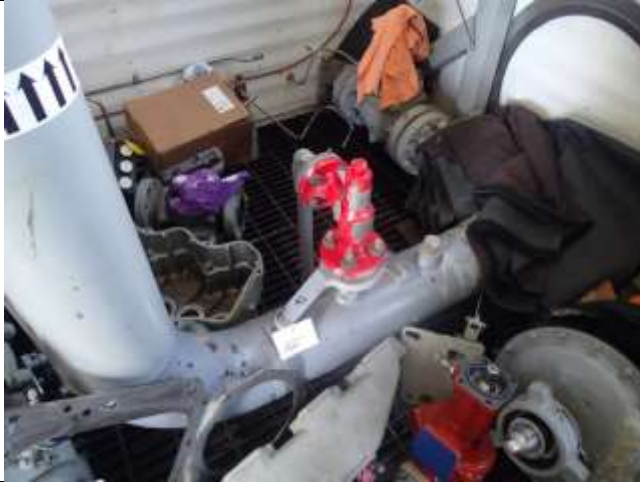
PSV overview – location on inlet to slug catcher

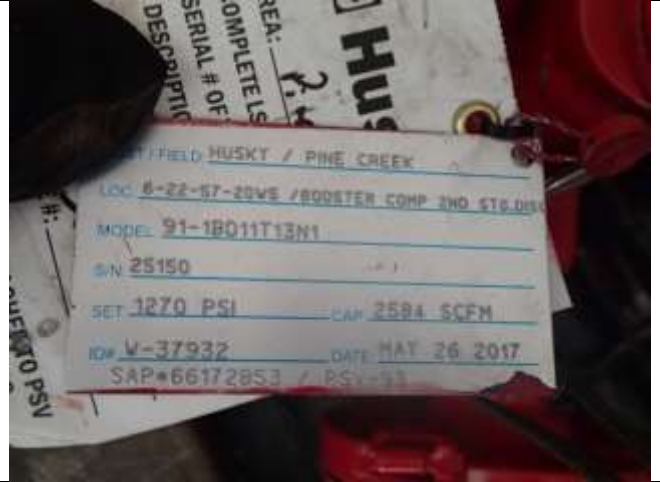
PSV service tag from May 2017 turnaround

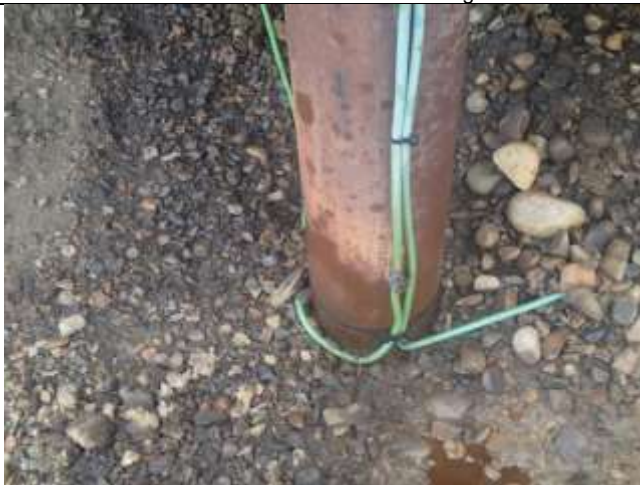
Skid grounding
