Imperial Oil Resources – ExxonMobil Canada Ltd.

STATIC EQUIPMENT INSPECTION REPORT

Item Inspected:	BOOSTER BLOWCASE
Location:	PINE CREEK 6-22-57-20-W5M
ABSA #:	A-457111 A457111
CRN #:	I 9454.213
Serial #:	00-742
SAP #:	
IORL#:	PID-014
Damage Code:	
AITEC Job #:	5301-6845

Inspection date: AUG 14, 2009

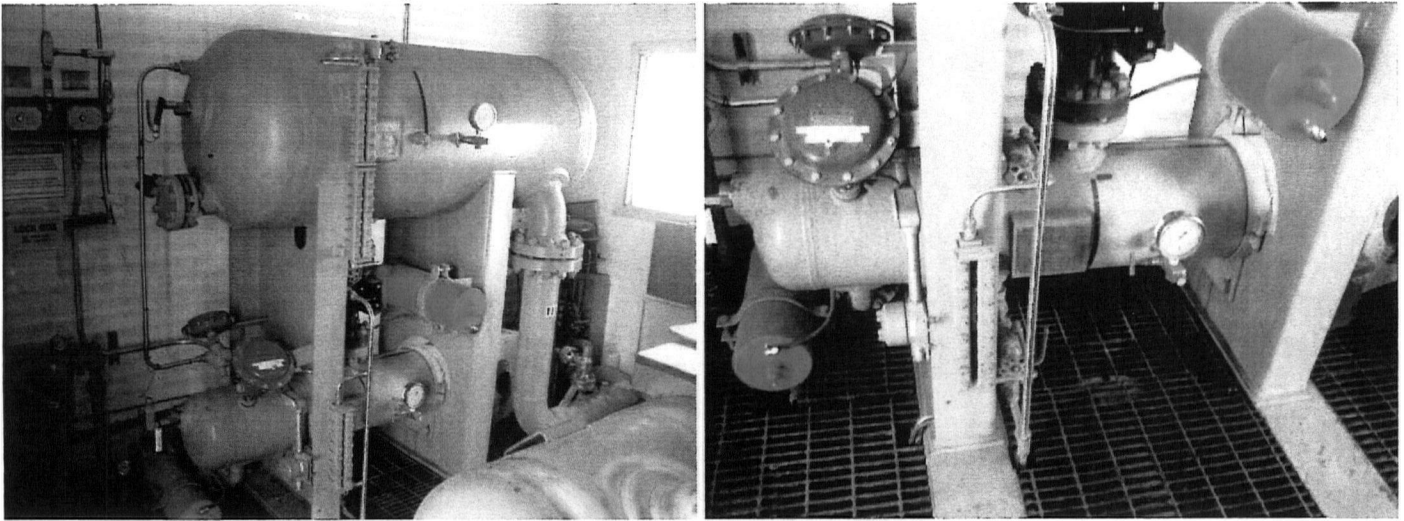
- Located inside Booster Compressor building bolted tight to floor
- Nameplate secure and legible
- Ground to support noted
- Paint in good condition
- Sight glass fouled
- Pressure gauge in good condition
- Piping appears adequately supported
- No concerns noted, near like new condition

BOOSTER BLOWCASE AT BOTTOM

- Acceptable for continued service
