## PRESSURE VESSEL & COLUMN INSPECTION REPORT

LSD: 06-22-057-20W5

SAP Equipment ID: 66172229

VESSEL STATIC DATA									
Plant: Foothills & BC			Op Unit Kaybob			System			
Prov. Insp. # 455864			CRN P0928.213			Equip Tag #			
Equipment Description			FILTER, 2 CHAMBER 1ST & 2ND STG INLET			Serial # 29697-01			
Manufacturer			ENERFLEX			Vessel Class Pressure Vessel			
Internal Access: Yes			Description: Removable 20" blind flange allows for torso in inspection of			Year Built 2000			
MAWP 740			Psi @ 100			MDMT -20 °F			
CODE : U			RT : 1			PWHT : Yes			
Diameter		Length		OAL		mm / in			
Shell	Mat'l	516-70N		Thickness	.625	In		Corr Allowance	.125 in
Head	Mat'l	SA-105/516-70N		Thickness	Left – 2.56	In		Corr Allowance	.125 in
					Right - .5625				
					Internal – 2.75				
Nozzle	Mat'l	106-B/105N		Thickness	Various	mm / in		Corr Allowance	NS mm / in
Internal Coating: NO			Internal Clad : NO			Capacity 2.86 Ft3			
Manway : No			Inspection Port : YES			Support: Custom Clamp			
Nozzle Rating	900	lb. ANSI		Painted : YES			Insulated No

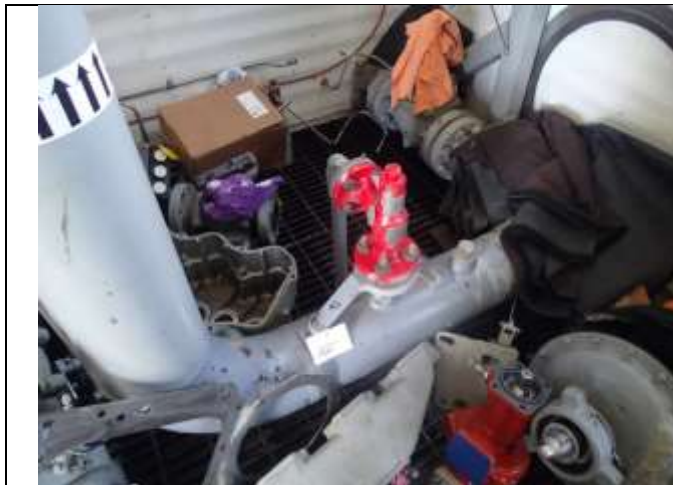
PSV overview – location on inlet to slug catcher

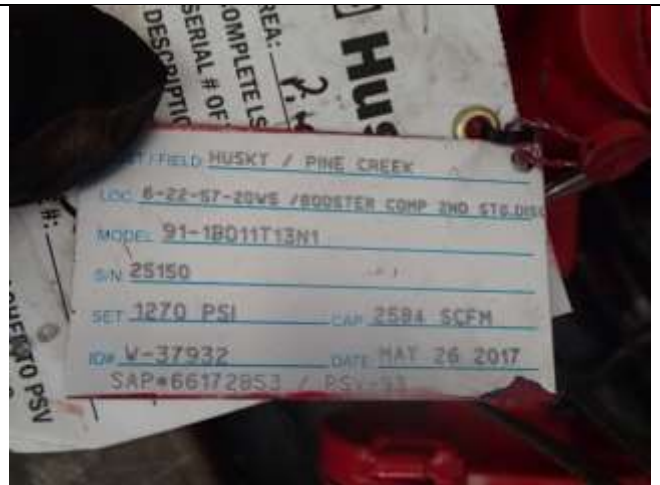
PSV service tag from May 2017 turnaround

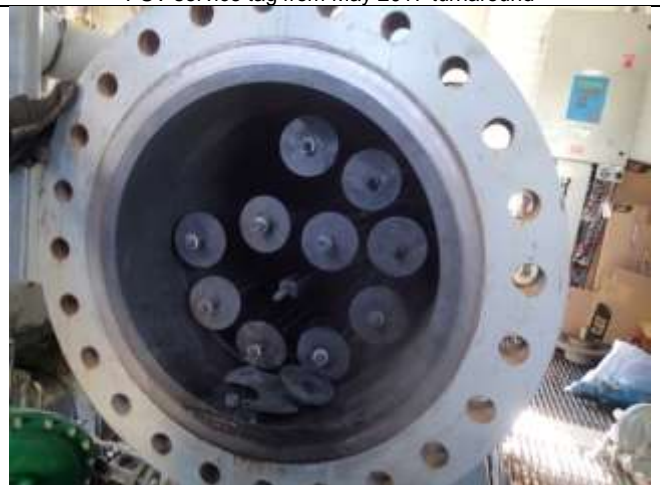
Internal – Access opening showing sealing surface, portions of shell and filter mounting hardware

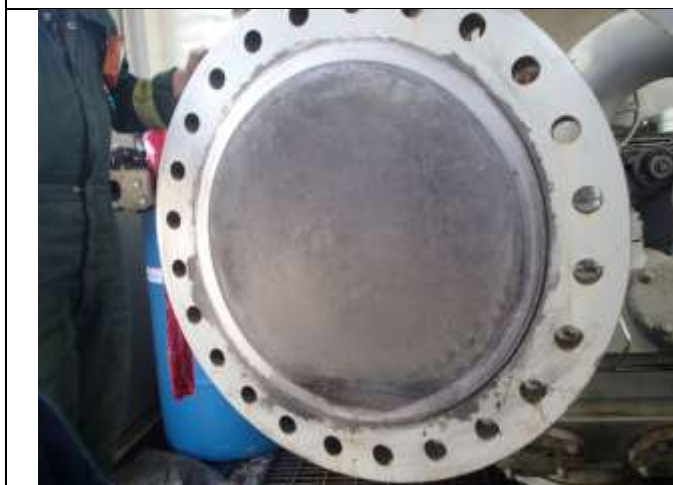
Internal – Access opening cover flange

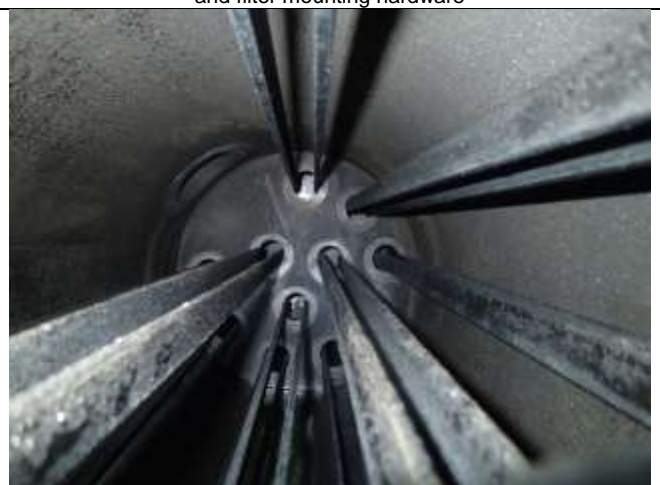
- No relevant indications of in-service corrosion/erosion/mechanical defects or damage in 'A' chamber. 'B' chamber cannot be accessed
- No non-conformances
- No inspection deficiencies
- No requirements for inspection interval change

Overview of 'A' chamber shell and filter mounting hardware. 'B' chamber not accessible
