Tank Floor Inspection Report

Husky Energy

Location: 07-27-51-19 W5
Tank Serial # 86779. Condensate Tank
Examined: Sep 12, 2011
Technician: Tom Dearden

HUSKY ENERGY INC.
ANSELL T/A
LSD 07-27-051-19W5M
CONDENSATE TANK
S/N: 86779

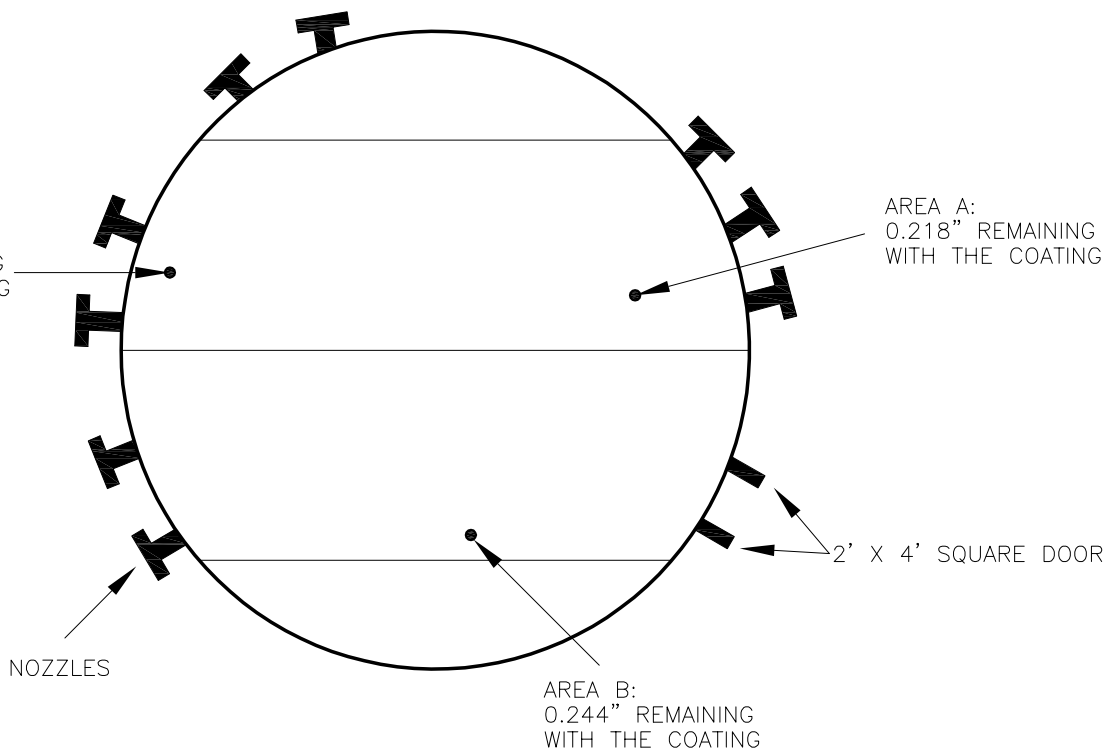
Based on the results of this examination the following conclusions can be made; three relevant indications were found (as illustrated following this report) and verified with ultrasonic examination.

Indication A; was found to have 0.218" thickness remaining with the coating. Ultrasonic examination was used to determine the thickness remaining with the coating.

Indication B; was found to have 0.244" thickness remaining with the coating. The indication found was 1/2" in size. Ultrasonic examination was used to determine the thickness remaining with the coating.

Indication C; was found to have 0.252" thickness remaining with the coating. The indication found was on the underside of a bulge in the floor that was 5" in diameter. Although unable to handscan the bulge, ultrasonic examination was used to determine the thickness remaining with the coating on the bulged area.

- NOMINAL FLOOR THICKNESS: 0.3125"
- SHOWN BELOW ARE AREAS WHERE PLATE LOSS IS PRESENT. NUMBERS ARE SHOWN IN TOTAL THICKNESS OF THE PLATE REMAINING

AREA C:
0.252" REMAINING
WITH THE COATING

AREA A:
0.218" REMAINING
WITH THE COATING

Based on the results of this examination, the following remedial action is recommended; monitor the three indications at the net service interval.
