STORAGE TANK INSPECTION REPORT

Date: Sept. 19, 2012

Plant	Minehead Compressor Station	Op Unit	6614 6030		System	
Asset #	222098	Equipment ID			Asset Type	
Description	400 BBL Produced Water Tank	Serial #	006782	Year Built	2003	
Manufacturer	Nusco					
Code	API-12F Modified	Fluid Service	Produced Water	Sour	MDMT	°C
Internal Access	Yes	Insulated	Yes	Internal Coating	Devoe 253

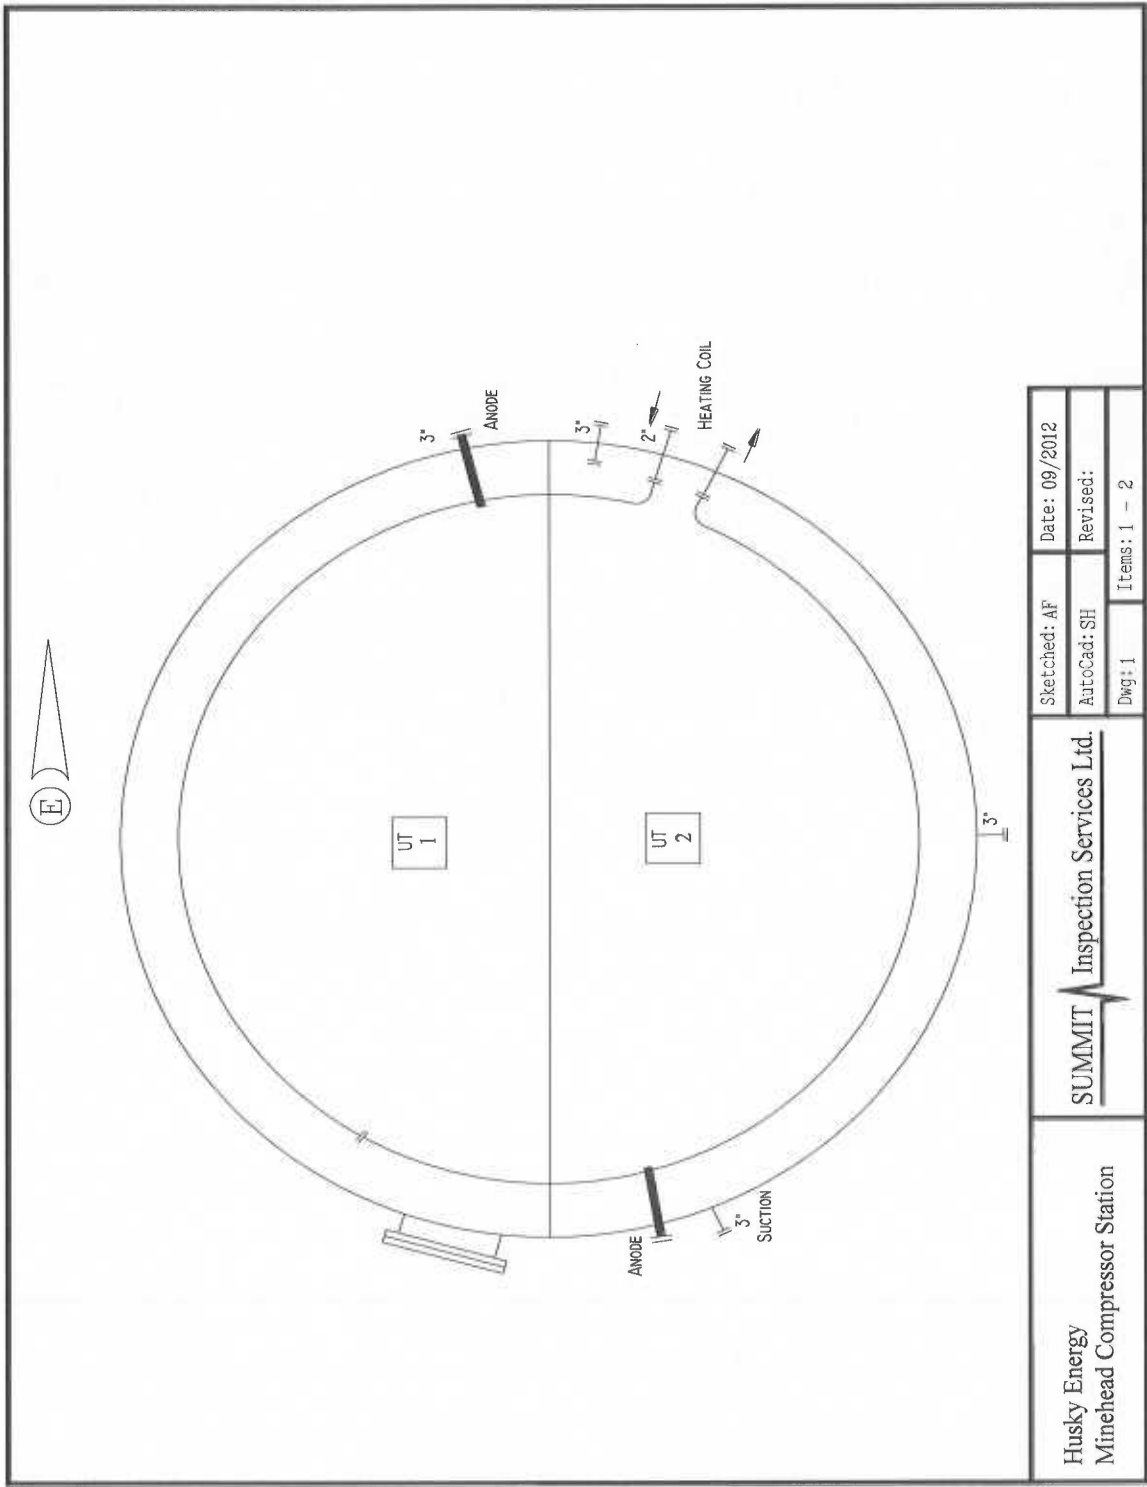
Floor Panel Design

UT thickness scans were performed on each of the internal floor plates (there is a double floor). Each scanned area was approximately 12" x 12", with an average and minimum thickness recorded for each area. Please refer to the attached floor map for the location of each test area.

Location#	1	2
Average	0.280"	0.285"
Min.	0.274"	0.276"

Nominal Floor Thickness is 0.250"

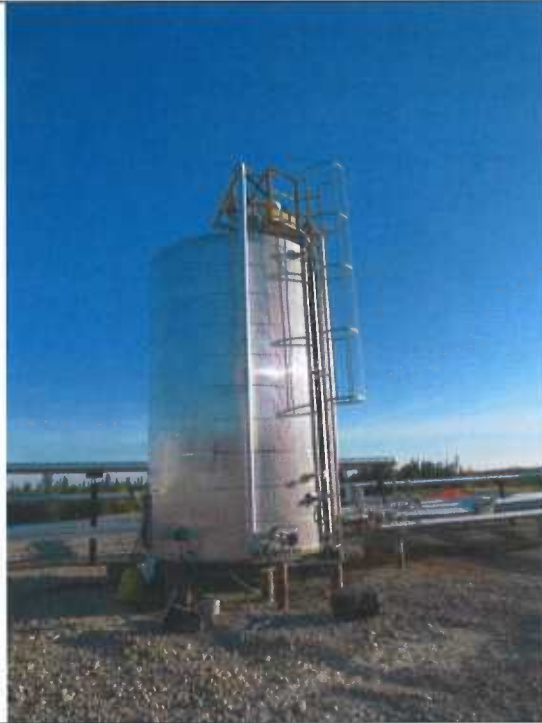
General external view of the storage tank

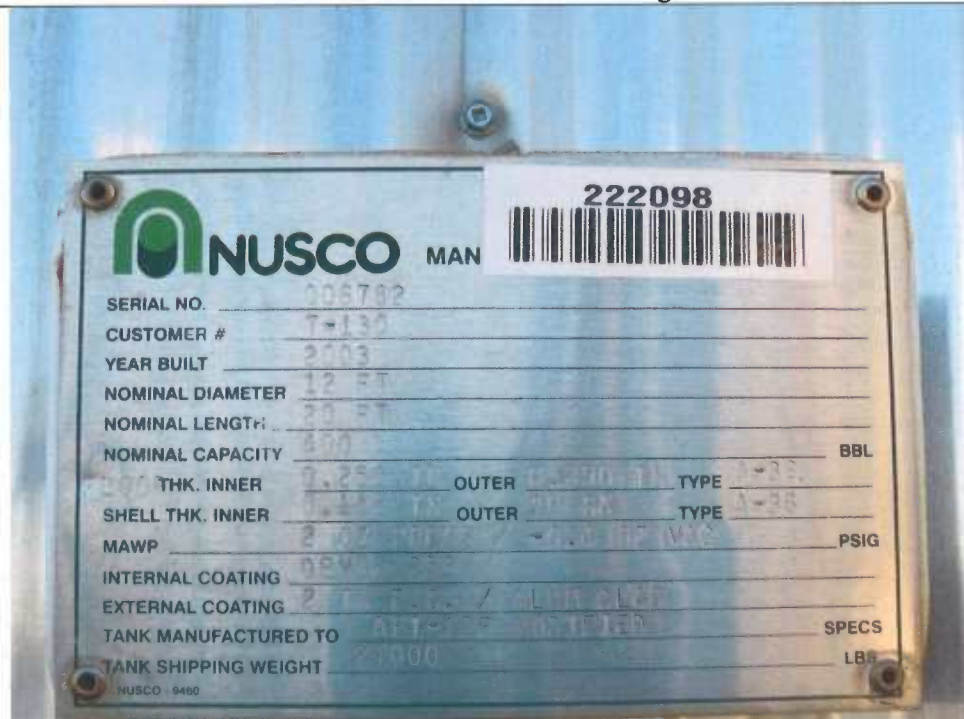
Nameplate

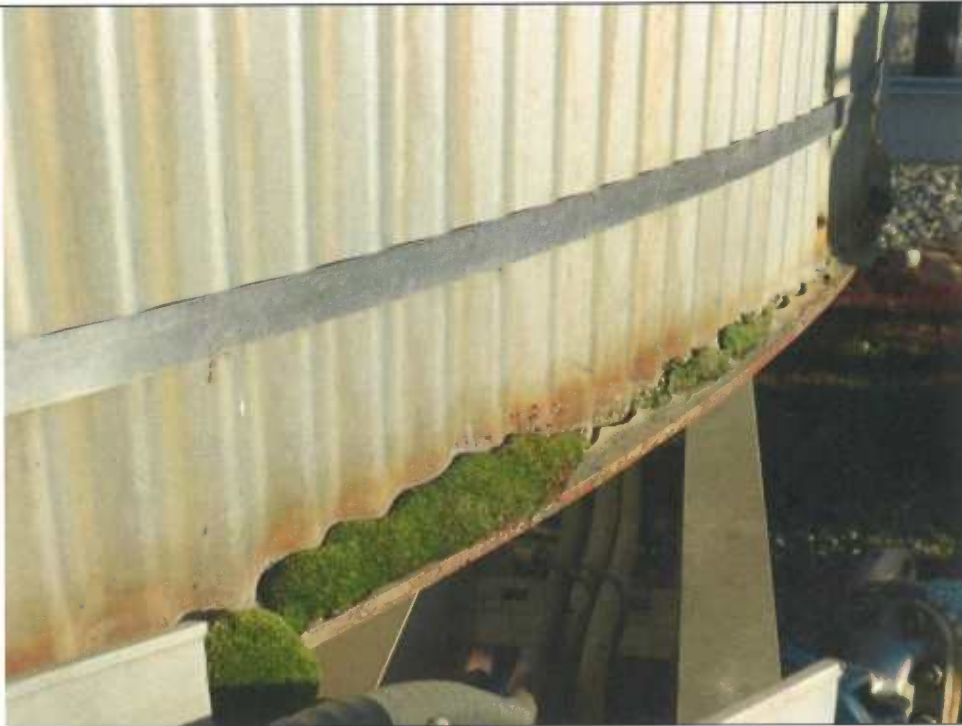
There were isolated areas of moss growing along the bottom of the insulation cladding.

Areas of moss growing along the bottom of the insulation cladding

All of the moss growing along the bottom of the insulation cladding should be removed in order to help prevent corrosion under the insulation.

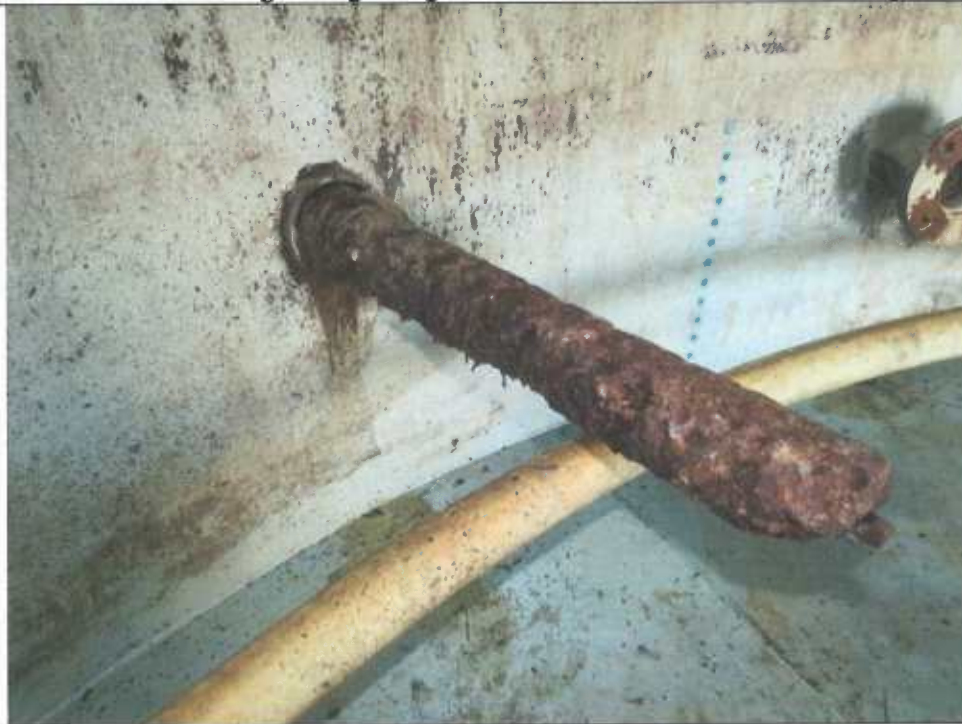
Internal anode

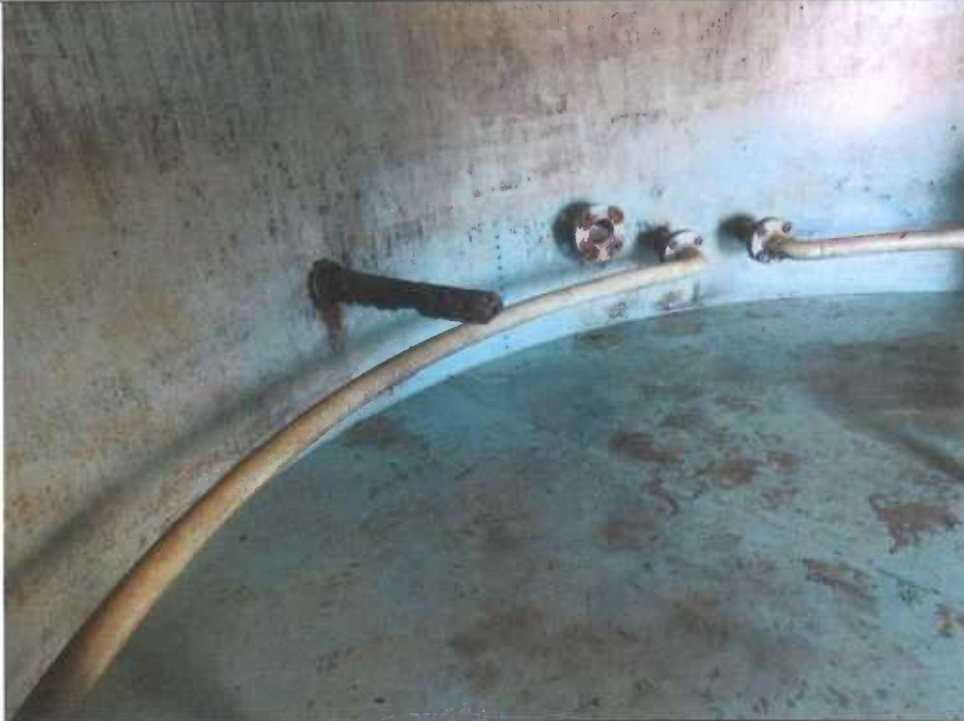
General internal view of the floor and lower shell

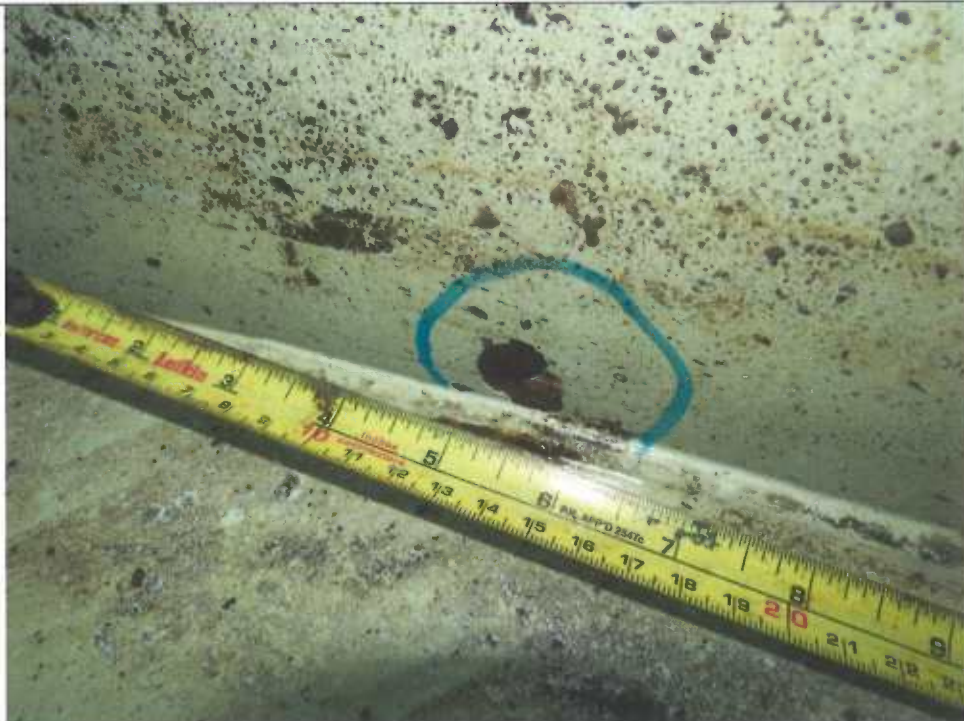
There were isolated areas of internal coating damage along the bottom shell, manway cover and the heating coil. Coating repairs were performed on the shell and manway, but the heating coil was to be removed prior to the tank going into service.

Isolated areas of coating damage along the bottom shell

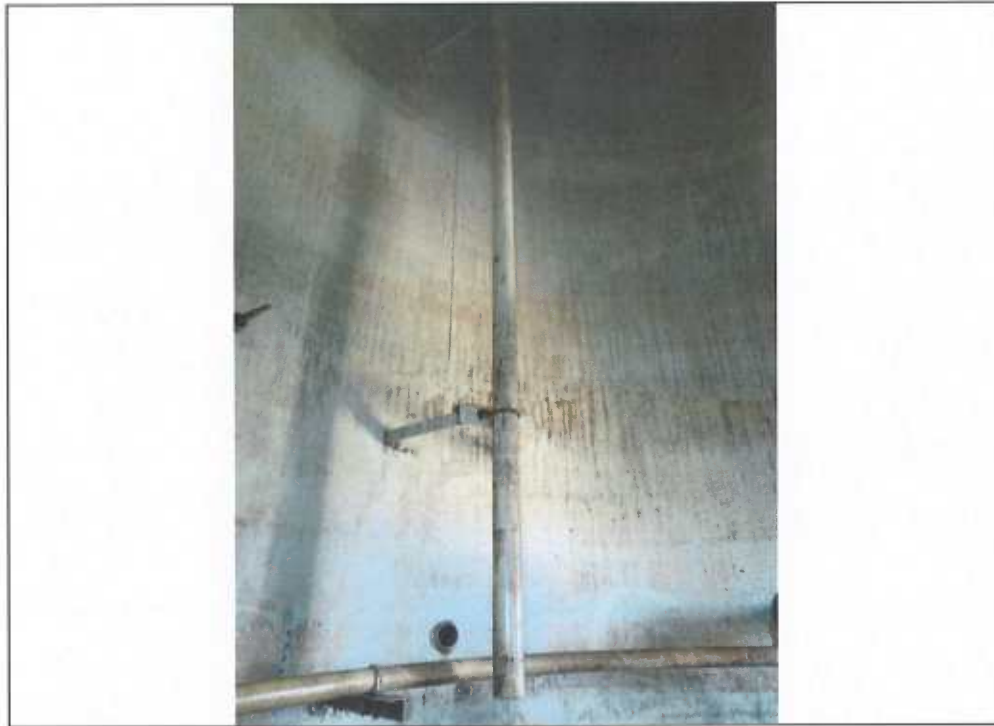
Internal overflow piping

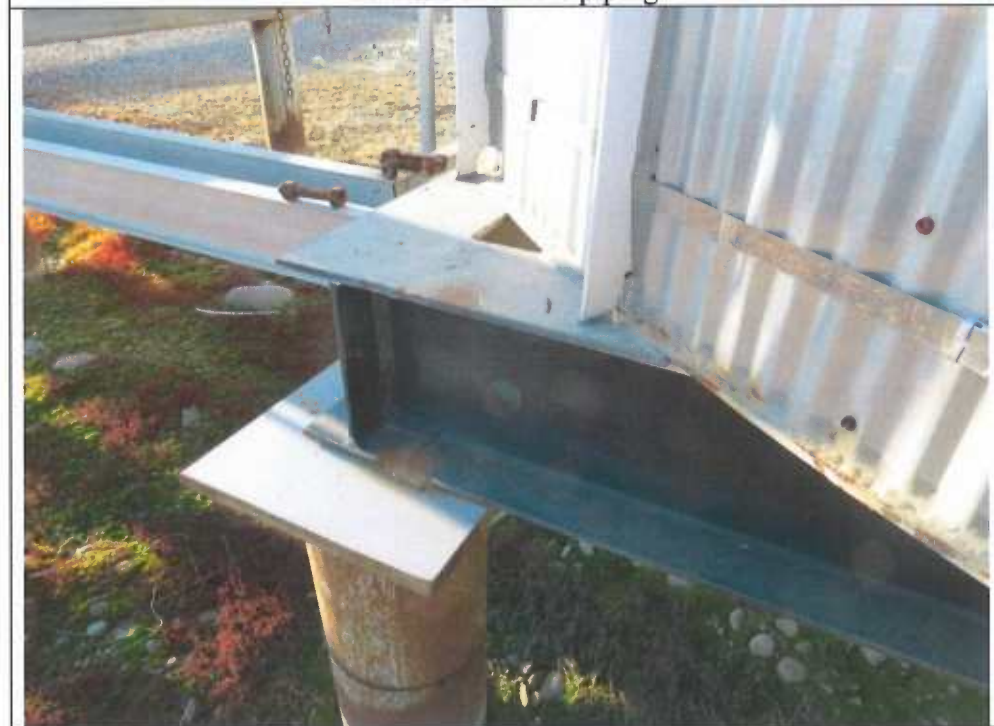
General view of the tank support system
