FIRED HEATER INSPECTION REPORT

LSD: 07-27-051-19W5M Date: JULY 10, 2014 SAP Equipment ID: 66036373

| | 3D. 01-21-031 | 10110111 | | Date. oc | JL1 10, 2 | .011 | O/11 L0 | juipinent it | J. 0000 | 0070 | | |
|--|---|---|---|---|---|---|---|---|---|---|---|---|
| Description | | Glycol | Reboile | r | | | | Serial | # | 5 | 413-70 | |

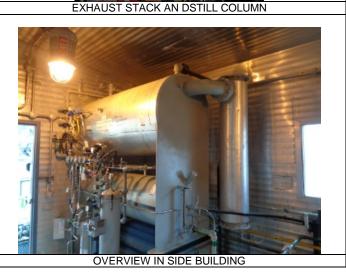
OVERVIEW

A visual external inspection was conducted on reboiler. In plant 1 dehy building. Plant 1 down at time of inspection. Dataplate is on burner, secure and legible.

Top vessel – reboiler - 36" dia x 168" approx.. Insulated and clad, cladding in good condition. Some outer layer paint deterioration on firetube flange. Some cladding damage / denting on still column. Burner and stack appear to be in good condition.
