## SHELL & TUBE INSPECTION REPORT

LSD: 07-27-051-19W5M

Date: JUNE 07, 2014

SAP Equipment ID: 66036274

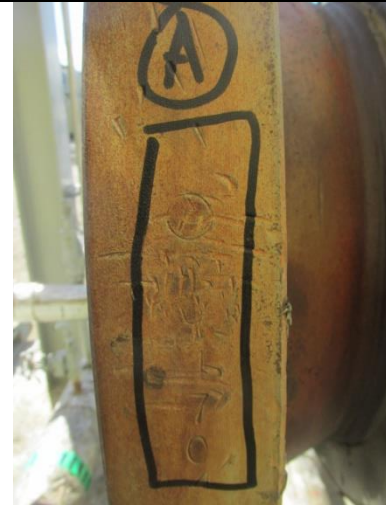
Dataplate was not located. Either it is missing or under insulation. A# was found stamped in shell to channel flange (shell side). Shell side and piping is insulated, preventing visual access to shell surface. Cladding and banding in good condition, no damage noted. Exposed nozzles show signs of heat caused paint deterioration. No corrosion noted on exposed surfaces. Channel bonnet was found to be in fair condition. Extensive paint caused paint deterioration and surface rusting / very light corrosion noted, however no significant wall loss was measured. Vessel saddle support anchor bolts are securely attached to structural beams, which are in good condition. Building skid is grounded but no direct ground connection to exchanger found. No visual access to support to shell connections. All associated piping appears well supported and in acceptable condition. Tube side PSV (off tube side piping) service is up to date. PSV inlet and outlet isolation valves are carsealed open. Shell side PSV was found to be off the stabilizer tower. UT corrosion survey performed by Streamline Inspection June 2014.

A# stamped in shell flange

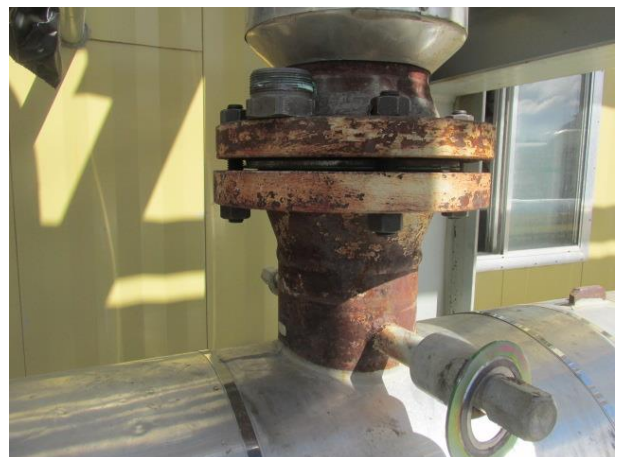
Nozzle paint deterioration due to heat, no significant corrosion

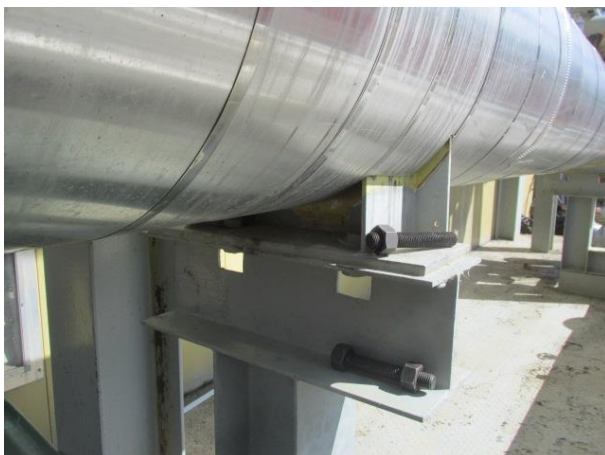
Saddle supports bolted to beams

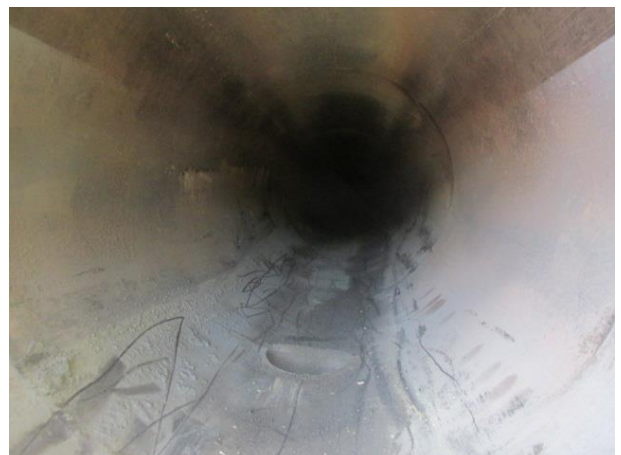
Shell side internal

Exchanger bonnet was removed and tube bundle pulled and cleaned for internal inspection. Shell side was found to be in fair condition. Several minor wear areas were noted on shell where tube bundle baffle plates are in contact with shell. These were located at approx. 83" and 56" in from shell flange. Wall loss was not measureable due to no access and vessel being insulated. Wall loss does not appear significant and is not a concern at this time. No other areas of corrosion or damage noted on shell, shell side nozzles or shell flange face. No visible corrosion or defects on shell or nozzle welds was observed. No visual access to far shell and head was possible due to distance from shell opening. Channel bonnet was found to be in fair condition. No corrosion or erosion noted on head, shell or nozzles. The partition plate was found to be securely attached with no deformation noted. Channel and channel nozzle flange faces were found to be in acceptable condition with no corrosion or damage noted. Tube bundle was found to be in fair condition. Tubes near return bends are being held in place by insulation straps. These tubes were found to be bent out of place at previous inspection. Some external pitting noted on one tube. This tube and one other have been historically plugged. Some bowing of the tubes was noted. A hard scale was found on tubes externally. No significant corrosion noted under scaling on tubes still in service. No fretting damage noted at or near where tubes pass through baffle plates. Eddy current was performed on tubes by FGG. Wall loss (approx. 0.030%) was noted on several tubes – see FGG report for details. As a result of the Eddy Current test, it was decided to plug 5 tubes.

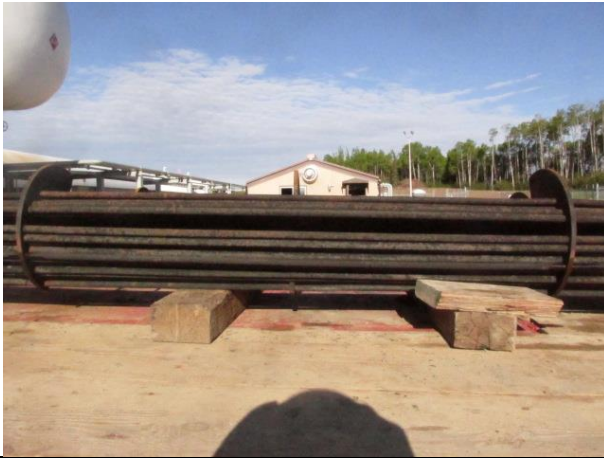
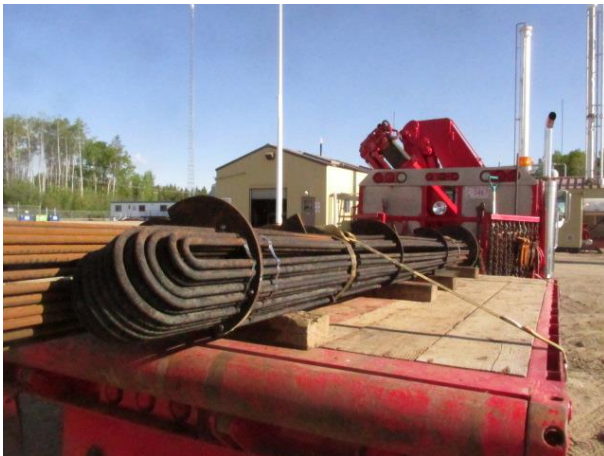
Tube bundle wall loss noted during FGG Eddy Current inspections – See FGG report for details.

It appears the tube bundle is reaching the end of it serviceable life span. Consider replacing tube bundle at next outage.

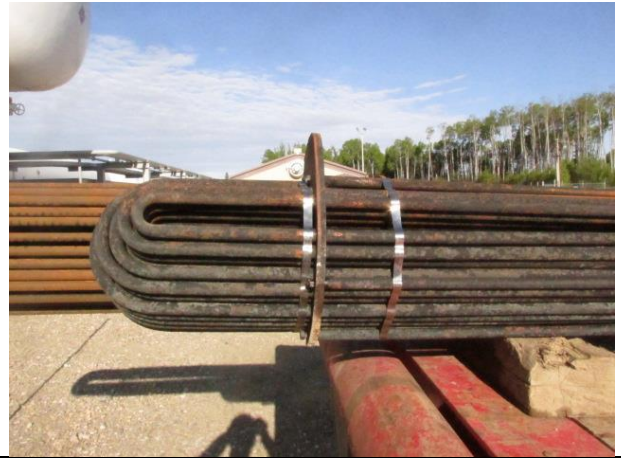
V21	Internals Other (Please explain)	Good	Channel partition plate		Securely attached, no distortion
V22	Demister	n/a			
V23	Baffle/Weir	n/a			
V24	Sparger	n/a			
V25	Thermowells	n/a			
V26	Metallic Linings	n/a			
V27	Nonmetallic Linings	n/a			
V30	Other Welded Attachments	n/a			
V31	Tubes	Fair poor	Tube bundle		Eddy current found wall loss on 5 tubes. These tubes are to be plugged. Tubes near tube return bends are being held together by insulation banding (several tubes were bent out of place at previous inspection.)
V32	Tube sheet	Good

Tube bundle return bends – bundle tubes have insulation banding holding it together

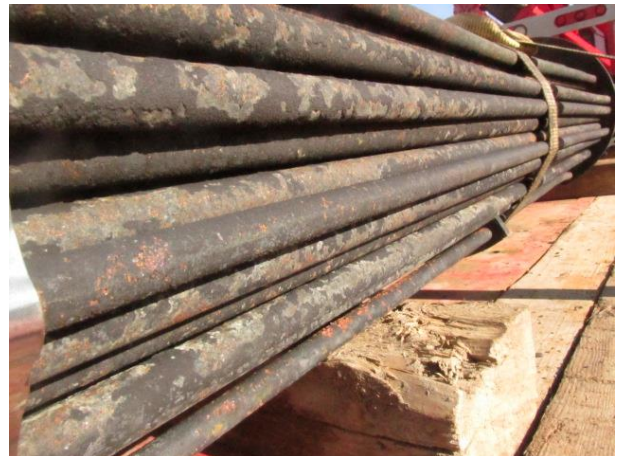
Tubes – scaly buildup

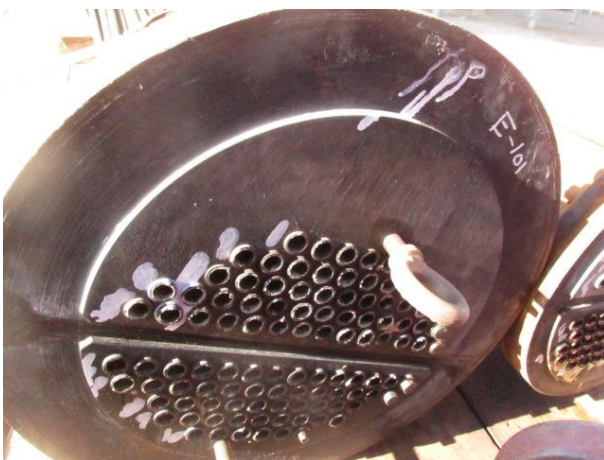
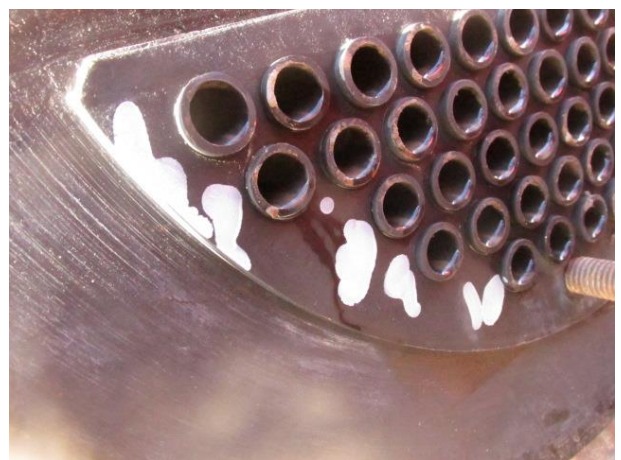
Tube sheet – 5 tubes marked for plugging after Eddy Current testing

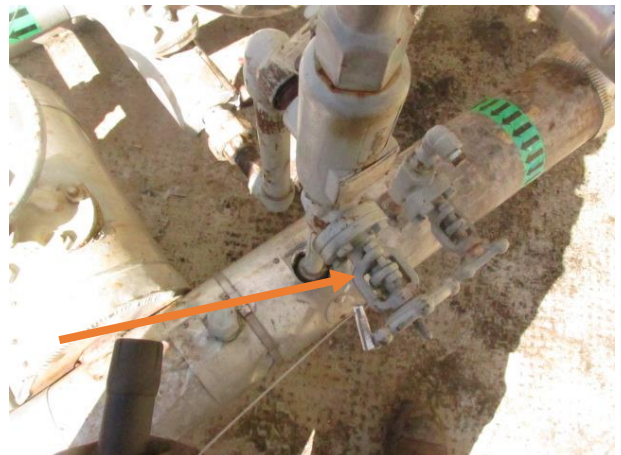
PSV inlet isolation valve carsealed open

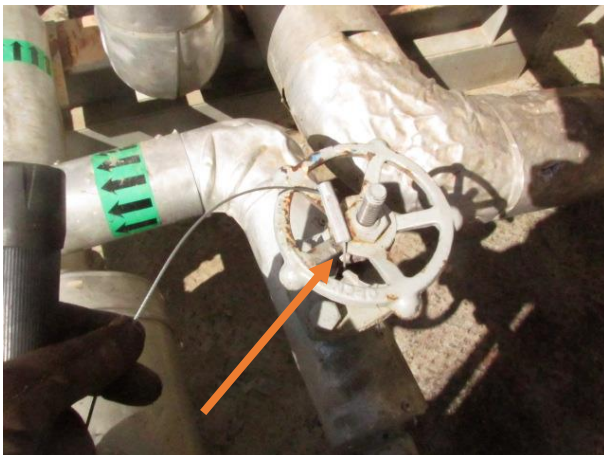
Tube side PSV outlet isolation valve carsealed open

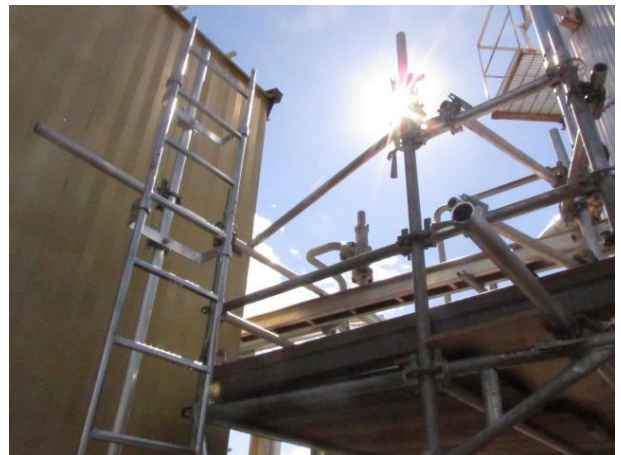
Shell side PSV – off stabilizer tower
