PRESSURE VESSEL & COLUMN INSPECTION REPORT

LSD: 07-27-051-19W5M

Date: JUNE 07, 2014

SAP Equipment ID: 66046896

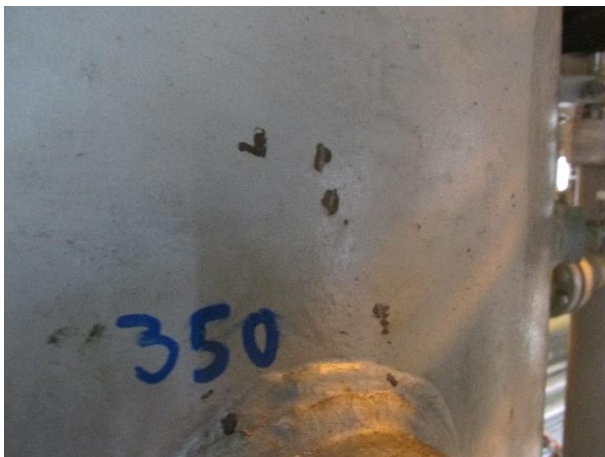
Minor paint damage to shell

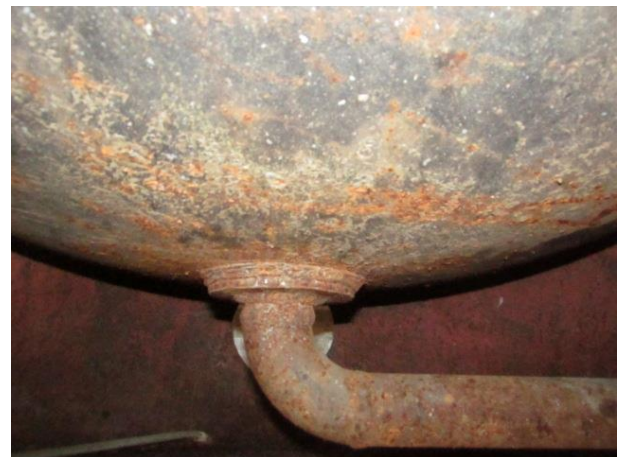
Vessel and piping are in good condition, piping well supports. No significant paint damage, corrosion or mechanical damage noted on shell, top head or piping. Light surface rusting and general corrosion noted on bottom head and drain line. Estimated depth 0.015". Some very small, minor paint chips found on vessel. Vessel is securely welded to the skid floor. An inspection access port is present in the skirt. Dataplate is securely attached to vessel and is legible. Manway davit is only has a single nut. Bridle top PSI gauge has paint spatter on the glass, making is hard to read. Gound cable attached to skid, no direct connection to vessel. PSV service is up to date, set below MAWP, vents to flare header. Shortbolting noted on PSV inlet flange. UT survey done 2014 by Streamline Inspection.

Bottom head general corrosion

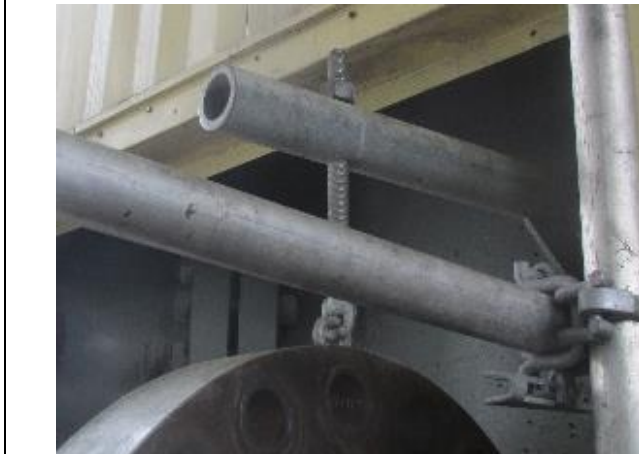
Davit arm, single nut only

Review UT Survey results.
Double nut manway davit.
At next plant outage remove and replace demister pad, Visually inspect top head once demister has been removed.
Fix shortbolting on PSV inlet flange, will require longer bolts – operations was informed of concern.

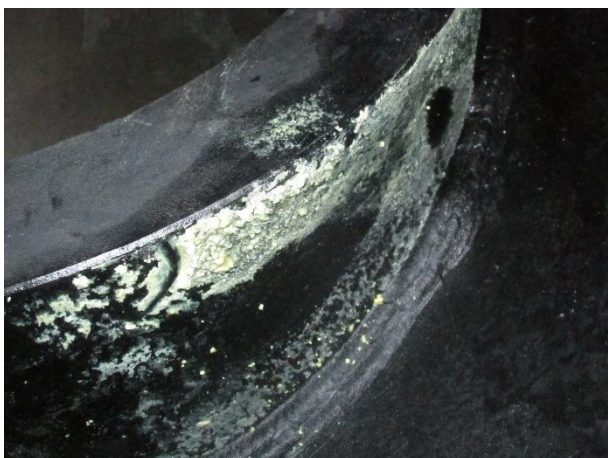
Some waxy deposits remaining on manway nozzle

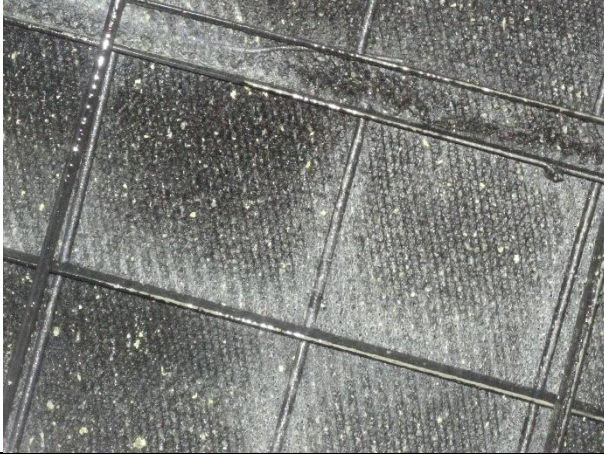
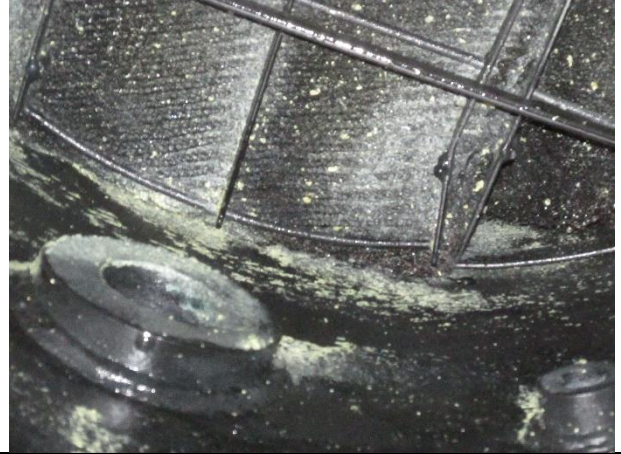
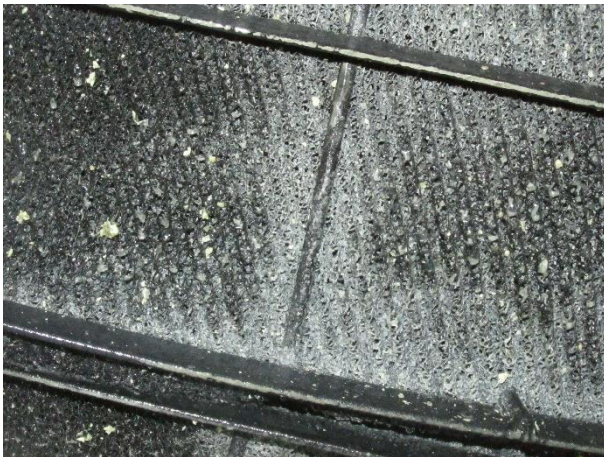
Demister pad fouling

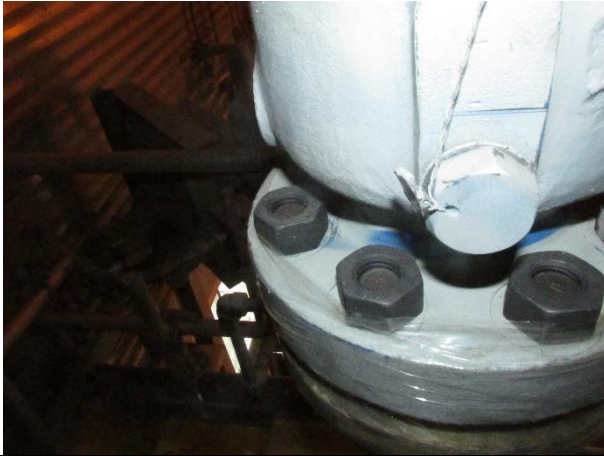
Shortbolting on PSV inlet flange.

PSV inlet flange shortbolting top of studs

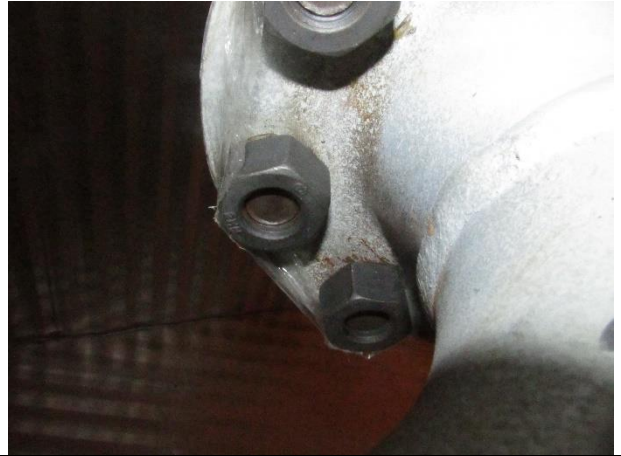
PSV inlet flange shortbolting bottom of studs

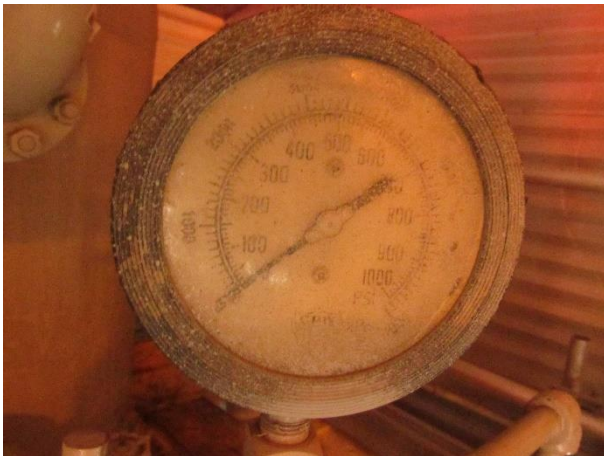
Paint overspray on bridge PSI gauge glass
