PRESSURE VESSEL & COLUMN INSPECTION REPORT

LSD: 07-27-051-19W5M

SAP Equipment ID: 66042738

VESSEL STATIC DATA						
Plant		Ansell Gas Plant		Op Unit		System
Prov. Insp. #		A0157978		CRN		F-2109.2
Equipment Description		Stabilizer Tower		Serial #		1704-201
Manufacturer		Vada Ind.		Vessel Class		
Internal Access: yes		Description: 2 x 20" manways		Year Built		1984
MAWP 486		PSI @ 354		°F		MDMT °F
CODE : U		RT : 1		PWHT : yes		
Diameter	30in	Length	(s/s) 814 in	OAL	mm / in	Vertical
Shell Mat'l	SA-516-70	Thickness	0.625 in	Corr Allowance	0.125 in	
Head Mat'l	SA-516-70	Thickness	0.543 in	Corr Allowance	0.125 in	
Nozzle Mat'l		Thickness	in	Corr Allowance	mm	
Internal Coating: NO		Internal Clad : NO		Capacity		m3
Manway : yes		Inspection Port : no		Skirt		
Nozzle Rating	lb ANSI	Painted : YES		Insulated		yes
PROCESS DATA						
Product Description		Condensate		Sweet		
Operating Pressure		PSI		Operating Temperature		°C
PSV STATIC DATA						
Serial No.	Location	Set Pressure	Capacity SCFM / Lbs/Hr / GPM	Manufacturer	Model / Type	Service Date / Company

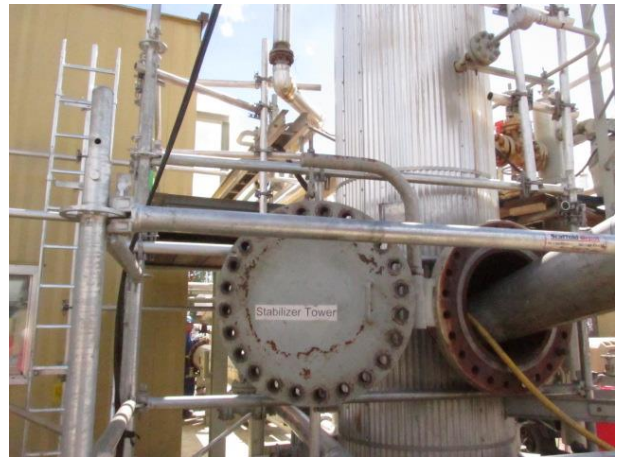
Bottom manway and davit arm, single nut only

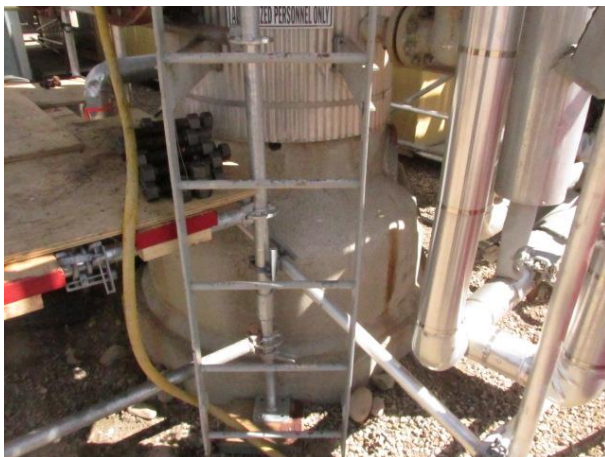
Concrete base

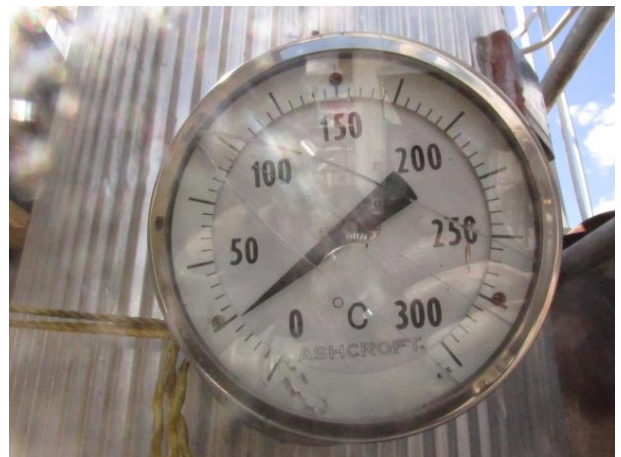
Cracked temp gauge glass

Consider removing larger section of trays for next inspection in a fashion that will allow for better / safer access for inspection / inspector. Tower will require a full top to bottom inspection. (review drawings).
Install longer safety chain / safety bar across platform opening to ladder (at top platform).
Replace temp gauge

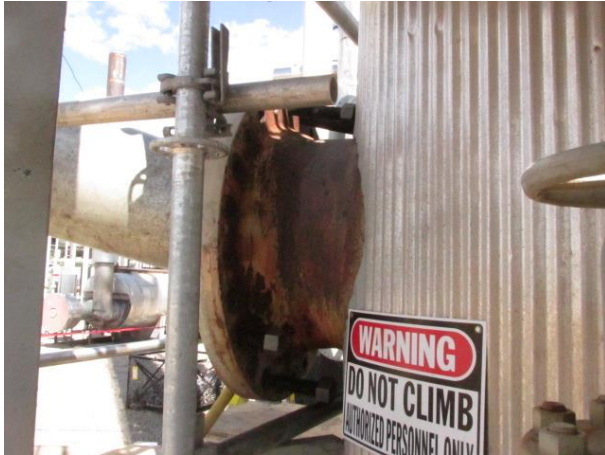
Paint deterioration on bottom manway

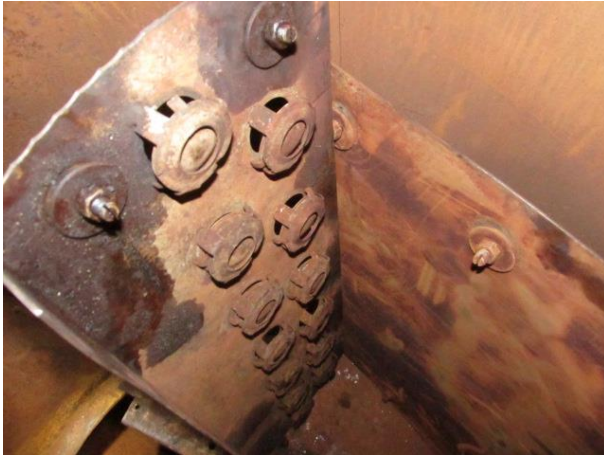
V28	Trays	Good	First 3 trays		Bubble caps have full functional mobility, no damage
V29	Tray Rings	Good	First 3 trays		Securely attached
V30	Other Welded Attachments	n/a

Bubble cap trays

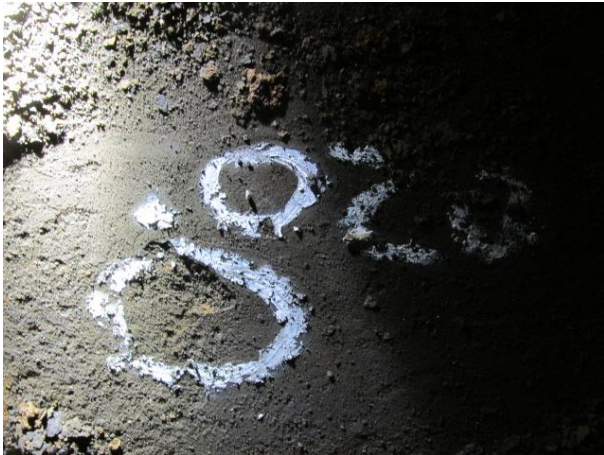
Corrosion on bottom head 0.020" deep

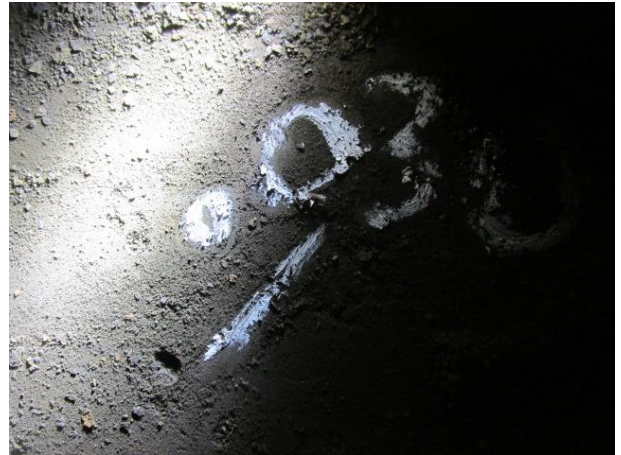
Corrosion on bottom head 0.030" deep

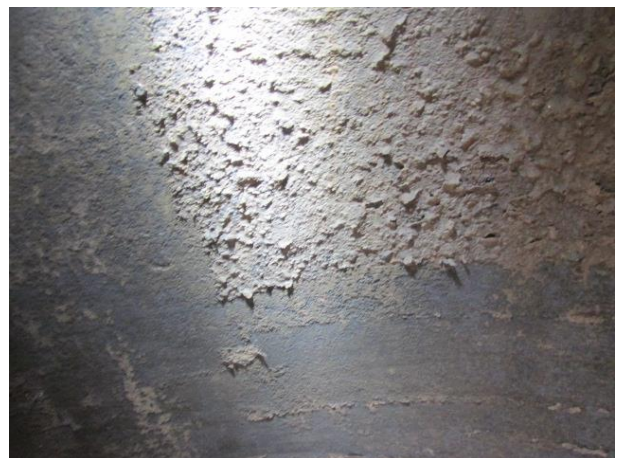
Bottom shell, scale and debris easily wire brushed clean
