PRESSURE VESSEL & COLUMN INSPECTION REPORT

LSD: 07-27-051-19W5M

SAP Equipment ID: 66005380

VESSEL STATIC DATA						
Plant		Ansell Gas Plant		Op Unit		System
Prov. Insp. #		A0436161		CRN X-0170.2		Equip Tag # V-102A (equip list). V101B (as per operations)
Equipment Description			Slug Catcher Separator			Serial # 3625A
Manufacturer			Vancouver Iron and Engineering			Vessel Class
Internal Access:		yes		Description: 18" MW		Year Built 1997
MAWP		400		PSI @ 650		°F
MDMT		0				°F
CODE :			RT :			PWHT : Yes
Diameter		78in		Length (s/s) too high to measure		OAL mm / in
Shell Mat'l				Thickness		in
Head Mat'l				Thickness min		in
Nozzle Mat'l				Thickness		in
Internal Coating: NO			Internal Clad : NO			Capacity 940 ft3
Manway : yes			Inspection Port : no			Skirt
Nozzle Rating		600 lb ANSI		Painted : YES		Insulated Yes – Skirt only
PROCESS DATA						
Product Description			Gas,liquids			Sweet
Operating Pressure			PSI		Operating Temperature °C	
PSV STATIC DATA						
Serial No.	Location	Set Pressure	Capacity SCFM / Lbs/Hr / GPM	Manufacturer	Model / Type	Service Date / Company

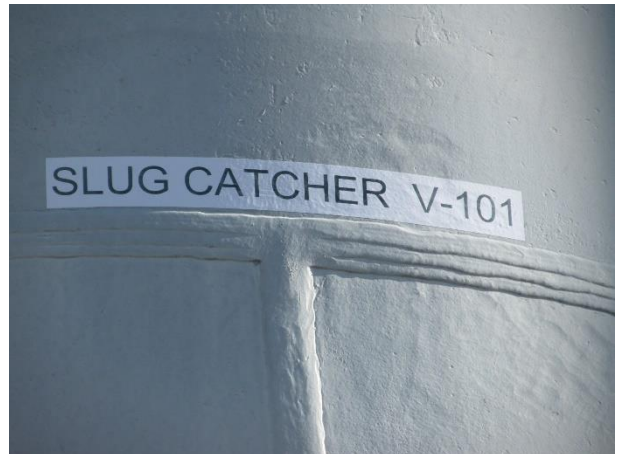
Note: Vessel tagged as V-102A on equipment list and SAP but tagged V-101B on vessel and as per operations.

Vessel labeled V-101

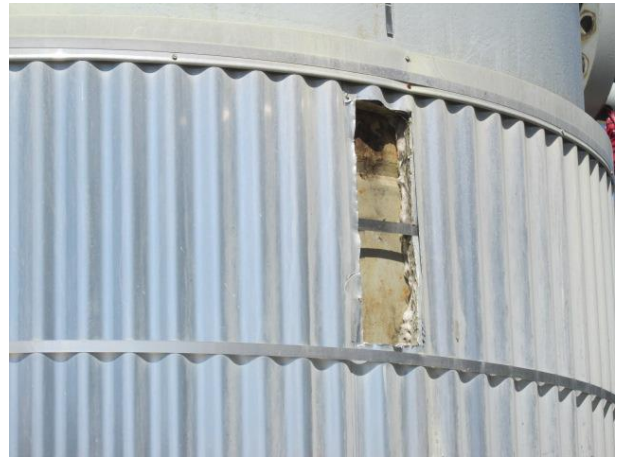
Vessel and piping are in good condition. Vessel and piping are painted, paint in good condition, no damage or corrosion noted. Vessel skirt is insulated and clad. Cladding in fair condition. There is an inspection access port cut in insulation with no coverplate, allowing moisture to get into insulation. Moss was found growing at top and at base of cladding / insulation. No visual access to skirt or anchor bolts as cladding comes down concrete foundation. Concrete foundation was found to be in acceptable condition, no significant cracking or damage noted. Vessel outlet piping is supported with a temporary support post resting on ground. Operations is aware of the poor support system for this section of piping. Manway davit arm appears in good condition, davit is double nutted. Piping off bottom is insulated and clad, cladding in fair condition with some minor damage noted. There is an inspection access under skirt to UT bottom head and drain elbow. This is considered a confined space. Some minor surface rusting noted on bottom head. Dataplate is securely attached to vessel, and is legible. Ground cable securely attached directly to skirt. PSV service is up to date, set at MAWP and vents to flare header. UT survey done 2014 by Streamline Inspection.

No coverplate on skirt cladding inspection cut out

Review UT survey results.
Install coverplate over insulation cut out, and seal.
Improve piping support for outlet piping – Pillings and structural steel supports

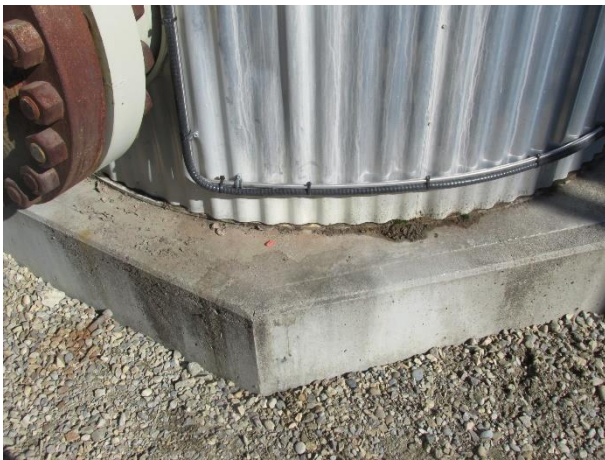
Concrete foundation

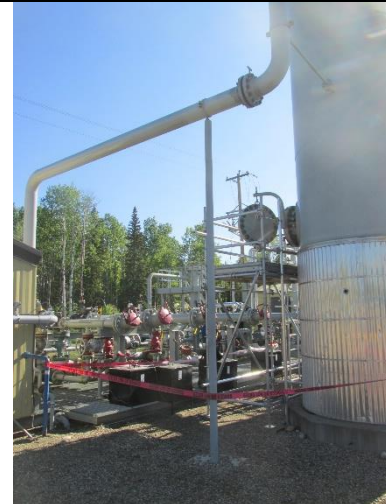
Temporary support for gas outlet piping, support post resting on ground

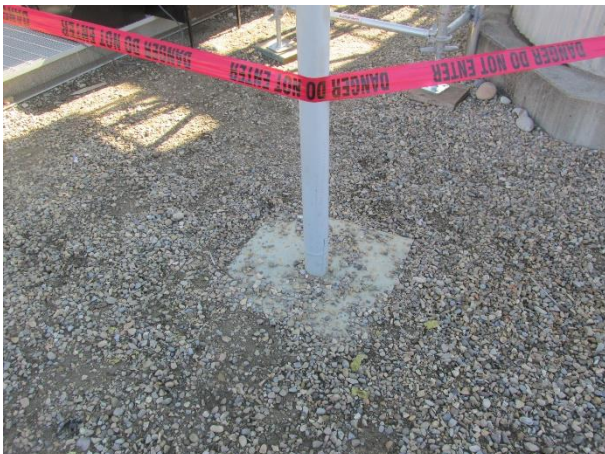
Temporary support for gas outlet piping, support post resting on ground

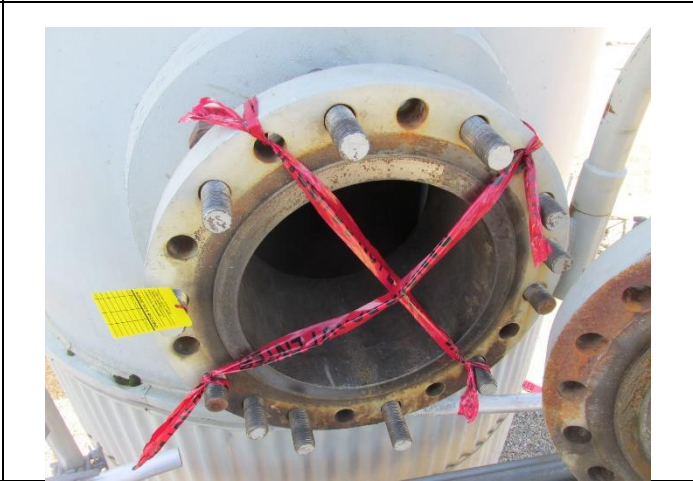
Manway flange face

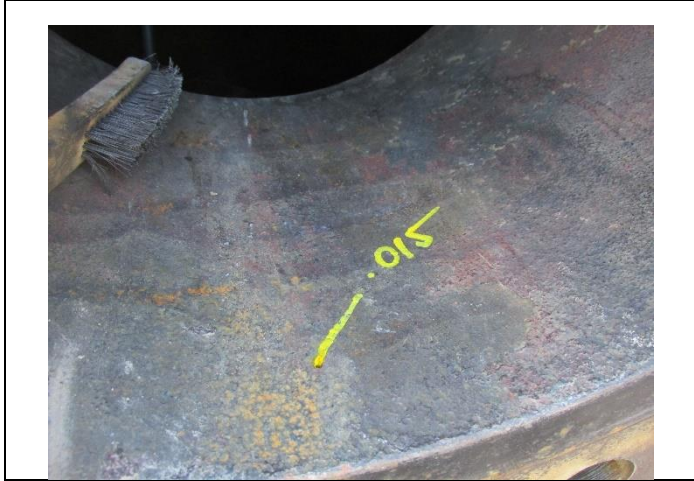
Internal inspection was done after vessel was aired out. Internal access is through 18" manway. Manway flange gasket surface in acceptable condition, no corrosion or damage noted. Minor surface corrosion noted on bottom of manway nozzle throat, approx. 0.015" deep. Scaffolding was set up within vessel to visual access upper portions of shell and top head. General corrosion was found throughout bottom shell course. There is no evidence that the general corrosion found is active. General corrosion depths average 0.015" to 0.025". Some small areas of hard black deposits found on bottom shell. No under deposit corrosion noted when areas scraped clean. No significant corrosion noted on circs, longseam, nozzle or attachment welds. Bottom head was found to be in good condition, no significant corrosion or damage noted. Bottom nozzle vortex breaker was found to be in acceptable condition and securely attached. Inlet deflector plate and nozzle cover attachments are all securely attached. There is a ring welded around top shell below top head for a demister. However there is no demister currently installed or in use in vessel. There was a large loose nut found laying on top of demister ring. Loose nut was removed from vessel. Half way up the shell there

General corrosion on bottom of manway nozzle throat

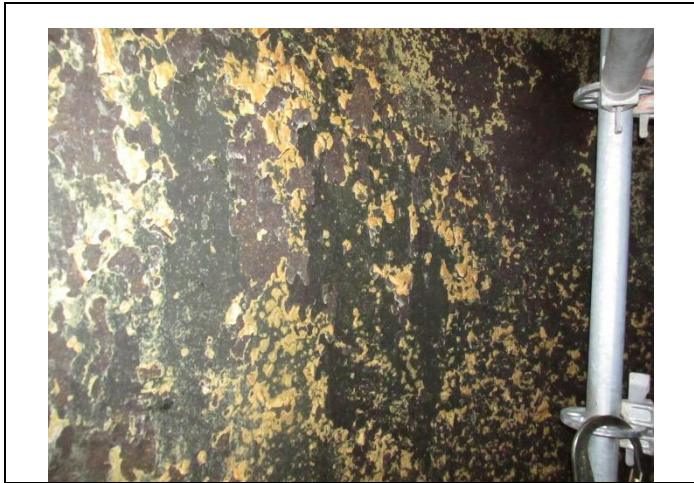
was some waxy product buildup remaining of shell and top head. This wax buildup was easily scraped off to allow visual access to shell and top head surfaces. No significant corrosion or damage noted underneath wax buildup on areas where it was removed via scraping on mid, or top shell, or on top head. No corrosion noted on top head or mid shell. No corrosion, damage or obstructions noted within inlet, top outlet or bottom outlet nozzles. No nozzle obstructions noted.

Mid shell waxy buildup

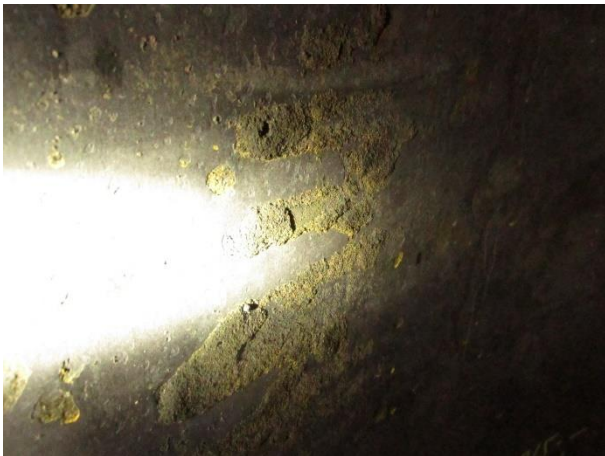
Bottom shell hard black deposits
